INTERDISCIPLINARY PARASEISMIC CONCEPTION AND REHABILITATION OF THE CULTURAL HERITAGE IN SMALL VILLAGES. WORKSHOPS WITH STUDENTS ON SITE.

Wilquin Hugues /Belgium

The case study of Colmars les Alpes

For its 7th seminar-workshop, PACT 19 undertook, from the 10th to the 16th of July 2000, the study of the small village of Colmars les Alpes (Alpes de Haute Provence, France).

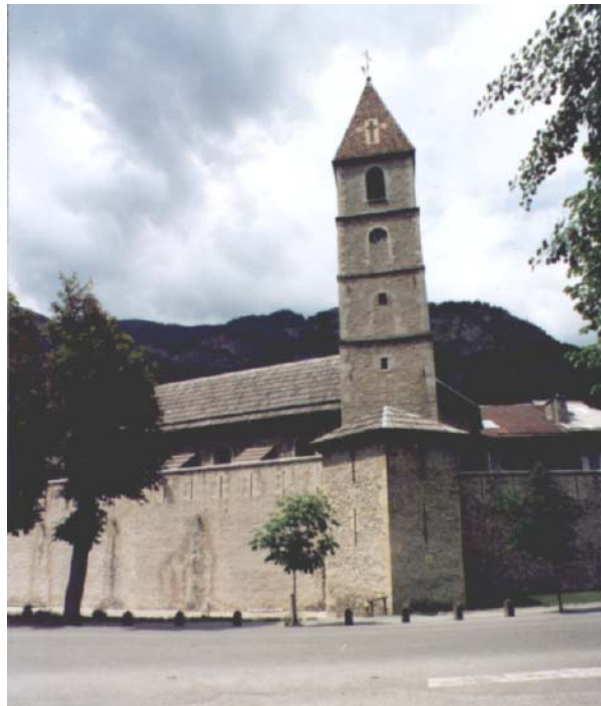
Fig. 1 External view of the Saint Martin church and damages on the vaults

3 the study of an important monument, the Saint Martin church (Fig.1)

church, written in old occitan language and “translated” into contemporary terms and put in relation with the architectural and structural observations of the building itself (based on deformations, pathological analyses,...), morphological and constructive evolutions were presented. It was then possible to draw up a mechanism of ruin under the effects of an earthquake (using possible spectrum of earthquake in the area). Proposals of appropriated techniques of mitigation (placement of ties, reinforcement of the chaining,...) and ways of rehabilitation were then proposed (the technical details were fully described and sometimes shown through sketches).(Fig.2)

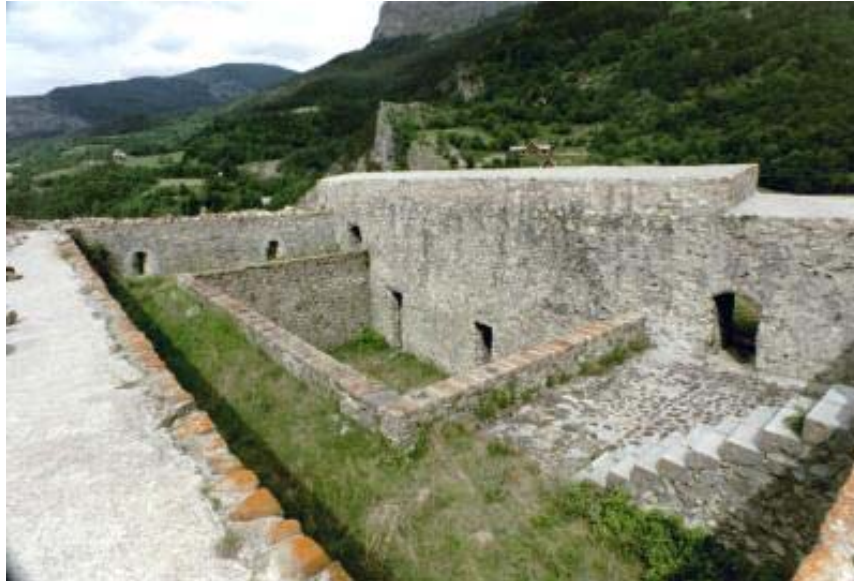
Fig.3 the fort of France

4 the study and proposal of re-use for a monumental unit (the fort of France)(Fig.3)

The study of the historical monuments (particularly the texts and drawings of the collaborators of Vauban) and of the scars and marks on the building itself made possible to draw up a report of the morphological evolution of the fortress.

The structural analysis and the study of the ground enabled us to present a “ clinical” description and diagnosis of the building.

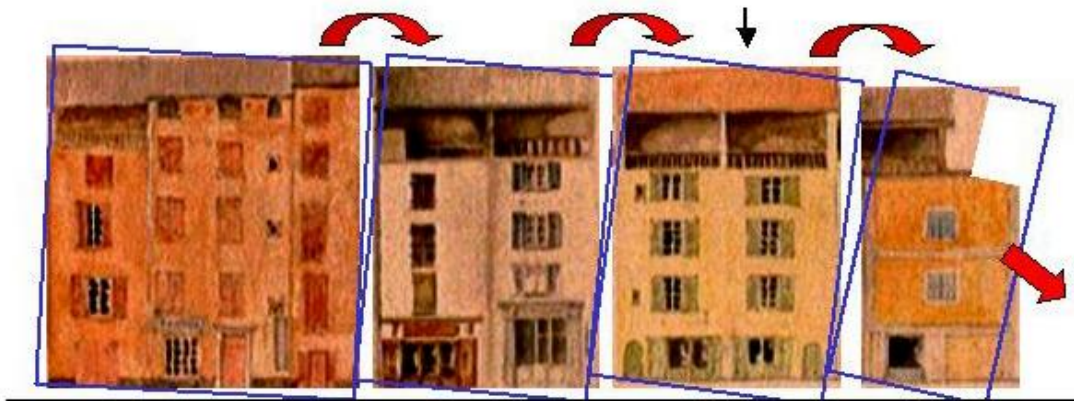
Fig.5: the Barbaroux house in the street

5 the study of two small houses with degraded structures. (Fig.5)

Accurate descriptions of the buildings were drawn up in plans, sections, facades as well as the constructive details, the cracks, the deformations and displacements in order to include/understand the constructive systems and their evolutions through time.

The weak points of the construction were pointed out starting from the cartography of the damages (cracks, displacements,...). Seismic assumptions of origins and effects tried to explain these damages in the buildings considered in their contexts (arranged, isolated,...). Proposals of mitigation techniques (ties, chaining, specific details,...) were described not only to try to decrease the

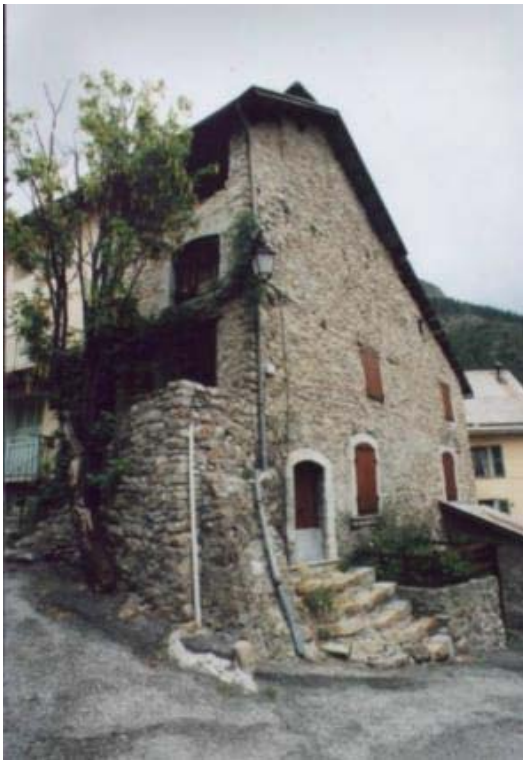
Fig.6: the Guyon house
