Applications of Non-Destructive Techniques in the study of a Caribbean historic timber house

Virginia Flores Sasso^{1*}, Esteban Prieto Vicioso², Gabriela Fernandez Flores¹, Raquel Carreras Rivery³

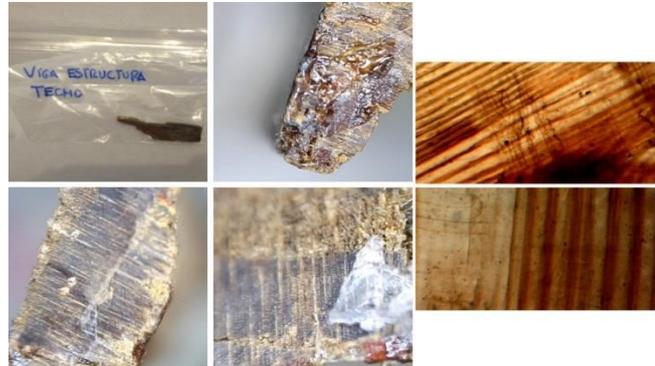
Fig.3. Wood of structure of the house (*Pinus Strobus L.*) (Carreras, 2019)

It was identified that all the piles are *Copaifera officinalis L.* (Amacey o Cabima), the beams, joist, decorative elements, some boards, the wood frame are *Pinus Strobus L.* (White Pine, Northern White Pine), the boards in the house extension and the repair woods are *Pinus taeda* (southern yellow pine). This indicates that the house was brought from the north of the United States, which was very common in the late 19th century (Fig.3). The piles are made of local wood. This was also very common, as the level of the house was resolved on site. The extension of the house and the repairs are

made in the middle of the 20th century and at that time the wood that came to the country came from Louisiana, so it is not strange that it is southern pine.

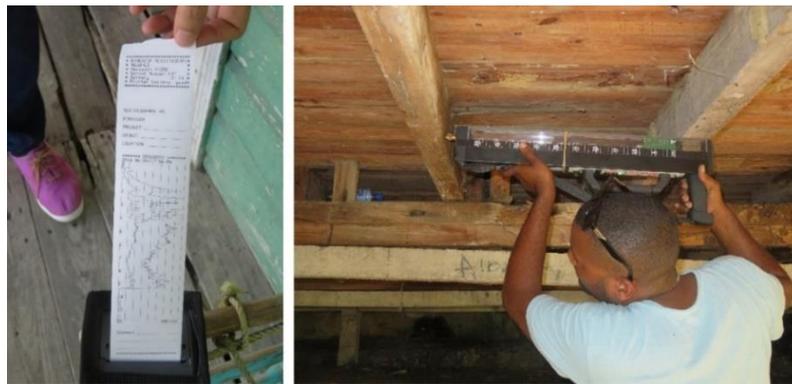
Figure 6. Using the resistograph in a rafter under the floor (Flores, 2018)

With the resistograph three drillings were performed in all these 12 pieces (Fig.6). The normal density values of *Pinus Strobus L* is 350-510 kg/m³, *Pinus taeda* is 450-550 kg/m³ and the *Copaifera officinalis L.* is 601-810 kg/m³. The averaged form the average Mean drill resistance [rel] of the samples indicated that the density of the pile are higher than the normal value, the C-1 and C-2 are within the normal range but C-3 is higher. The density of the samples of the beams and joist are higher (Table 2).

In some columns, the effect of the moisture content could be observed by finding little resistance with the drill of the resistograph. The permanence of moisture in the wood could be confirmed visually by the presence of fungi. This is important to know because it influences the mechanical properties of the wood.
