The Great East Japan Earthquake

Report
on the Damage
to the Cultural Heritage

20 November, 2011

Japan ICOMOS National Committee

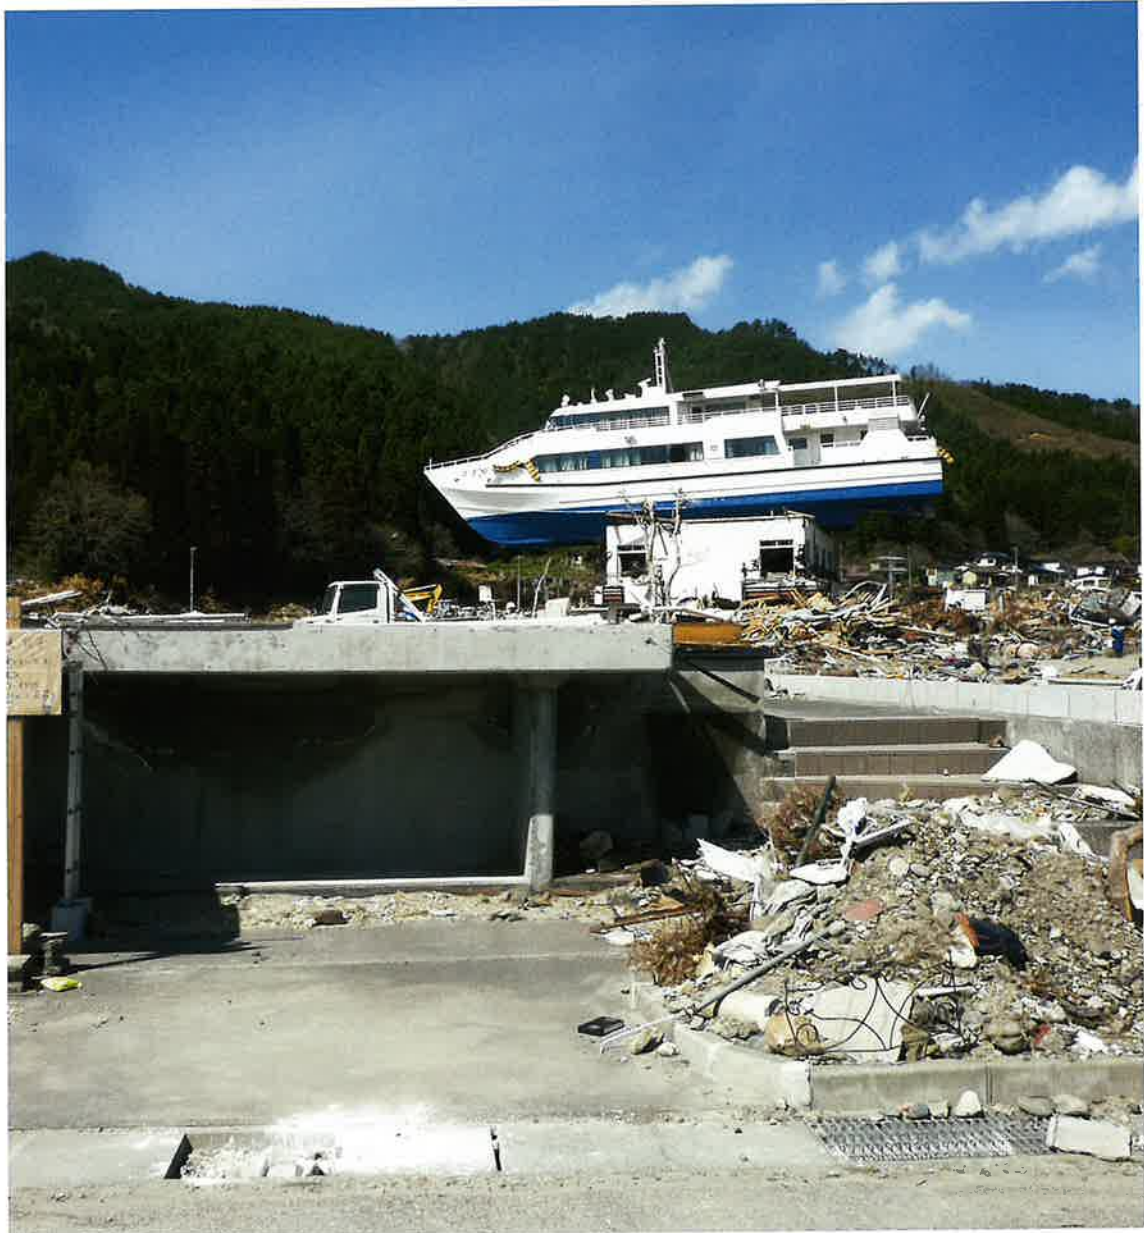
A ship washed up on the rooftop of an building by Tsunami (Oduchi Town, Iwate Prefecture)

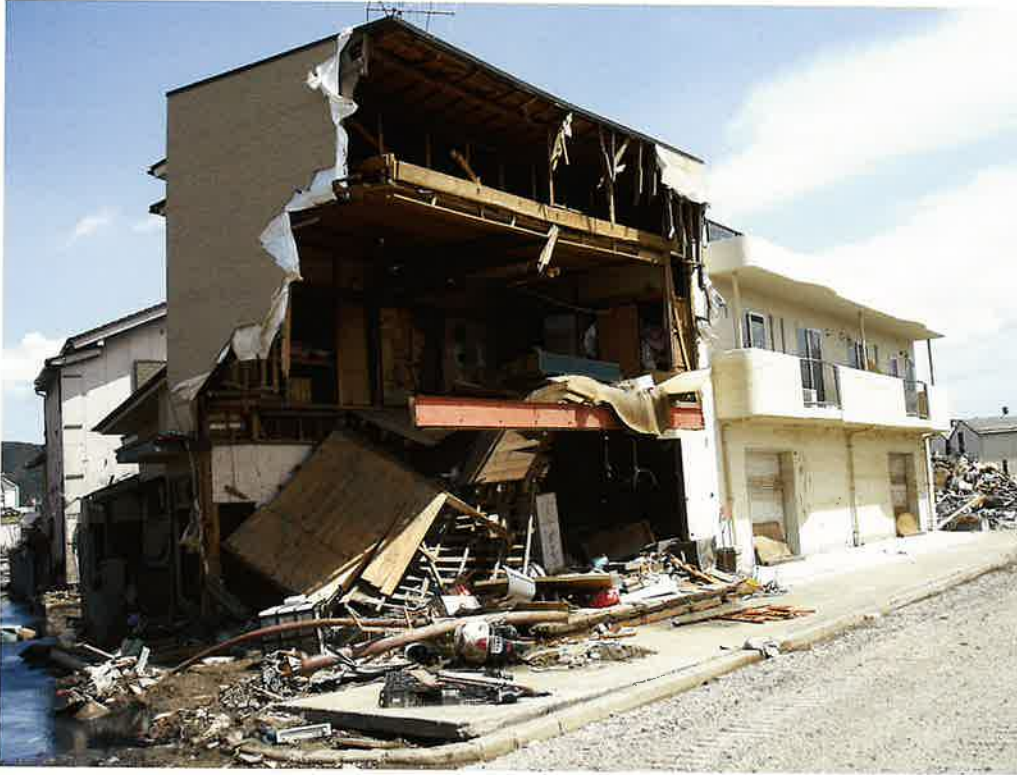
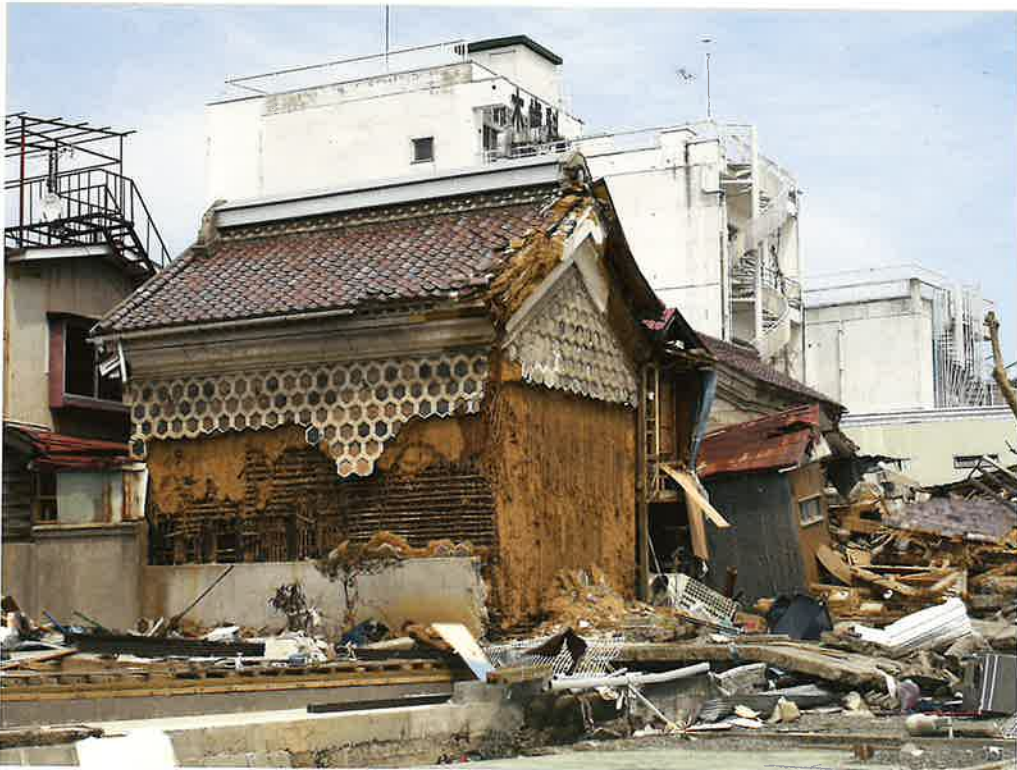
Collapsed buildings (Kesennuma City, Miyagi Prefecture)

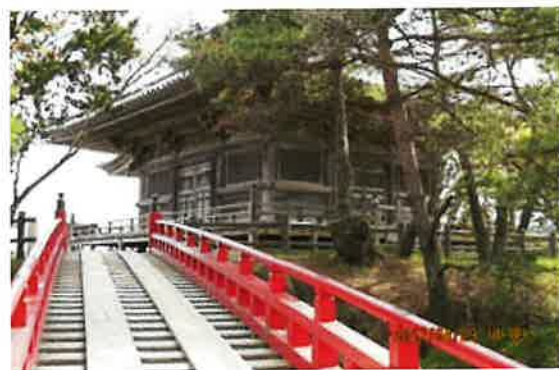
Figure 2.6 The important cultural property, Godaido, standing in the beauty spot of Matsushima: Undamaged

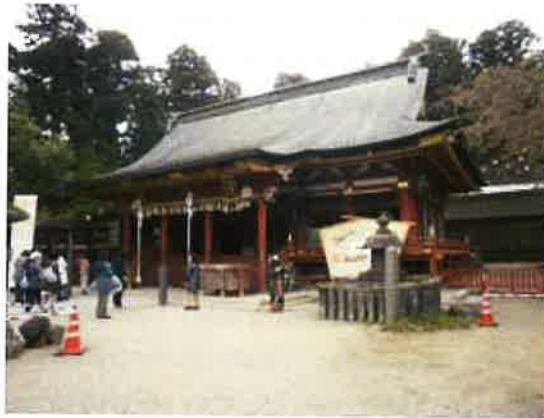
Figure 2.17 The Shiogama Shrine, an important cultural property: Undamaged

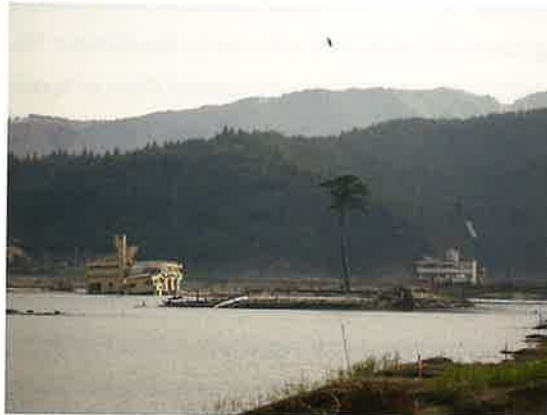
fallen pine trees are now scattered over the sandy area of the western half, which has retained its island shape. It is believed that the width of the reef from north to south has reduced to one-third following the disaster. Figure 2.34 shows, only one red pine on the western tip of the reef survived without being swept away. A three-story reinforced concrete building located in the Hirota Bay side acted as a buffer, so the red pine was able to avoid the effect of the tsunami. Accordingly, it is seen as a miracle that this red pine survived. Since the surrounding fallen trees were all shallow-rooted, it is believed that the surviving red pine has no axial root. A sand embankment was built to prevent the effect of seawater when a spring tide occurs, but the seawater came around behind the embankment and completely saturated it. As a result, the branches and leaves at the top of the pine tree are weakening. Considering that the administra-

Figure 2.34 Survived only one red pine, Takata-matsubara

nation. This is the only case of delisting that has happened as a result of the disaster. The place of scenic beauty, Takada no Matsubara, suffered devastating damage with only 1 pine tree remaining. It has not been delisted, and efforts to protect the pine tree and to restore the pine forest have got underway.

tive authorities of Rikuzentakata City are temporarily incapacitated, the Iwate Prefecture Development and Promotion Bureau is endeavoring to support the conservation of Matsubara. It is seen as important to leave behind regenerated pine trees from Takadamatsubara to revitalize the area. In order to increase the number of pine trees by taking cuttings of the

pine trees remaining in the island-shaped reef and grafting them elsewhere, it is seen as necessary to confirm the status of surviving trees. The topography and pine vegetation sustained serious damage due to the earthquake-induced tsunami, but part of the beach terrain certainly still remains. From hereon, it will be necessary to canvass the owner, Rikuzentakata City, as well as citizens and other concerned parties to confirm their willingness to preserve the area, while at the same time build consensus on restoring it to its status as a place of scenic beauty by restoring its topography and vegetation.

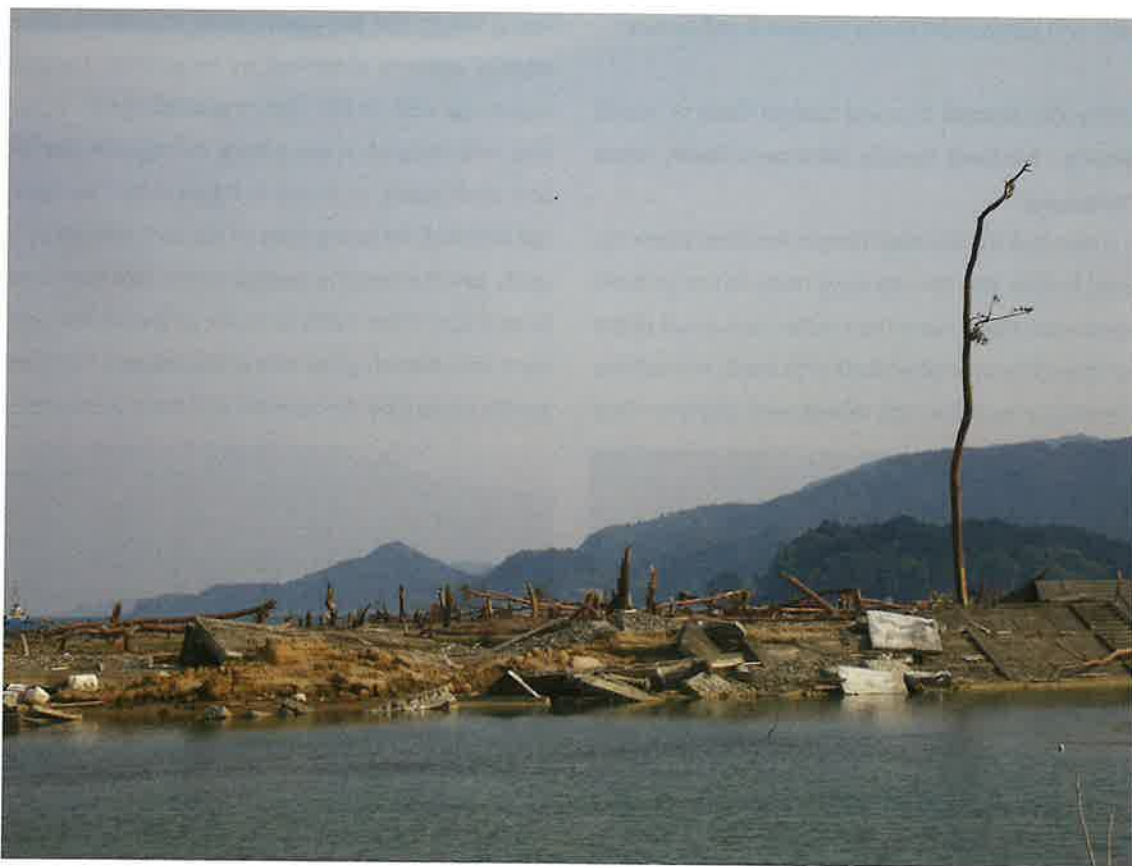
Facing Hirota Bay, the breathtaking Matsubara (pine woods) scenery is backed by beautifully-shaped mountains such as Mt. Hikami and Mt. Raijin. However, unfortunately it was greatly damaged by the recent earthquake, as shown in Figure 2.33. This damage included the topography of the reef, formed by a sandy beach extending approximately 2km from east to west and 300m north to south, as well as the pine trees that densely grow there. The eastern half was greatly eroded by the tsunami and large numbers of

Figure 2.33 Tsunami-swept seashore, Rikuzentakata City

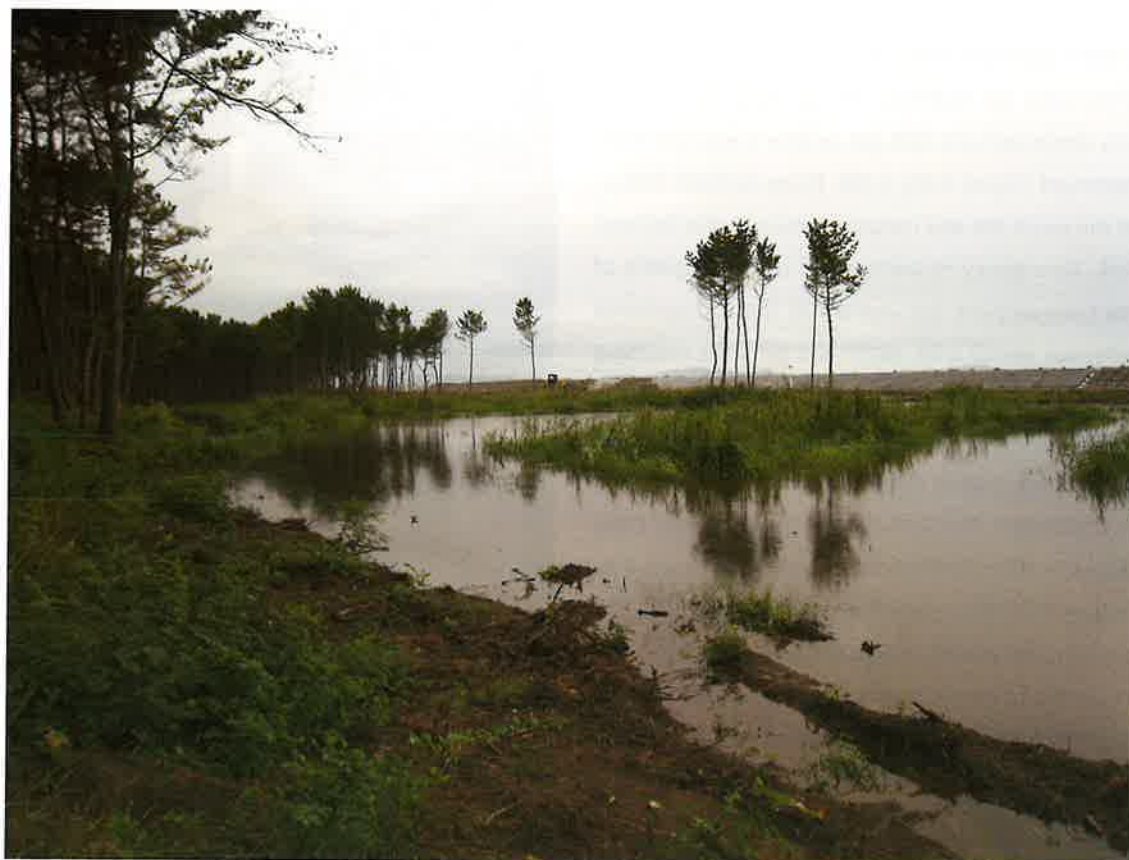
There is a need now to combine activities preserving the landscape of the nationally-designated Special Place of Scenic Beauty, Matsushima, and restoring it after the Great East Japan Earthquake. The Higashi-Matsushima City, Nobiru area, known as “Oku-Matsushima”, sustained the largest damage among the designated districts. As shown in Figure 2.37, the area where pine trees were literally uprooted and carried away by the tsunami has become a basin and water is still accumulated there (as of 22nd September, 2011). Half a year has passed since the tsunami struck, but a lot of time and patience is required to restore this place of scenic beauty.

Figure 2.37 Current state of the Matsubara coast in the Nobiru area (half a year after the tsunami struck)

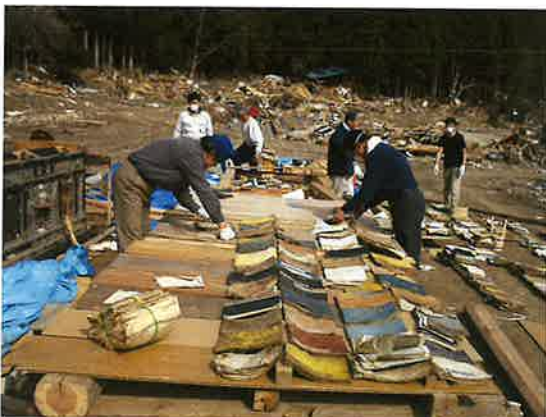
Figure 3.1 Salvage of water-damaged documents

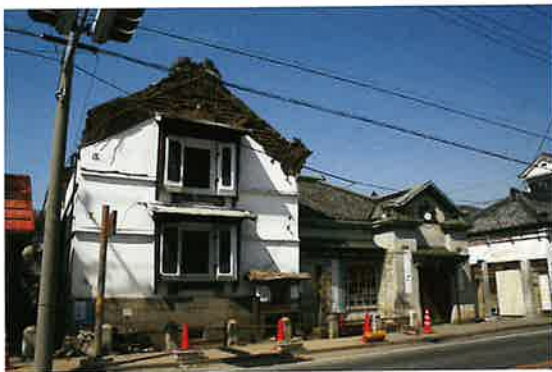
Figure 2.10 Damage to classic *dozo* (mud-wall warehouse) - the registered tangible cultural property, the Mori Goshi Gaisha storehouse

Further, damage to cultural heritage not only affected the Tohoku region, but extended over a wide range as far as the North Kanto region including damage caused by subsequent frequent aftershocks. It was reported that the majority of damaged cultural property in Kiryu City, Gunma Prefecture; which is developing a policy to establish an Important Preservation District for Groups of Traditional Buildings; was nationally-designated cultural property (of the 117 matters in 34 places, 41 matters in 17 places were affected by the disaster), and that the scale of the damage was more serious than expected (Figure 3.2).

Figure 3.2 The Mori Goshi Gaisha storehouse, a registered tangible cultural property (Kiryu City, Gunma Prefecture)

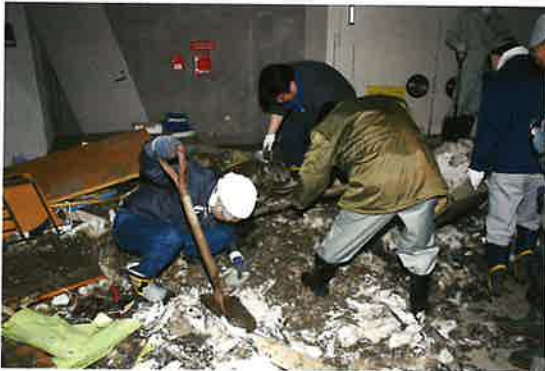
For example, at the Ishinomaki Cultural Center its work started by removing the sea bottom sludge and rolled paper from the neighboring paper factory, which occupied the entire floor. We salvaged all the works including artworks, archeological artifacts, articles for everyday use, and the Mouri collection materials, and stored them in several facilities in Miyagi Prefecture after securing a route to transport these items.

Figure 3.4 Salvage activities at the Ishinomaki Cultural Center

We are still dispatching workers from the committee in response to rescue requests while taking measures to temporarily store the salvaged goods by vacuum freeze drying or washing them in order to prevent wet items from deteriorating.

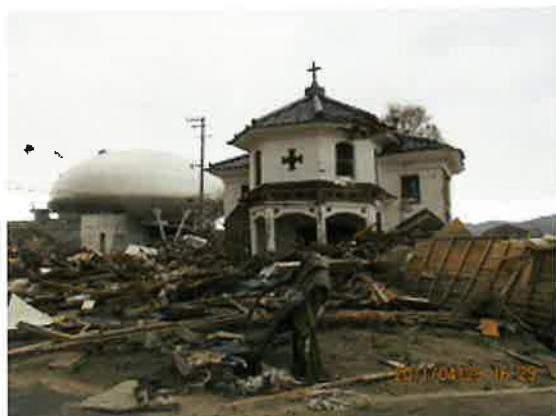
severe damage during the 1978 Miyagiken-oki earthquake (M=7.4). It has been utilized as a museum since it was relocated. The current structure employs the traditional Japanese timber framework method of utilizing braces. Before the relocation, the outer walls adopted the shitami itabari style (wooden board siding with battens), but mortar with a thickness of about 20 to 30mm is now used for finishing. Reinforced concrete is used for the strip footing and is connected well to the base of the frame. It is considered to be fortunate that since the church stands on the sandbank of the river, it might not be struck by the houses that were swept away. A combination of several factors seemed to contribute to the survival of the building. (Figure 4.1, 4.2)

Figure 4.1 Ishinomaki St. John the Apostle Orthodox Church (Ishinomori Manga Museum in the back)
