The Kumamoto Earthquake

Report on the Damage
to the Cultural Heritage

1 December 2017

Japan ICOMOS National Committee

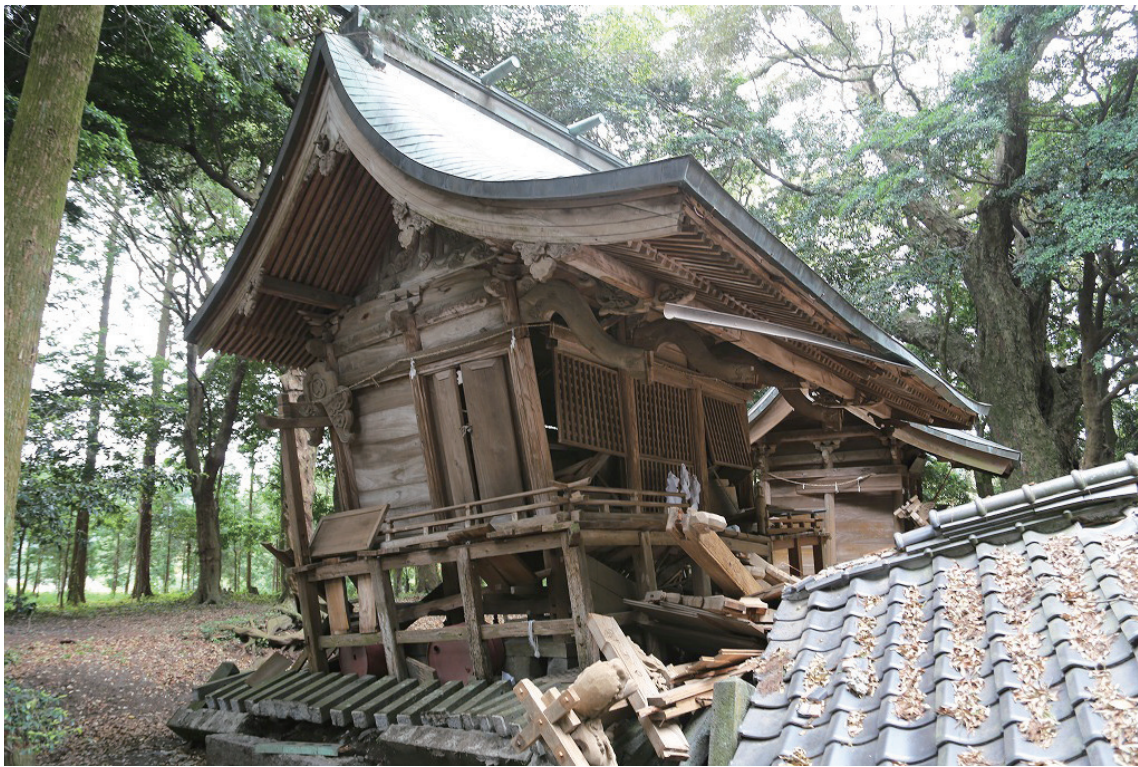
A huge sloping the main hall and collapsed the worship hall, Hachiosha Shrine

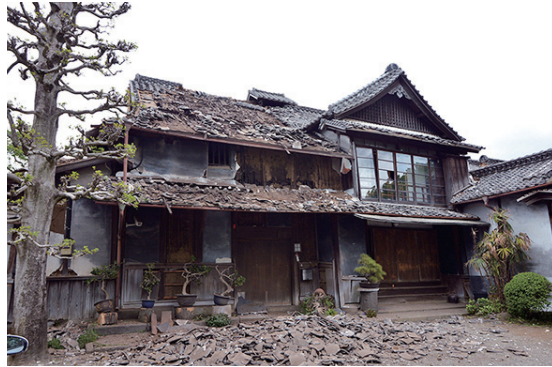
earth walls of the central storehouse. Effects of the main-shock earthquake extended to the main building: the building inclined up to more than 1/8 towards the west side, roof tiles and earth walls fell down. As for the interior, parts of the ceiling above the large room (*hiroma*) fell, the reception room (*zashiki*) inclined towards the south, and the walls attached to the alcove were damaged. In terms of structure, the main building is divided into three buildings: one centered on the earth floor *doma*, another on the south side centered on the *zashiki* reception room, and another comparatively new one to the north side; it is the connections between these buildings that broke, with fractures up to some 50cm where large. The stable's west side outer wall fell and the building inclined greatly towards the road on the west side. At the central storehouse, the pillars came off their foundation stones and the structural frame inclined towards the west side. Also, most of the earth walls fell. The rear gate collapsed onto the road on the west side. Protrusions occurred at parts of the stone wall on the north side of the site. The Eto family home is located to the northeast of the Futagawa River fault, which was the epicenter of the main-shock earthquake. The main building and other buildings on the site inclined to the west side or the west-southwest side due to the main-shock earthquake; this inclination shows a direction similar to the direction of displacement of the Futagawa River fault, which extends from east-northeast to west-southwest.

Photo 3.1.1.2 The main building (after the earthquakes)

As emergency response measure to prevent collapse, temporary reinforcements were installed to the main building's interior and exterior on the west side, which had acquired a significant incline. Also, because there were concerns that during the rainy season leakage from broken roofs into the interior of the building would seriously damage the pictures on the partition walls, these were removed as a priority and stored separately. The stable had greatly inclined

From now on, measures will aim at making the structural frame of the main building sound after completely dismantling the building's west part that was significantly damaged. There are plans to build back the buildings centered on the reception room and that on the north side. Additionally, diagnosis of seismic resistance will be carried out and measures to strengthen the earthquake-resistance performance will be taken. The structural frame of the central storehouse will be temporarily dismantled to carry out conservation and repair works. Restoration works will be carried out for the stable, the *nagayamon* gate, and the rear gate. Works are scheduled to last around 4 years (until fy2020) for the main building. Repair works of the central storehouse and the stable are expected to start in fy2019 and take 3 years, up to fy2021. After that, the plan is to continue work on the other structures, including the *nagayamon* gate, the rear gate, the hut, and the outer structure, until fy2022.

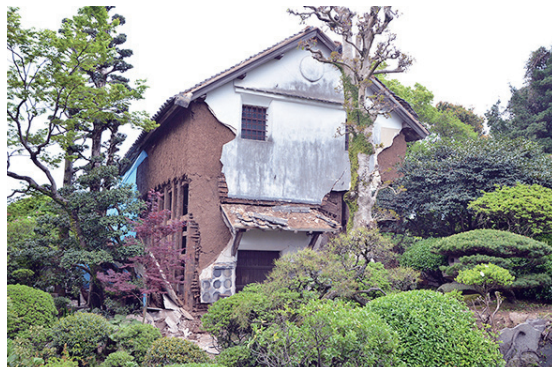
Damage in the fore-shock earthquake was limited to the collapse of the chimney on the north side of the main building and the partial collapse of the

Photo 3.1.1.4 The central storehouse (after the earthquakes)

towards the road side, up to as much as 1/8, and the deterioration of the bases of its pillars was also significant; it was temporarily dismantled for safety and preservation. At the central storehouse, the remaining earth walls were dismantled and removed, and temporary reinforcements were installed inside the building to control the incline. As for the stone wall, only sections with protrusions were dismantled, and the stones were put in storage.

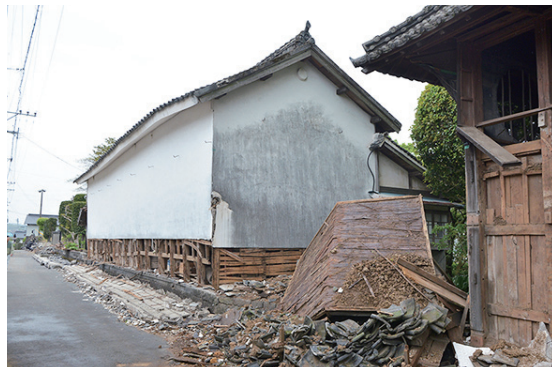
Photo 3.1.1.6 The stable (after the earthquakes)

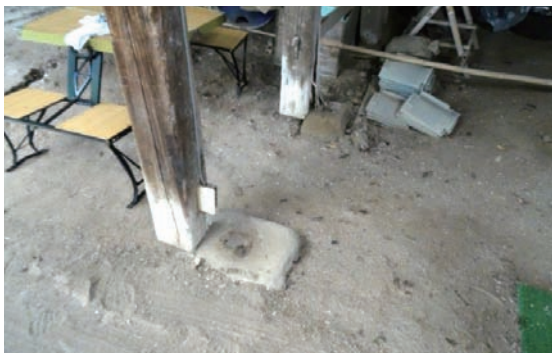
Photo 3.1.2.3 The shed pillars have come off their foundation stones at the Yano family home (*Hontaku*)

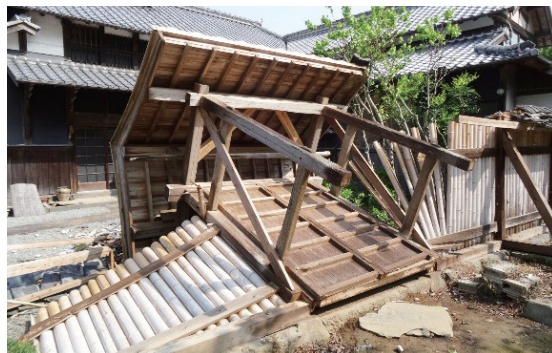
Photo 3.1.2.4 The middle gate collapsed at the Yano family home (*Hontaku*)

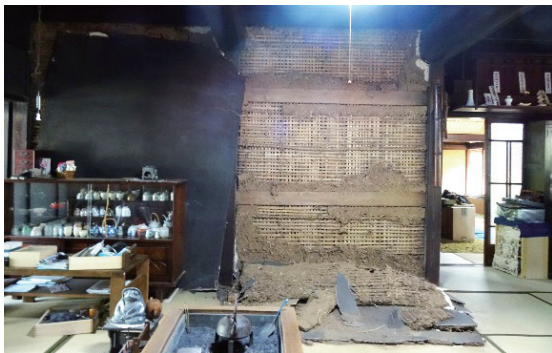
The tiled roof of the main building had been re-done prior to the earthquake, and survived the quake practically sound. However, the building sustained major damage such as the collapse of parts of the walls, and if one is to take into account those parts that have fissures, the majority of walls is not in sound condition. As for the structural frame, pillars are inclined in some parts, and in many places, they have come off the center of the foundation stones. Due to the fissure running under the main building, a dislocation appeared in the ground in the north-south direction, which caused various problems, such as the fall of the alcove lintel in the reception room and the dislocation of threshold members and head jambs.

Photo 3.1.2.5 The wall of the formal room collapsed at the main building of the Yano family home (*Hontaku*)

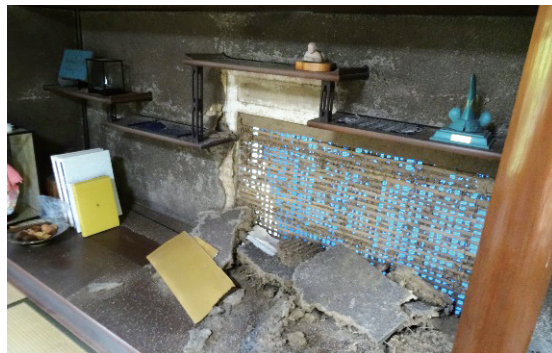
Photo 3.1.2.6 The wall of the reception room at the main building of the Yano family home (*Hontaku*)

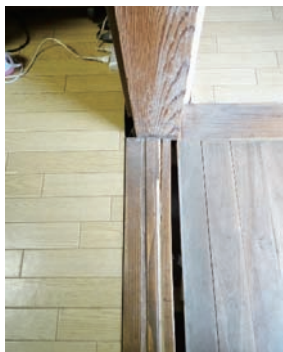
Photo 3.1.2.7 The thresholds have become misaligned at the main building of the Yano family home (*Hontaku*)

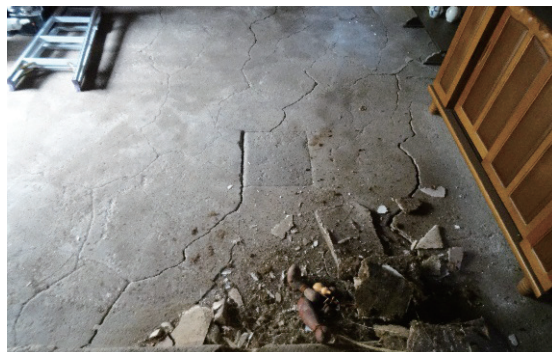
Photo 3.1.2.8 The fissure in the earthen floor of the main building of the Yano family home (*Hontaku*)

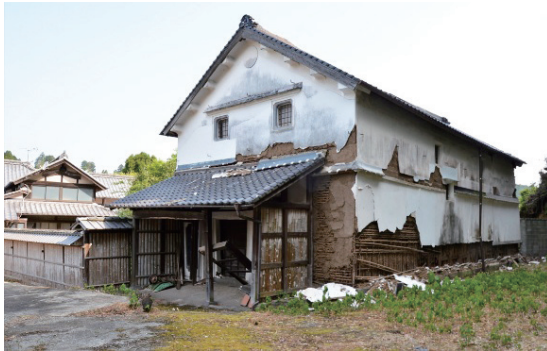
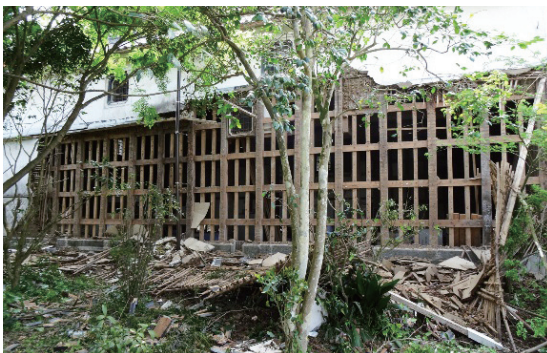
Inside the storehouse, a fissure runs along the

Photo 3.1.2.9 The storehouse of the Yano family home (*Hontaku*)

Photo 3.1.2.10 The storehouse of the Yano family home (*Hontaku*)

earthen floor, the groundsill and the structural frame are significantly out of alignment, and the beams are pushing the pillars: there are concerns of collapse.

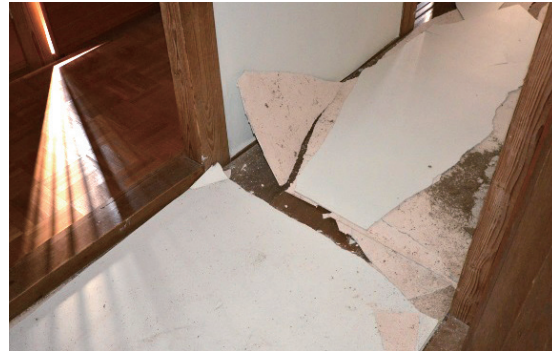
The *Shintaku* or Annex, located on the east side of the main home (*Hontaku*), is a partly two-story building constructed in 1929. It was registered at the same time as the Yano family's *Hontaku*. The roofs and the structural frame are basically sound. Some of the walls collapsed, have cracks, or have parts of their upper layer of plaster that have peeled off; the stairs moved towards the west, creating a misalignment.

Photo 3.1.2.14 The wall's upper layer fell off at the Yano family home (*Shintaku*)

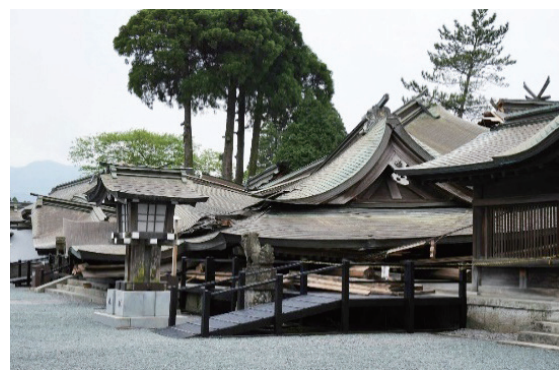
The Romon Gate, which was one of the Three Greatest Romon Gates of Japan, had an upper structure that was extremely impressive. The main-shock earthquake that struck the Aso region on April 16th registered a weak 6 on the Japanese seismic scale and the Romon Gate is considered to have collapsed due to the inclination of the columns caused by the tremors and the P-Δ effects resulting from the heavy weight of its upper part.

Photo 3.1.3.2 The collapsed Romon Gate of the Aso-jinja Shrine (inside the site).

The policy for the repair works of these buildings, which have been designated as Important Cultural Properties, is repair through dismantling for the Romon Gate and through partial dismantling for the other damaged buildings. The work began in Heisei 28 (2016) and is scheduled to continue until Heisei 35 (2023). (Photos 3.1.3.1-5 Taken by the author.)

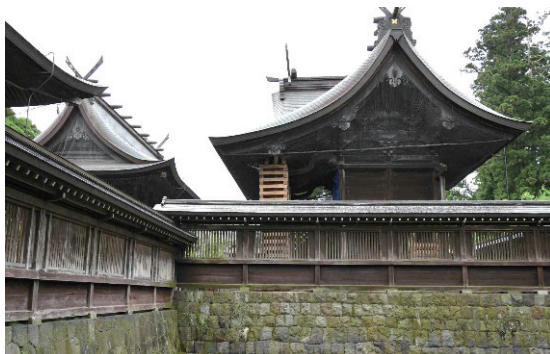
damaged in the recent main-shock earthquake. In addition, the Worship Hall within the precinct collapsed completely, and also the stone lanterns on the approach road collapsed.

Photo 3.1.3.3 The Worship Hall of the Aso-jinja Shrine was damaged.

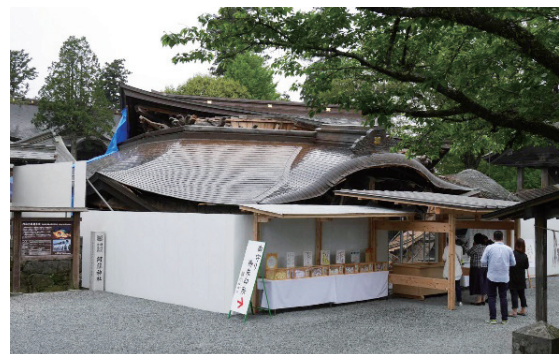
It was reported that, at the Kangyomon Gate and the Shinkomon Gate, some of the decorative parts fell down and there were some overall distortions. At the three sanctuaries, the damage to the San-no-shinden Shrine was the most severe, consisting of a deep inclination in the direction of the west cliff, and it has

been reported that the shrine is in danger of collapsing. The damage at the other two shrine buildings included the lifting up of some of the columns.

Photo 3.1.3.4 The emergency support at the San-no-shinden Shrine building in the Aso-jinja Shrine.

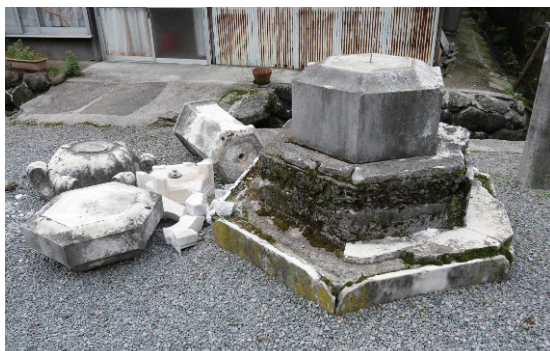
Photo 3.1.3.5 The collapsed stone lantern of the Aso-jinja Shrine.

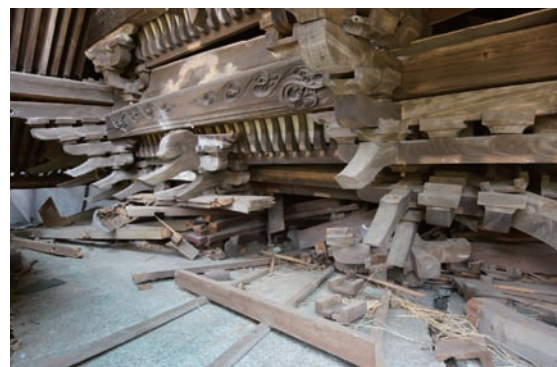
Photo 3.1.5.2 The decorated structural element which joins columns and the beams of a roof. (Sculpture of Horeki Era.)

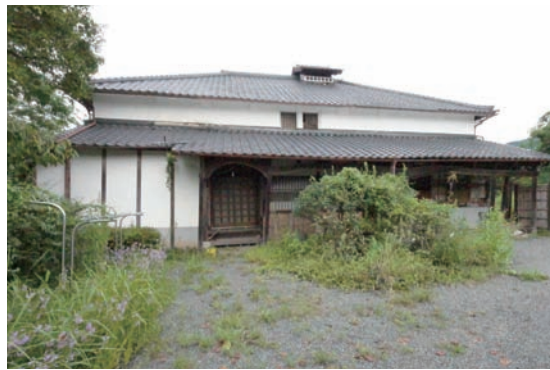
Photo 3.1.5.3 The Saionji family home

Due to the Kumamoto earthquakes, some of the columns and beams have been damaged and it appeared an incline of 1/5Rad. to west-northwest direction in maximum. It was barely avoid from collapse down.

The Footing of column which has been put on the traditional base stone was slipped on the stone base by the shock of the earthquake by about 40cm but safely remained. In contrast, at south part of the gate house, some columns of which has been coupled with reinforced concrete base foundation were cracked and about to falling down.

In case of no purchaser is not going to be found, it will be demolished by public expense in the near future. (Photos 3.1.5.3-3.1.5.4)

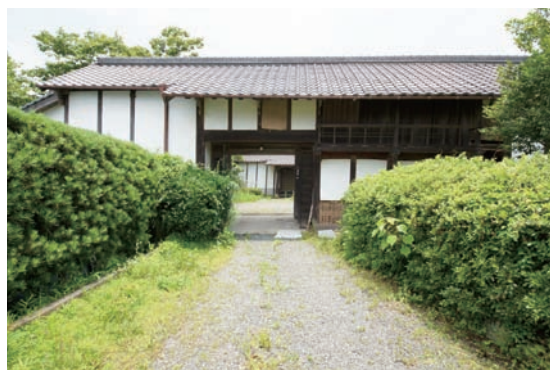
Photo 3.1.5.4 The Saionji gate house “*Nagayamon*”

The gate house “*Nagayamon*” on the boundary of the residential site, where a stone wall, maximum height of which is 3 meters on the south cliff side arranged in L-shape, was partially distorted and damaged.

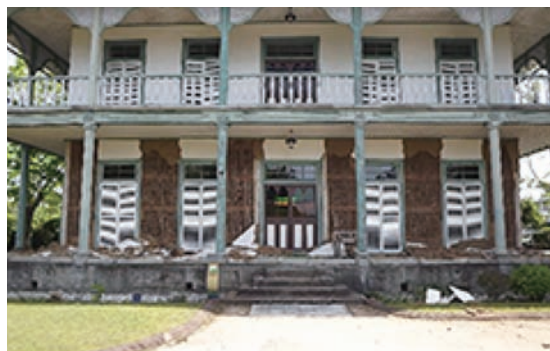
In the fore-shock earthquake of April 14, as is shown in Photos 3.1.6.1 to 3.1.6.4, the earthquake-resisting element of the mud-plastered walls suffered major damage.

Photo 3.1.6.1 The damage caused by the fore-shock earthquake (front).

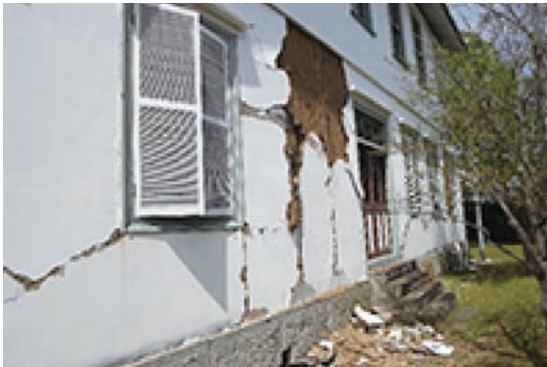
Photo 3.1.6.2 The damage caused by the fore-shock earthquake (rear).

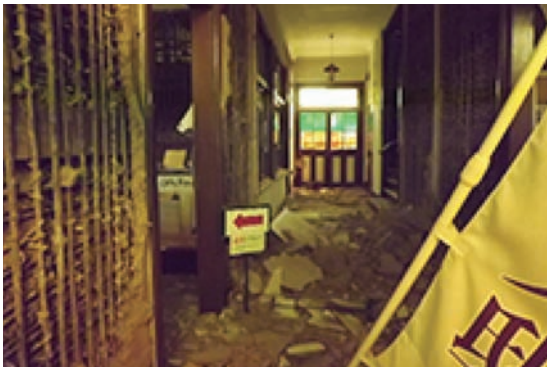
Photo 3.1.6.4 The damage caused by the fore-shock earthquake (interior).

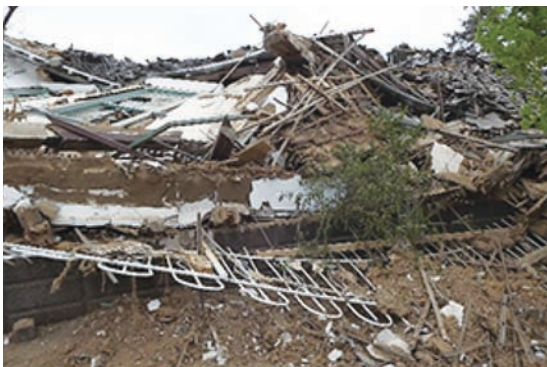
It was then completely destroyed in the April 16 main-shock earthquake, as shown in Photos 3.1.6.5 to 3.1.6.6. There were other wooden houses and buildings around this building, but, at least in terms of their external appearance, they did not suffer any damage, and only this historic property specifically was damaged. In addition, many of the archival documents that were stored inside as the museum collection were damaged. Since the earthquakes, rescue efforts for the documents have been continued by the Janes Promotion and Education

Photo 3.1.6.6 The building was completely destroyed in the main-shock earthquake (2).

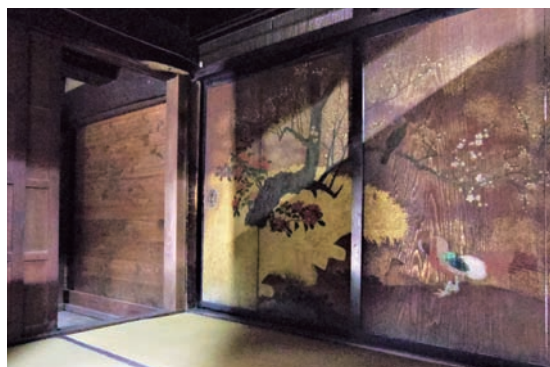
Photo 3.1.7.4 Additional earthquake-resistant walls (left side of the wooden door).

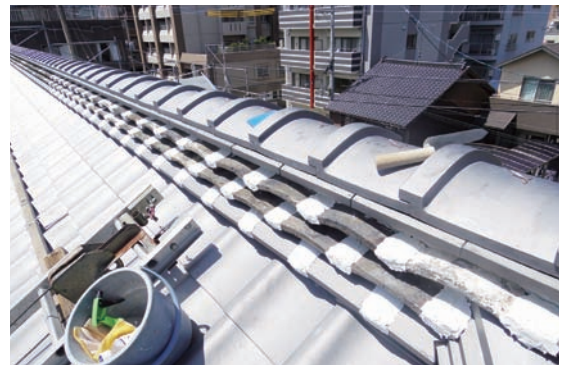
Photo 3.1.7.6 Restoration of the large building using the original tiles (main building).

Therefore, the fundamental repair policy is to restore the property on the basis of the historical facts but without excessive focus on the restoration to avoid expensive repairs, carrying out the repairs with the aim of maintaining the site until it can be fully repaired (expected in the future). In the course of repairs, besides supervision by experts in restoring

cultural properties, reference is being made to the specifications of the tiles and walls from the initial construction that have survived within the site. In addition, private records and photos from the Meiji Period to the pre-war periods were referred to. Moreover, samples were kept of the tiles and earthen walls that had to be removed, and photos and other records of them were taken. These are being kept as references for when the full repairs take place.

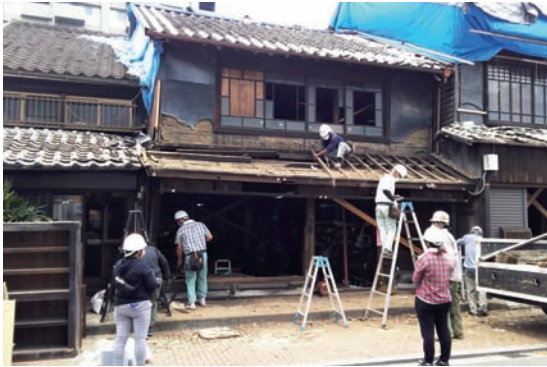
In the store section, which included the *battari shogi*, was designed to create an open space by having few columns, which caused localized deformation during the main shock of the earthquake. In addition, each of the buildings densely constructed within the site had oscillated during the earthquakes, and consequently damages were concentrated at the joints between them. In addition, the falling roof tiles and collapsed earth walls completely changed its appearance, which canceled out all the expense and efforts that the owner had spent to ensure the continuous of these buildings, the damages that were so overwhelming. However, at that point in time, there were only few concerns of collapse, and it was judged that they could be restored, technically speaking.

Photo 3.1.8.1 The facade immediately after the disaster.

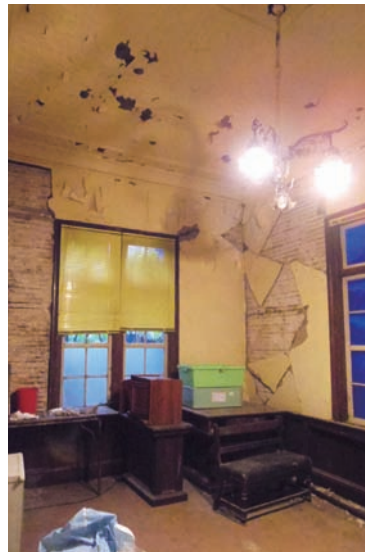
Although the buildings escaped collapse in the main-shock earthquake, there were localized damages, such as the loss of pillars in the entrance hall. From a visual inspection, it is estimated that, on the basis of the partially collapsed outer walls, there was widespread rotting and ant damage to the wall bases and structural materials. In addition, the falling of plaster from the interior walls was extremely severe, and the owners had to spend a huge amount of time to clean it up that also created

Photo 3.1.9.2 The interior after the disaster.

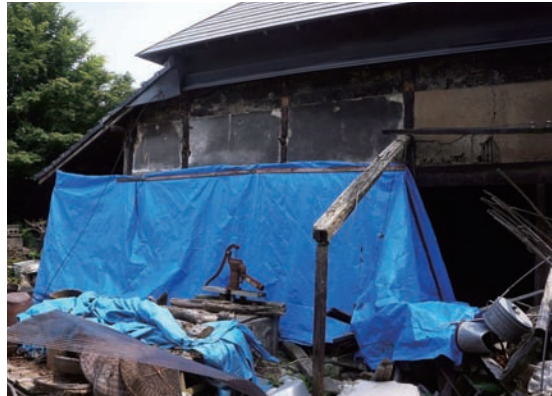
The buildings suffered various kinds of damage in the recent earthquakes, including the collapse of earth walls and the displacement of roof tiles. Overall, the damage was kept down to partial destruction, but it was comparatively large in the small annexes and the toilet. The small annex (es) north to the earth floor collapsed, and the wall at the edge of the earth floor collapsed. In addition, the floor of the small annex on the north of the anteroom collapsed. The wall of the toilet and the floor of the corridor also collapsed. After these places, the damage was next greatest in the sitting room. The alcove's *otoshikake* (a bar placed across the upper part of the alcove) fell down, the wall collapsed, and the alcove's transom bar fell down. In the sitting room, the columns acquired an incline (in a southwest direction) of 1/30. In addition, the floor of the six-tatami room on the east side of the entrance collapsed.

Photo 3.1.10.4 The collapsed small annex on the earth floor north side.

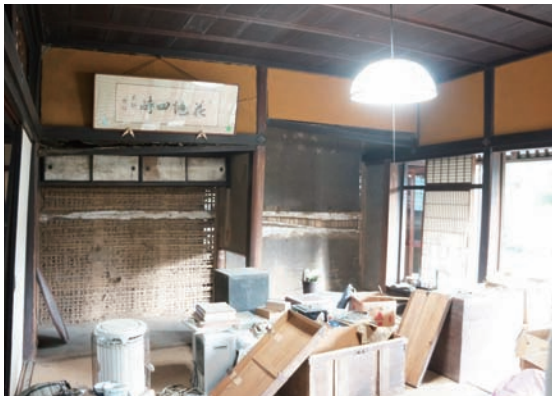
Photo 3.1.10.5 The sitting room: Collapsed interior earth wall.

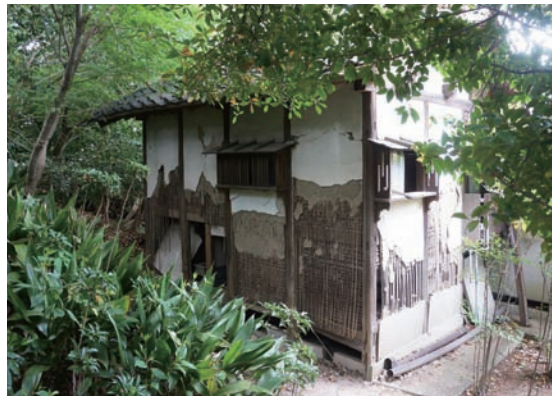
Photo 3.1.10.6 The toilet: Collapsed earth wall.

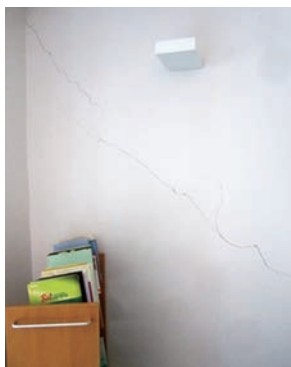
Photo 3.2.1.4 Shear cracks appeared in the walls.

due to this out-of-plane bending deformation were observed at the corners. Moreover, cracks due to bending of the walls were seen. Shear cracks also appeared on the surfaces of the plaster-finish walls (although the width of these cracks were small) (See Photo 3.2.1.4). A more detailed investigation would be needed in order to ascertain whether these cracks only occurred in the finished plaster, whether they reach as far as the interior of the brick masonry, or whether they penetrate all the way through the walls.

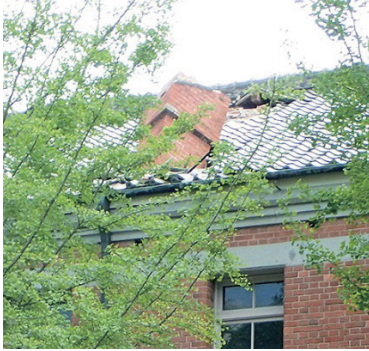
The Lab Building, built of brick in 1889 and 42.5 m long from north to south, was used for chemical experiments and lectures. It was not damaged much because it is single storied low building with transversal walls. The fall and shift of several chimneys was conspicuous. Some minor cracks on the interior wall were observed.

Photo 3.2.2.1 A chimney which fell down on the roof.

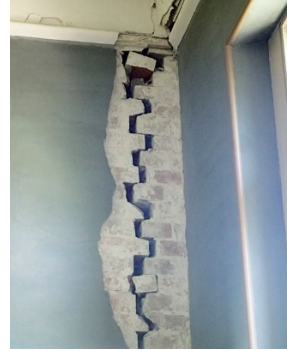
Photo 3.2.2.2 A crack on the classroom wall.

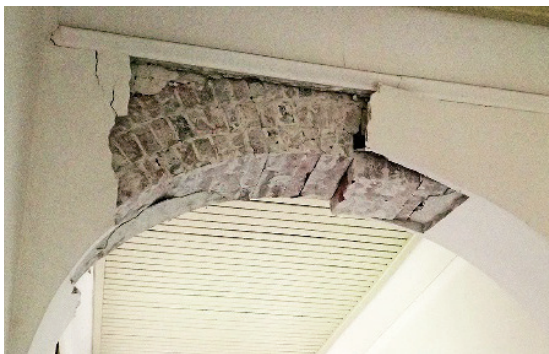
Photo 3.2.2.3 Cracks and fall down of the surface plaster on the corridor arch. (The Fifth High School Main Building)

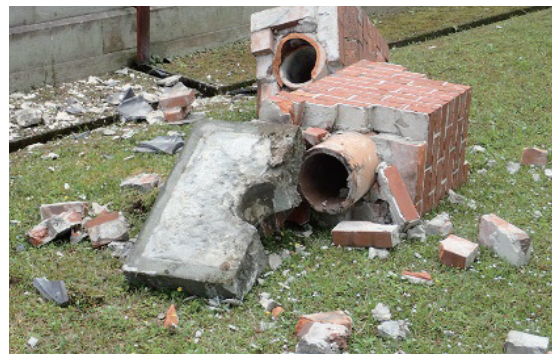
Photo 3.2.2.4 Fragments of a chimney on the ground. (The Fifth High School Chemical Lab.)

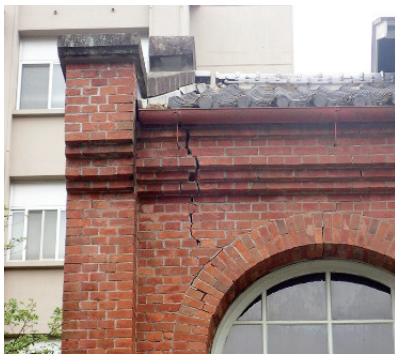
Photo 3.2.2.5 Crack on the top of corner walls.

Many cracks on the brick walls are observed from place to place; the top on the four corners of the walls, around the round window on the upper part of the east gable, etc. The top of most of the arched windows were also cracked. In addition, the horizontal continuous cracks on the walls were also observed at the level of lower window frames at the height of 1m above ground level. It suggests that strong horizontal shear force concentrated here.

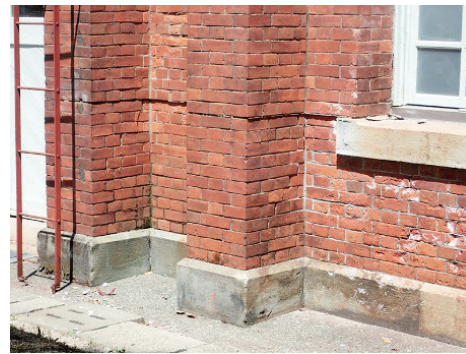
Photo 3.2.2.6 Horizontal crack at the lower level of the wall. (Kumamoto Technical High School Machine Lab.)

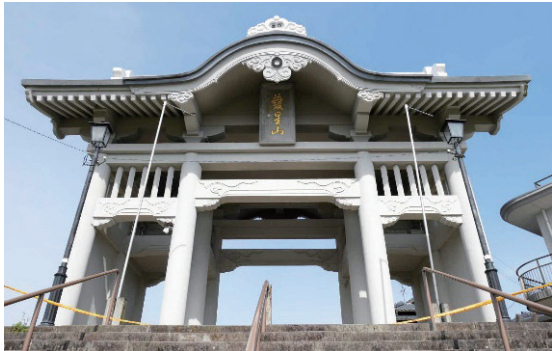
Photo 3.3.1.1 Honmyo-ji Nio-mon: front.

Following the recent earthquakes, various kinds of damages to the Deva gate were confirmed, including [1] flexural cracks around the joints between columns and middle beams, [2] detached bracket arms, [3] damages around column bases, and [4] shear cracks on the walls below gables. The 12 columns that constitute the gate are connected at their upper and middle sections by beams, and because the weight and rigidity of upper sections above middle beams are extremely large, it was observed that flexural deformations of the lower sections were more prominent than at the upper sections. The flexural damages were also more pronounced in the gate's longitudinal direction than in the transversal direction, and in its transversal direction, the damages were greater at its two central column rows than at the side end column rows that were infilled with walls. Although the widths of wall cracks were narrow, there were concerns that the rigidity of the walls had been reduced.

in July 2017. The noteworthy items in this report are that [1] the differential settlement of building is extensive, and the south side's column bases (left side of Photo 3.3.1.1) have sunk by around 120mm

more than those on the north side, which is the main reason for the gate's incline (it is also one of the causes of the damage to the column-beam joints); [2] the columns and RC piles are directly connected,

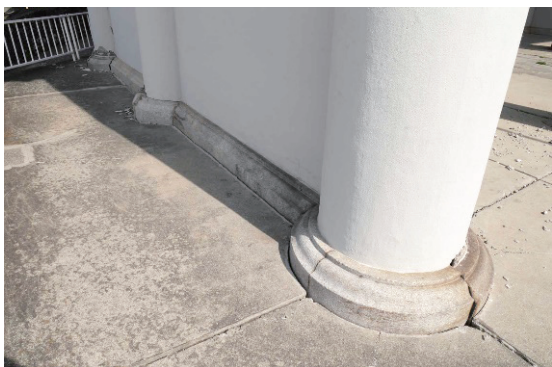
Some damages are also found on the concrete ground slab around column bases. The slab at the back of Photo 3.3.1.3 would seem to have been partially removed to create enough space for vehicles to pass, because the extent of concrete ground slab is smaller than that of other columns, thus it is possible that this fact increased damages and subsidence around the column base.

Photo 3.3.1.3 Honmyo-ji Nio-mon: column bases and the surrounding area.

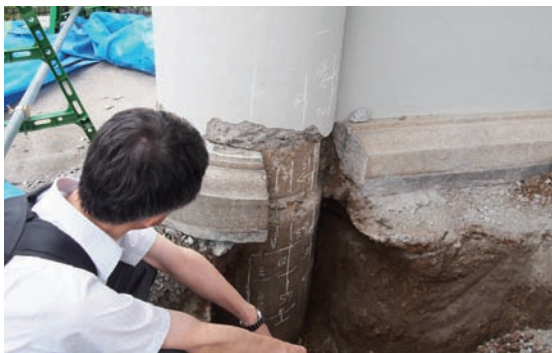
Photo 3.3.1.5 Honmyo-ji Nio-mon: the state of the ground around the column base.

and the damages that can be seen in Photo 3.3.1.4 are almost completely limited to the strips of stone footings and their adjacent areas; and [4] there are no ground beams or footings (Photo 3.3.1.5) as well as the extremely weak soil condition from 3m to 11m underground, so it is highly possible that this is the cause of the defects to piles penetrating this ground. Going forward, the results of other surveys are going to be reported, the seismic capacity of the building will also be evaluated, and seismic retrofitting will be assessed on the basis of these surveys and evaluations as scheduled. (Photos 3.3.1.1-3.3.1.4, 3.3.1.6 taken by the author, Photo 3.3.1.5 taken by Mariko Nishijima.)

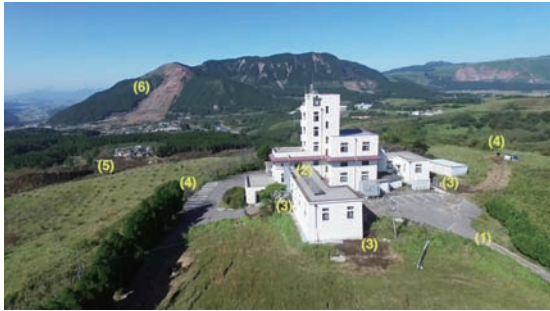
Photo 3.3.2.1 This is an aerial photograph taken of the Aso Volcanological Laboratory and its surrounding area on October 24, 2016. In the far distance can be seen Mount Unzen on the Shimabara Peninsula. Below are the explanations of (1) to (6) in the photograph.

- (1) From July to August 2016, one part of the access road to the Aso Volcanological Laboratory and the road within its site were temporarily repaired. This made it possible to access the Laboratory's buildings using an ordinary car.

- (2) August 2016: Emergency measures were implemented to prevent water leaking into the buildings from the cracks.
- (3) September to October 2016: A damage survey of the foundation was conducted.

- (6) Repair work is in progress at the sites of collapse on National Highway 57, the JR Houhi Line, and the Aso Ohashi Bridge. However, it has not been determined when the repair work will be completed.

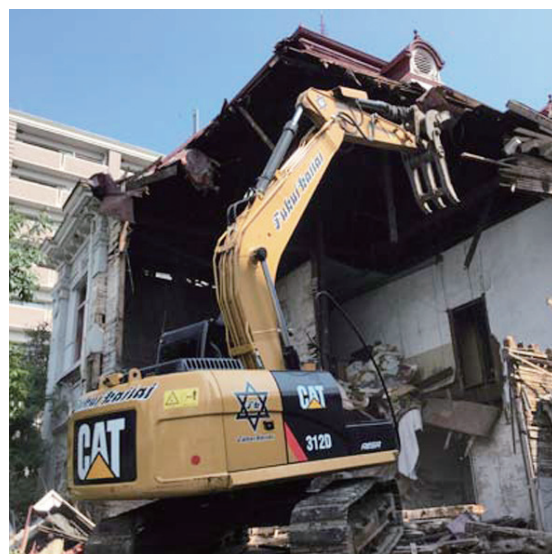
Photo 3.4.1.4 A townscape-formation building being dismantled (July 2017).

Despite the arduous “life-saving” efforts made in the year after the earthquakes, two townscape-constituting properties had to be dismantled one after the other in June and July 2017 (Photo 3.4.1.4). Going forward, in order to maintain the historic landscape over the long term, it is hoped that:

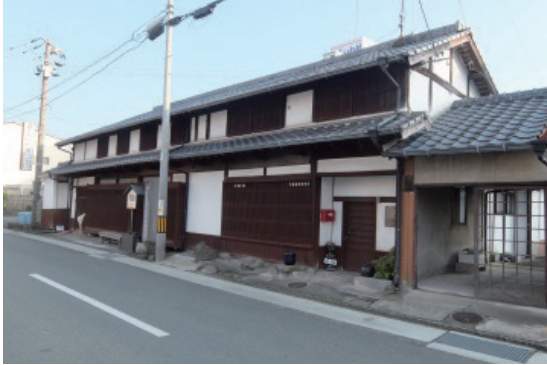
synchronize with the seismic frequency. As far as we can say, it did not suffer earthquake damage. (Photo: the Imamura family home)

Photo 3.4.2.1 The Imamura family home (nationally designated undamaged)

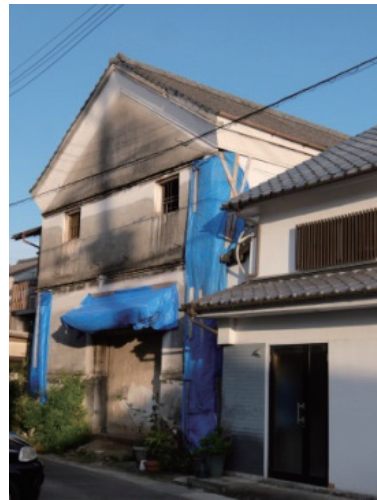
Photo 3.4.2.4 Warehouse in the town

was great. In one square kilometer, there are over 60 dismantled buildings, old and new. There remained a privately owned warehouse. There is no relief system. There is the “Town Development Subsidies Project,” but a structure is not eligible for

this unless it faces the road. Repairs are possible at a very small cost, but a flexible response is required. (Photos: a warehouse in the town, a map of the dismantled structures)

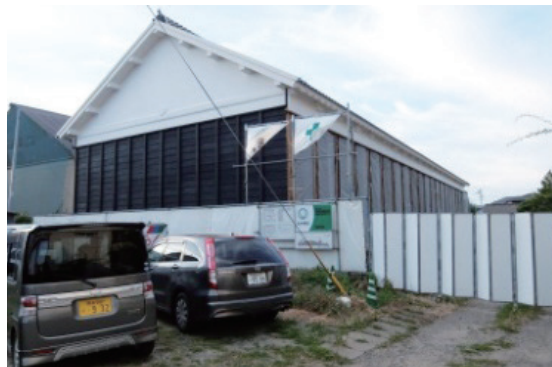
- The nationally designated Hosokawa clan rice granary is undergoing construction work, and as the earthquakes occurred before the roof and walls were installed, the building was light and suffered hardly any damage. The restoration work will be completed in November, as planned. (Photo: the Hosokawa rice granary)

Photo 3.4.2.10 The Hosokawa Domain rice granary (nationally designated)

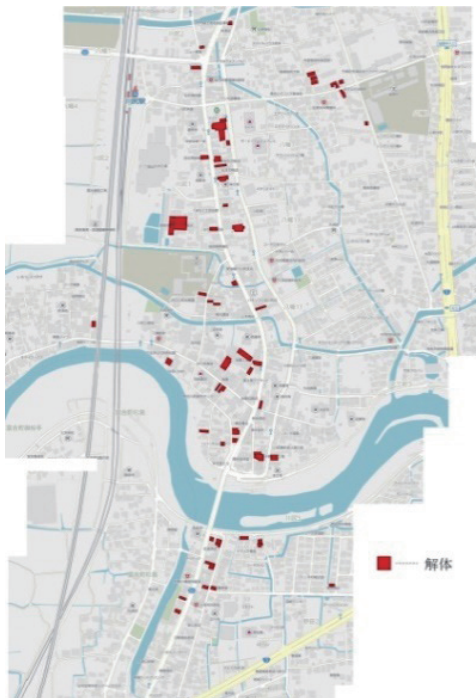
Photo 3.4.2.11 Dismantling in the Kawashiri District (60 buildings)

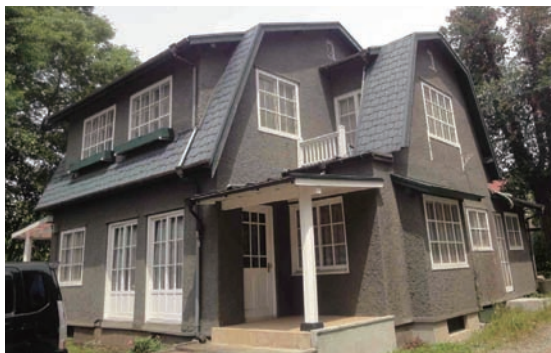
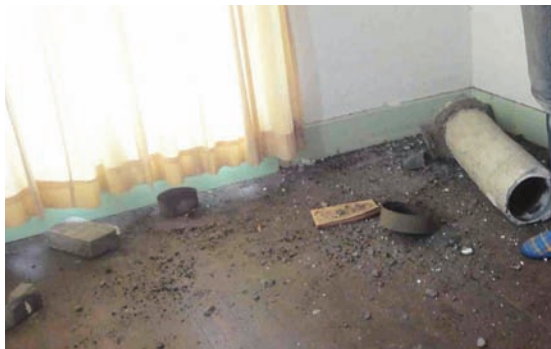
Photos 3.5.1 Maude House

The home of the missionary Maude Powlas, who established the “Jiai-en” Social Service Community. There were no major problems with the main structure, its external walls and roof were not damaged, however, few cracks were identified on its internal walls, while the chimney duct in the attic had broken and fallen off through the ceiling into the room below. In addition, planters attached under external windows had fallen off at several places. As Jiai-en is an iconic building and the design office that was involved in previous preservation and renovation works is nearby, it is believed that careful restoration

works will be conducted to the building.

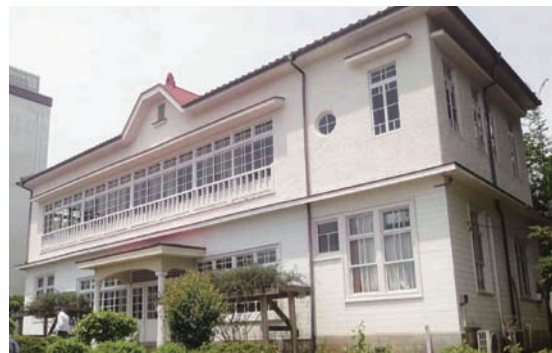
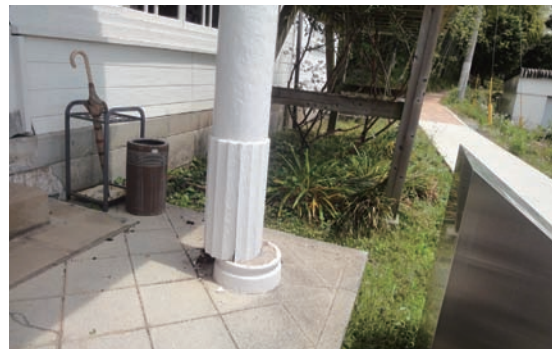
Photos 3.5.2 The Riddell-Wright Memorial Hall

A research facility for Hansen’s disease (leprosy) established by two female, Ms Riddell and MsWright. It is two-storey building with a long, east-west rectangular shape. The building suffered from various kinds of damages caused by the earthquakes, as the ground at the south elevation was shifted forward by around 10cm. Along with this ground shift, cracks had appeared onto its foundation, columns became misaligned, and some parts of internal walls were peeled off. A large-scale construction works is required, including jacking up the building to replace it to its original position. It had been used as an exhibition hall, however it is currently closed.

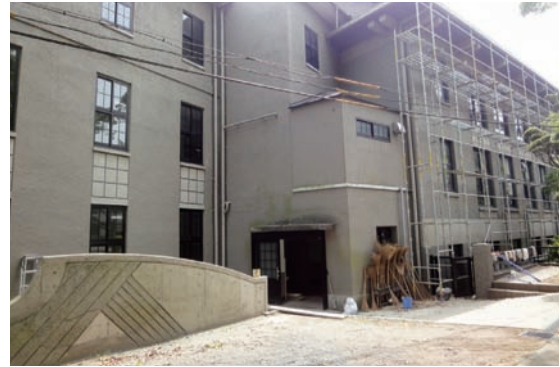
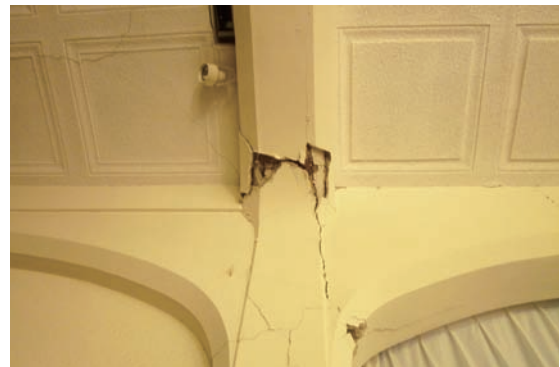
Photos 3.5.4 Kyushu Jogakuin High School main building

The main building of a missionary school designed by Vogel, an American architect. There were cracks

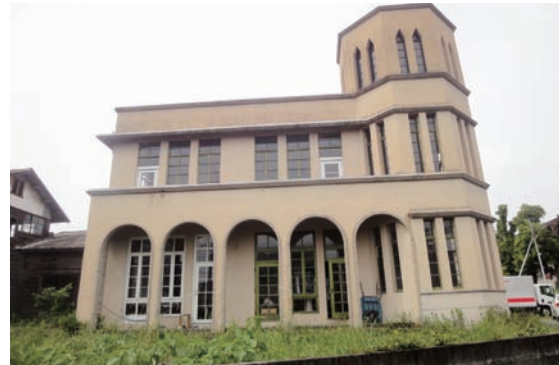
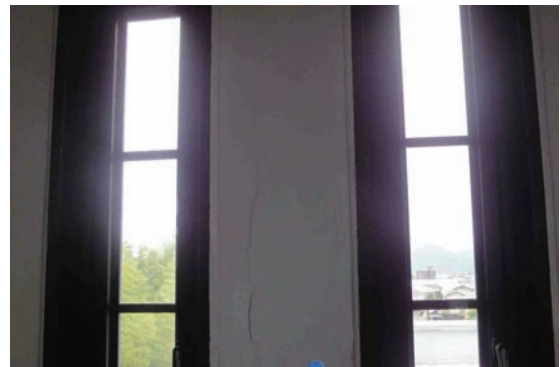
Photos 3.5.5 A meeting hall for Bible study

A meeting hall for Bible study that was built with donations, from the North American YMCA, volunteers from the former No.5 Senior High School and such. Cracks were observed in the internal wall of its penthouse, other than that, no other major damages were found.

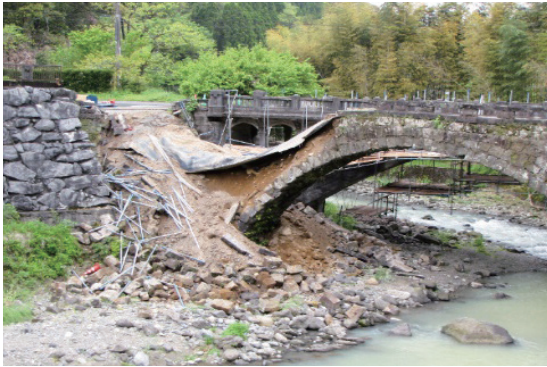
Photo 3.6.1.2 The collapsed stone wall at Futamata Fukura-watashi

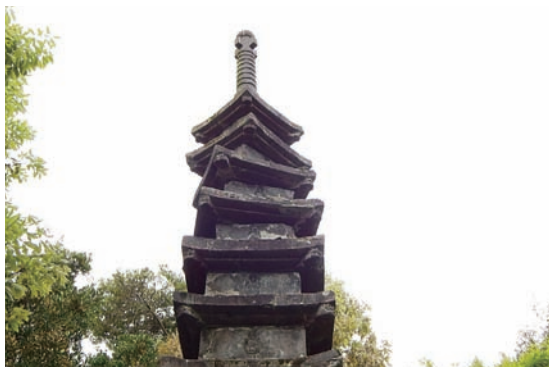
of these earthquakes, the top four stories and the roof of the pagoda rotated and some of the stone materials were damaged. Afterwards, the stone materials that suffered heavy damage at the fifth story and above were quickly dismantled and stored, and that made it possible to avoid collapse or other major damage during the after-shocks. There were center holes in the stone materials used for the pagodas and in the roof, so it is highly possible that there was something like a center pillar at the time of the original construction, but this pillar was not installed when it was relocated in the present site. Moreover, lead boards have been used at the upper end of the pagoda to adjust the unevenness in the stone materials.

Photo 3.6.2.2 The upper part of the twisted thirteen-storied pagoda

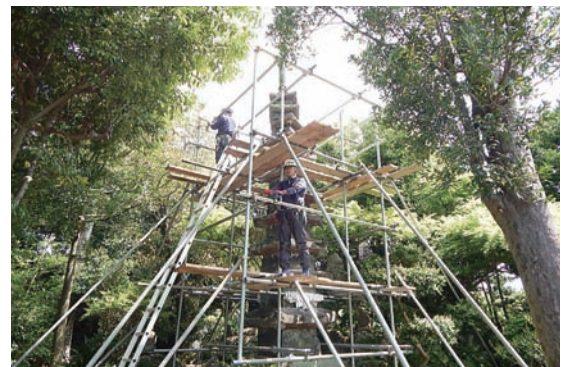
Photo 3.6.2.3 The dismantling of the upper part (April 19th, 2016)

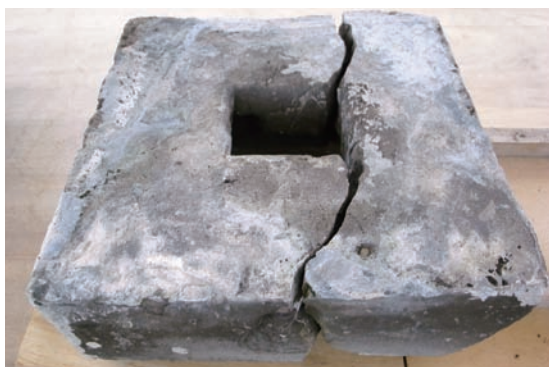
The stone materials that suffered severe damage were on the fifth story, which split into two large sections (Photo 3.6.2.4), and on the seventh story,

Photo 3.6.2.4 The damaged fifth story of the pagoda

which roof was fragmented at the eave-ends. They are being reinforced using stainless steel dowel pins and epoxy resin combined together and, in order to improve earthquake-resistance, stainless steel core post is to be installed during reassembly.

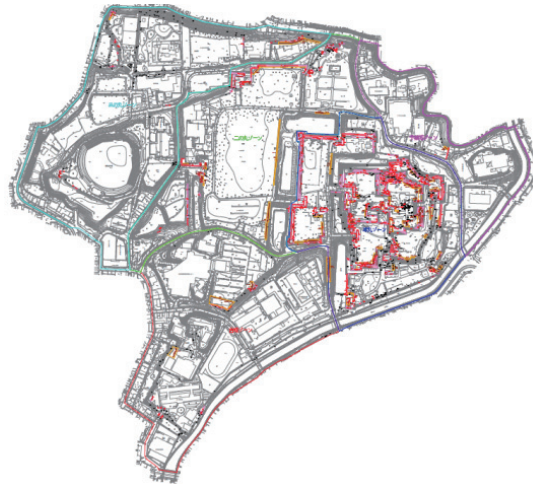
During the 2016 Kumamoto Earthquakes, in the fore-shock earthquake of the night of April 14th, the dry stone wall collapsed in six places and extensive ground damage was ascertained, including

Figure 3.7.1.1 A map of the places where the Kumamoto Castle's dry stone wall was damaged in the 2016 Kumamoto Earthquakes

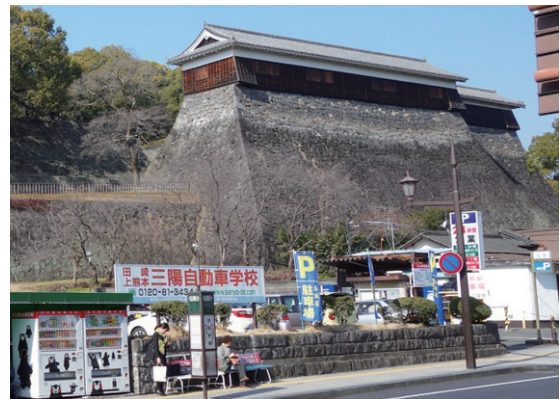
Photo 3.7.1.7 The Higashi Juhachiken Turret before the damage

It has been ascertained that during the fore-shock earthquake, fine cracks occurred to the surface of the West side of the turret, while in the main-shock earthquake, the East side stone wall, which formed part of the turret’s foundation, largely collapsed, and as a result of this, the upper parts of the stone wall on the West and South sides also collapsed. In the Southern half of the turret base, the stone ramparts are entirely filled with cobblestones, circular gravel ranging in size from that of a fist to that of a head; they had been tightly packed in, so that any soil or other substances was hardly added. More than 1,800 construction stones were collected, and here the

scale of the collapse was greater than anywhere else. The cracks on the curved surfaces were increased in number and made wider by the main-shock earthquake.

The turret’s wooden materials and roof tiles that fell off in the collapse were extensively damaged, but all were collected and after the cleaning work and the work to remove the nails

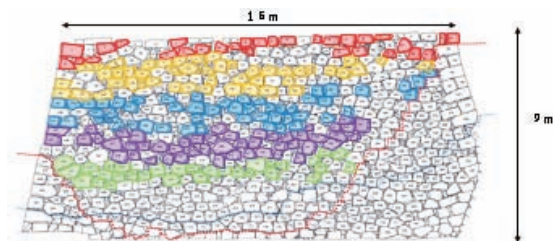
Figure 3.7.1.9 An elevation diagram of the Miyauchi dry stone wall

Ninomaru castle compound, the protrusion of the lower part had become so conspicuous that in 2003 repair works were carried out, assigning numbers to the stones while temporarily dismantling them, to re-pile them up again. In these recent earthquakes, the damaged parts corresponded almost exactly to those previously repaired, and it was possible to determine the original positions of the collapsed stones.

The stones in the lowermost four levels of the collapsed area fell to lay face down directly beneath the stone wall, and were covered by the backfill cobblestones. Then, on top of these, the upper construction stones fell and spread in a semi-circular shape, but retaining the vertical relationship between them. In other words, this situation suggests that the collapse occurred in an instant, with the lowest part of the collapsed section collapsing first, followed by the backfill cobblestones, which flow out, while the upper part of the stone wall slid off retaining the vertical relationship that existed prior to the collapse, thus fell at once.

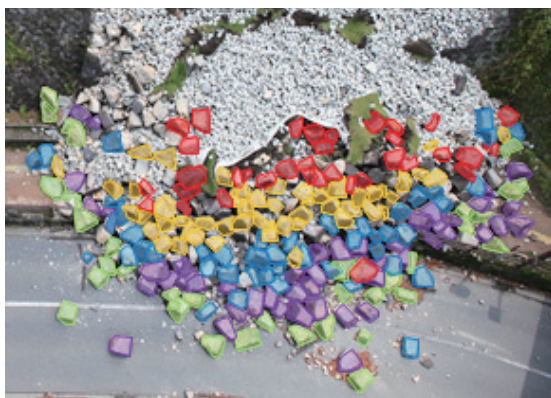
Figure 3.7.1.10 The collapsed Miyauchi dry stone wall

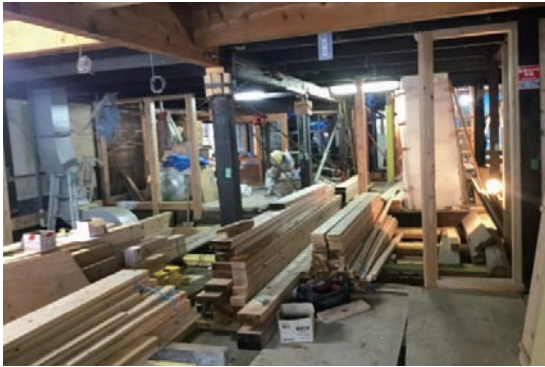
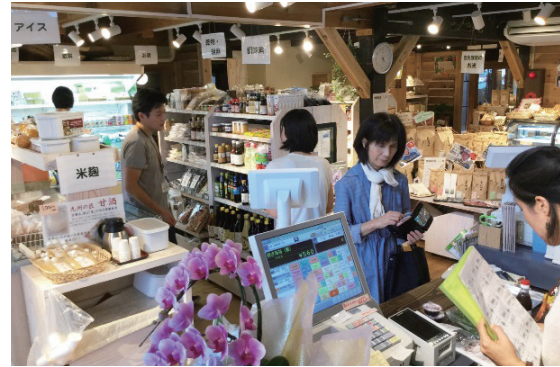
no business establishment has completed its rehabilitation works yet and therefore no business has progressed to the subsidies stage so far. However, among the businesses within the Shinmachi-Furumachi District, there is one that has applied as part of another group (not in the “commercial district” category) and which rehabilitation works have progressed to a certain extent to be able to reopen its business in August 2017 (Photo 4.4.2).

Photos 4.4.2 The rehabilitation works progress (June 2017) and the reopened store (August 2017).
