EARTHQUAKE DISASTER PREVENTION OF CULTURAL HERITAGES - EXPERIENCE AND DEVELOPMENT IN JAPAN -

**August, 2023
ICOMOS Japan**

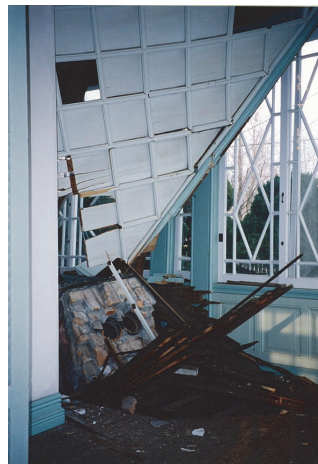
Photo 2.12 An example of a chimney that fell indoors (Former Hunter Residence)
(Photo provided by Agency for Cultural Affairs)

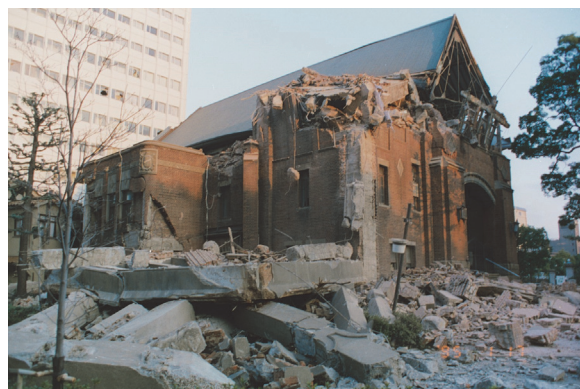
Photo 2.13 Damage to a church
(Photo provided by Kobe City)

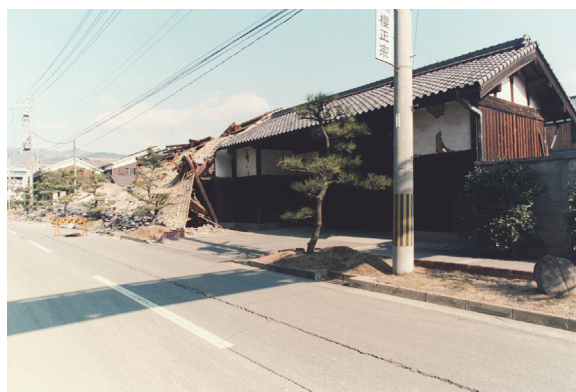
Overall, 75% of the surveyed 1260 historic buildings suffered some kind of earthquake damage, which included 163 completely destroyed houses. In terms of the degree of devastation by building type, *sake* breweries suffered the most, followed by farmhouses, *machiya* (townhouses), and modern houses. Damage to temples, shrines, and modern architecture was relatively low, while residential buildings were affected the most. Looking at the degree of damage by building structures, brickwork constructions were the most affected, with 62% of them being completely or partially destroyed. Wooden constructions were the second structure type most severely damaged, while 12 reinforced concrete constructions in Kobe City were completely destroyed.

Photo 2.14 Damage to sake breweries
(Photo provided by Kobe City)

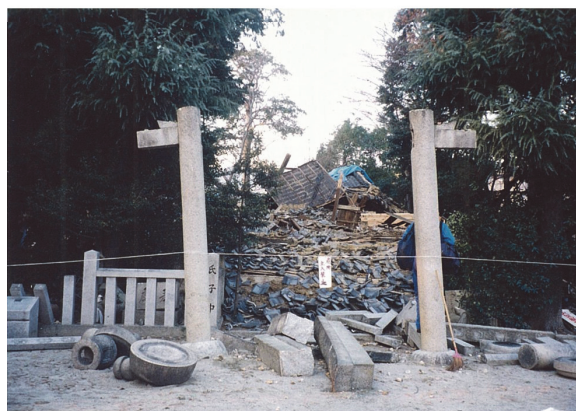
Photo 2.15 Collapse of the main building of Yasaka Shrine
(Photo provided by Agency for Cultural Affairs)

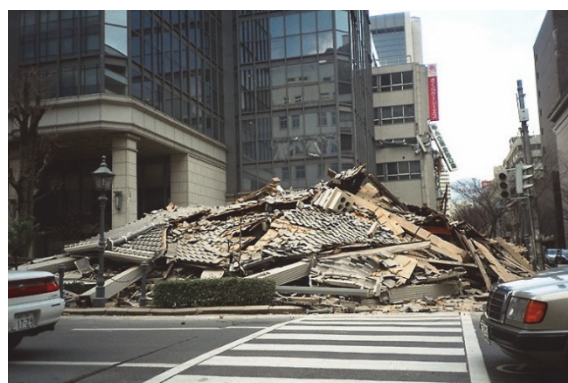
Photo 2.1.6 Damage situation of the former Kobe Settlement 15th Building < National Important Cultural Property>
(Building ownership: Nozawa Corporation, Photo provided by Kobe City Museum)

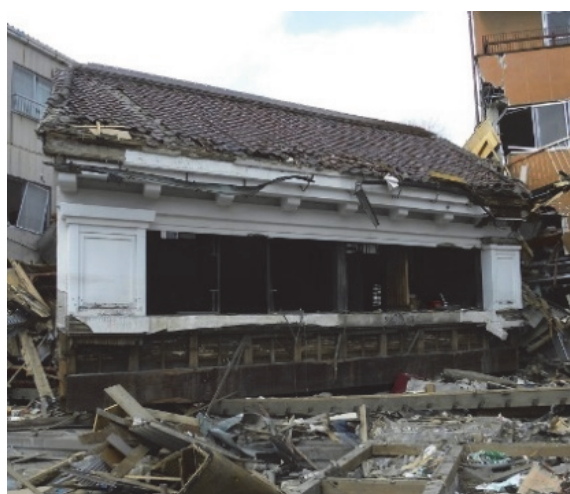
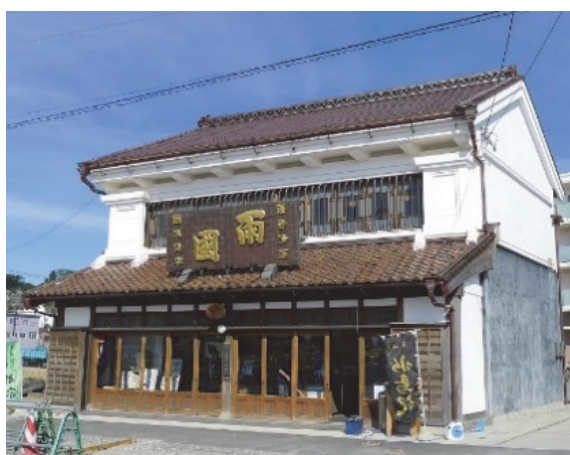
Photo 2.2.1 The Kakuboshi Sake Brewery Store registered cultural property after the Great East Japan Earthquake and tsunami (above) and after rehabilitation (below)
(Photo courtesy of Shigeki Sekiguchi)

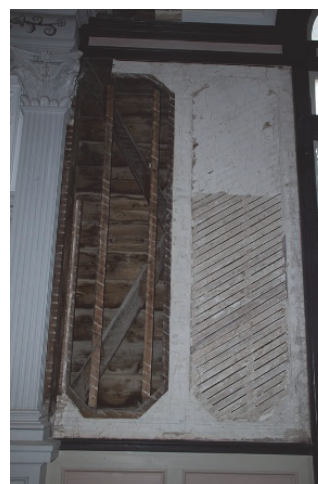
Diagonal braces inside the wall

Horizontal braces were also installed on the steel beams behind the ceiling to strengthen the horizontal structural plane. Unsafe columns that could break during earthquakes were reinforced with braces.

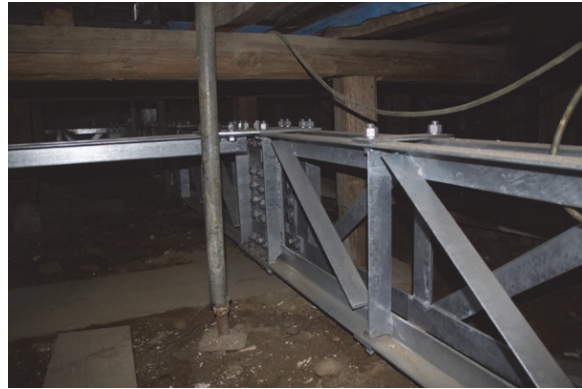
Subfloor steel beam

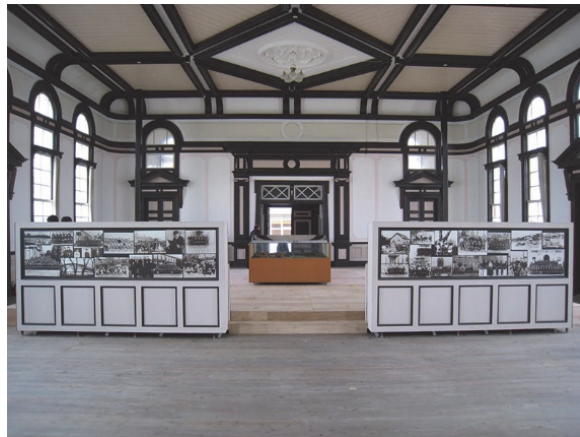
Interior view after completion (steel columns are painted in the back corners)

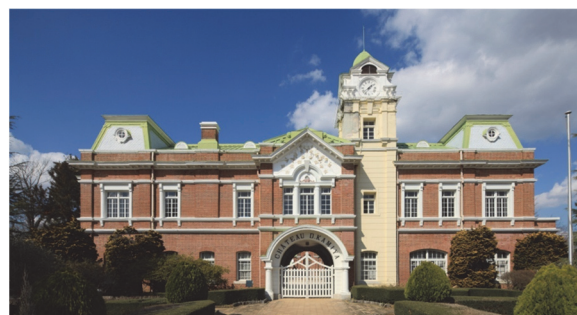
During the Great East Japan Earthquake disaster, Ushiku City was hit by a seismic intensity of upper 5. Damage to the brickwork constructions of this facility was mainly caused by cracks in the framework. The strength of the bricks used here was notably weak, resulting in cracks that penetrated through the bricks themselves, even though the lime mortar used for the joints was even weaker than the bricks. The office suffered more damage

Office Building exterior view after the earthquake

Based on the damage conditions, it was decided that the office and fermentation buildings (including the underground nursery and washing house) would be reroofed and partially repaired. The storage building would be partially repaired, and in conjunction with this work, all building structures would be reinforced.

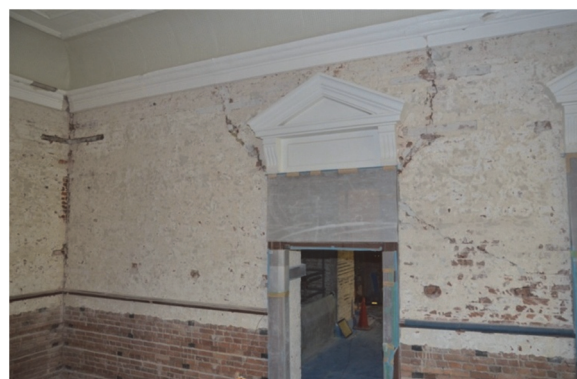
Wall cracks in the Office Building

than the other buildings because of its many openings and the presence of the clock tower. Cracks were usually found at the top of the openings, at the corners, and at the interior corners where the walls met perpendicularly. The clock tower was cracked horizontally at the second-floor level and bent into a "1:25 clock hands" shape. Four of the five chimneys were tilted, and two of these collapsed at the base. In the fermentation building, there were cracks around the openings, and the ground subsided unevenly in the basement of the nursery attached to the fermentation building. The pediment of the washing house was tilted out of the plane and was close to collapsing. In addition to the cracks around the openings, horizontal cracks along the brick joints were found on the side walls of the storage building.

It was also observed that the aftershocks caused more severe damage to the bricks, widening the crack openings.

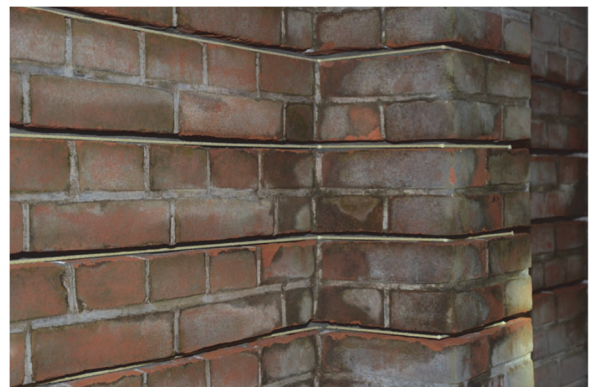
Reinforcement of the joints, Office Building

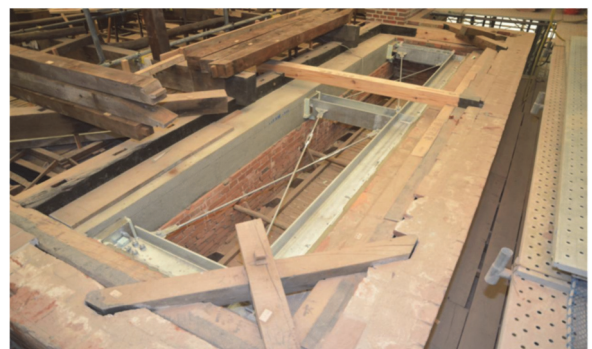
Installation of reinforced concrete (RC) beams

inserting stainless steel rods and a steel brace to reinforce the chimney. The necessity of installing reinforced concrete beams at the roof level was discussed carefully since removing a portion of the top

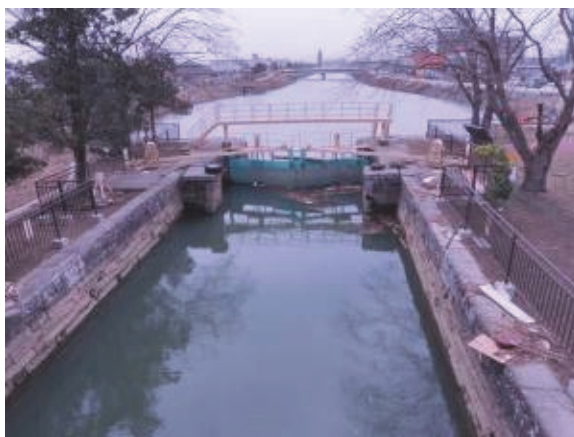
Damage conditions of the lock chamber and lock tail after the tsunami

However, the tsunami that came in from the canal pushed the closed miter gate open, which severely damaged the gate operator that was replaced in 1966, deforming the surrounding stone and brick masonry. In addition, the land subsided in a wide area, causing the entire Ishii Lock to sink about 60 cm and lose its flood control function as a levee that responded to the flooding of the old Kitakami River.

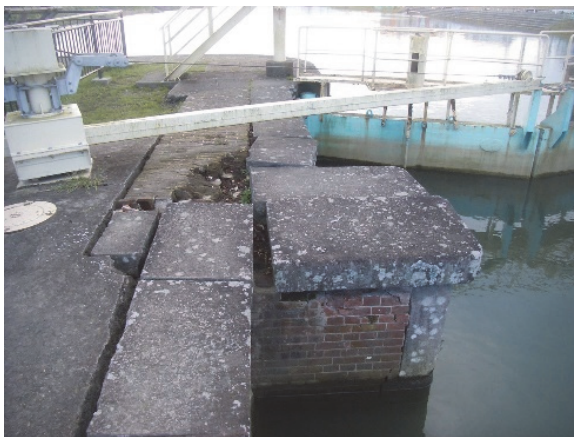
Damage conditions of the gate posts at the lock tail (left bank) after the switch gate was replaced

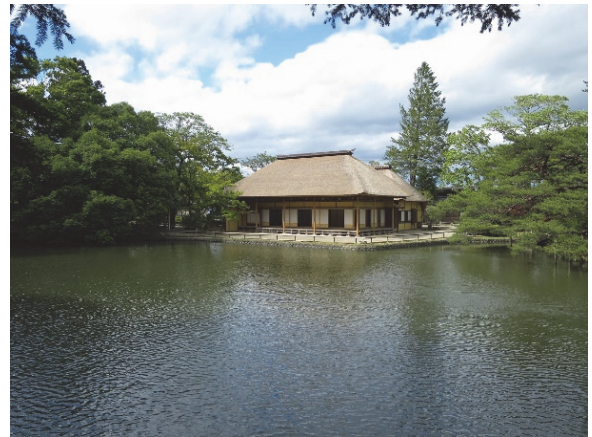
South view, after restoration (main building in front, the annex at the back)

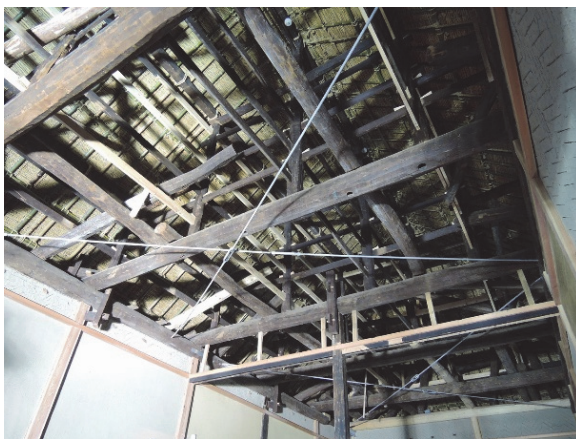
Roof truss with iron rod bracings

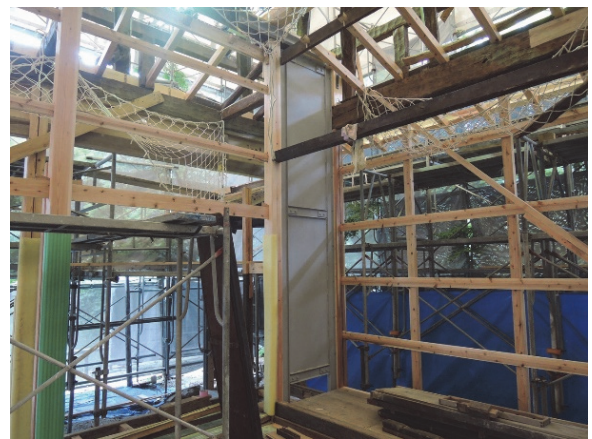
Structural reinforcement example, steel framing

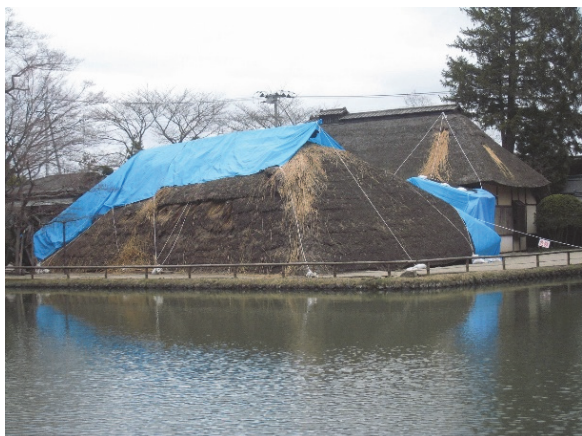
Other buildings (the annex buildings, corridor, tea ceremony house, and main gate) had distorted shafts and partially collapsed walls but did not collapse. In the garden, the ground subsided behind the pond embankment, and damage and cracks were observed in the garden paths.

South view, damage conditions (main building in front, the annex at the back)

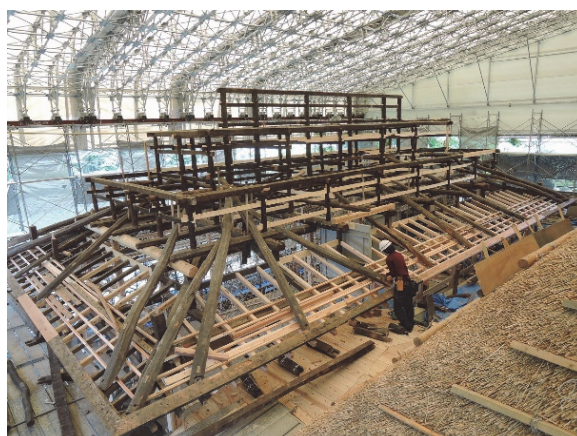
Erecting of floor frames, posts, and truss

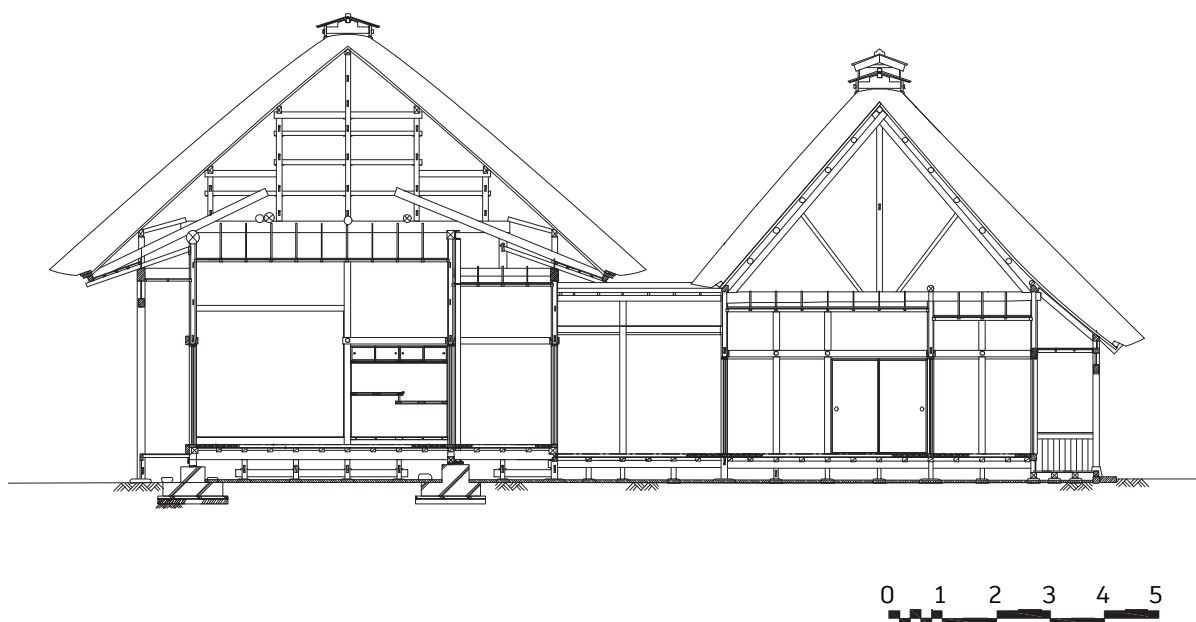
Post-restoration cross-section drawing (Main building to the left, annex to the right)

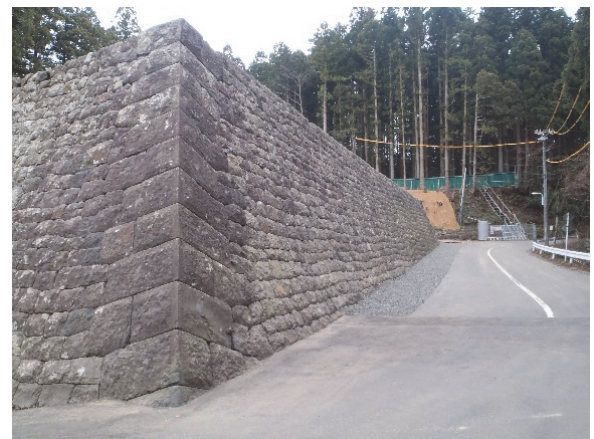
C-side of the northwest stone wall of the central compound after recovery

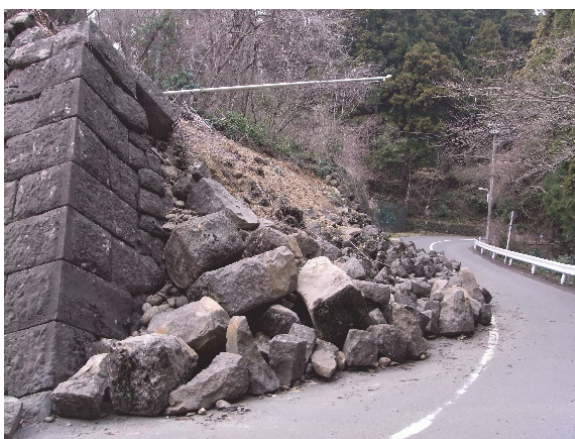
The c-side of the northwest stone wall of the central compound collapsed due to the Great East Japan Earthquake in 2011

Regarding the restoration after the Great East Japan Earthquake, since the Sendai Castle Site is a nationally designated historic site, we aimed for the restoration to reach a state as close as possible to the pre-damage, original state, using traditional construction methods as much as possible. Following this policy, the north stone wall of the Nakamon Gate, which was renovated in 1977 by altering staking techniques with a non-traditional method using concrete, was restacked to the traditional dry masonry form by removing the concrete. The earthen wall on the north side of the Otemon gate had been renovated with mortar during the recovery from the Earthquake off the coast of Miyagi Prefecture in 1978, so the entire surface was removed and the wall was restored using traditional dry masonry. In the recovery of the collapsed earthen wall,

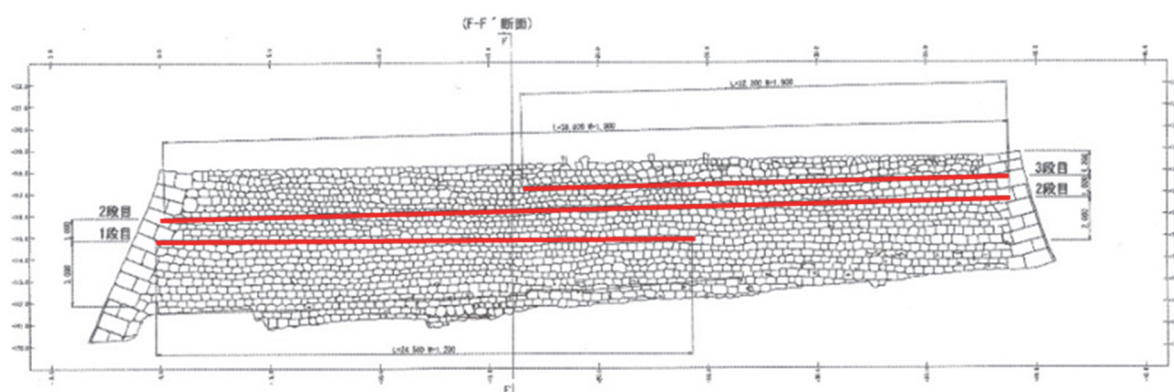
Elevation

(Construction diagram of geotextile reinforcement northwest stone wall of the central compound)

the remains of the castle were preserved, and some modern construction methods were adopted in order to build within the scope of modern era construction. Regarding the construction method, several layers of synthetic fiber reinforcement nets (geotextiles) were inserted into the backfilling stone layers for the recovery work to reduce the earth pressure.

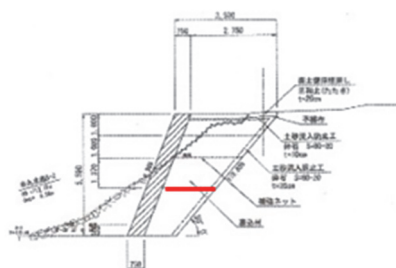
Cross-section view

(Construction diagram of geotextile reinforcement northwest stone wall of the central compound)

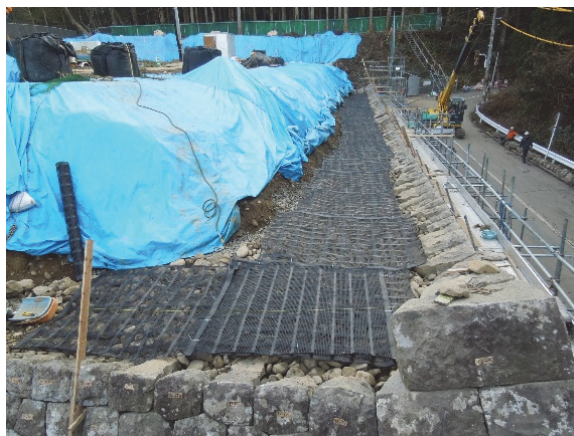
Geotextile reinforcement work at the C-side of the northwest stone wall of the central compound

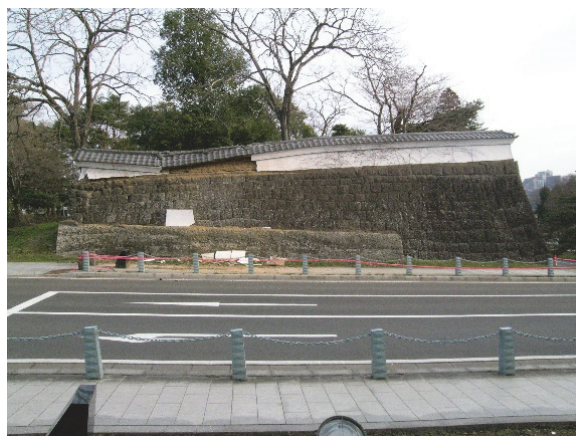
Earthen wall on the north side of the Otemon gate collapsed by the Great East Japan Earthquake

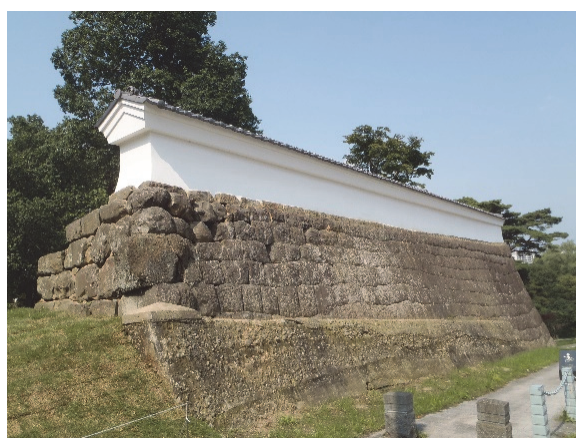
Earthen wall on the north side of the Otemon Gate after completion of recovery work from the Great East Japan Earthquake

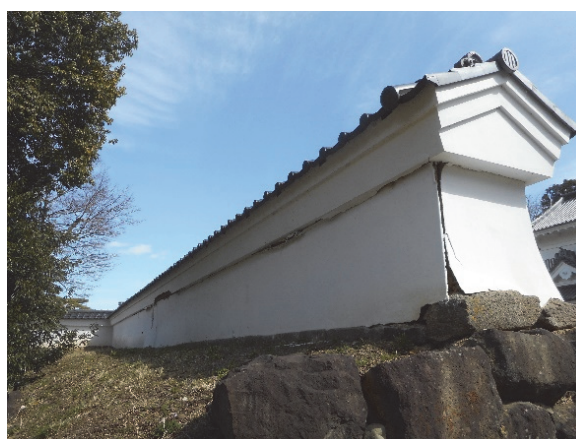
Earthen wall on the north side of the Otemon gate deformed by the Earthquake off the coast of Fukushima Prefecture in 2022

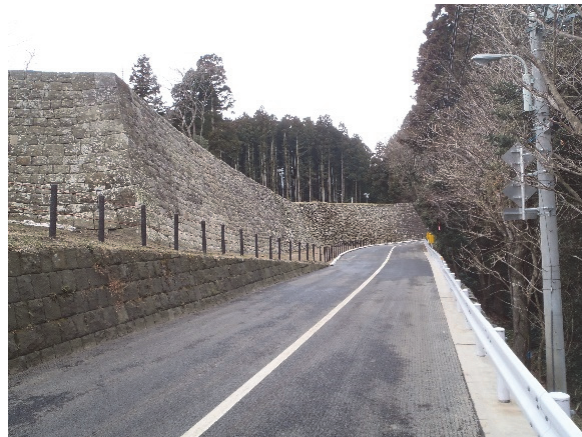
E-side of the northwest stone wall of Central Compound (Main Compound) after completion of the recovery work from the Great East Japan Earthquake

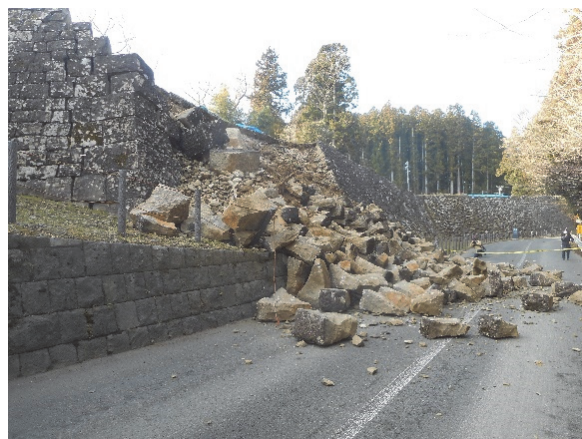
Northwest stone wall E-side of Central Compound (Main Compound) that collapsed again after the Earthquake off the coast of Fukushima Prefecture in 2022

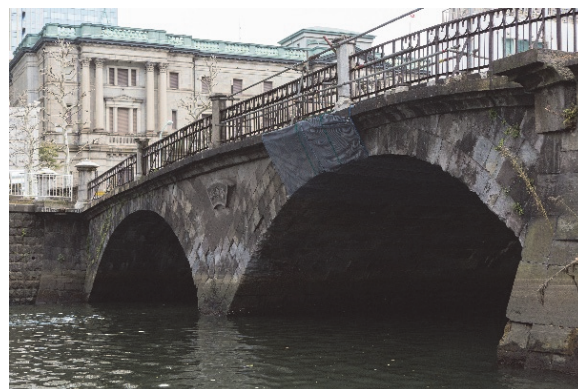
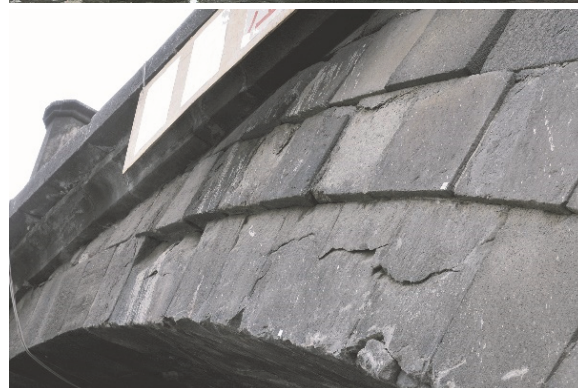
Disaster conditions

Deck paving stones caving in

There were significant voussoirs jutting out of the back of the arch on the right bank side, which caused the deck surface to cave in.

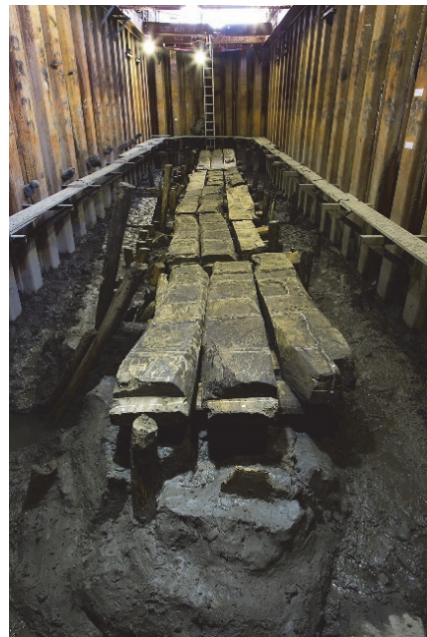
The wooden members of the foundation structure were judged according to their damage and decay after cleaning. The damage conditions were determined visually and measured with a measuring stick.

Condition of the foundation

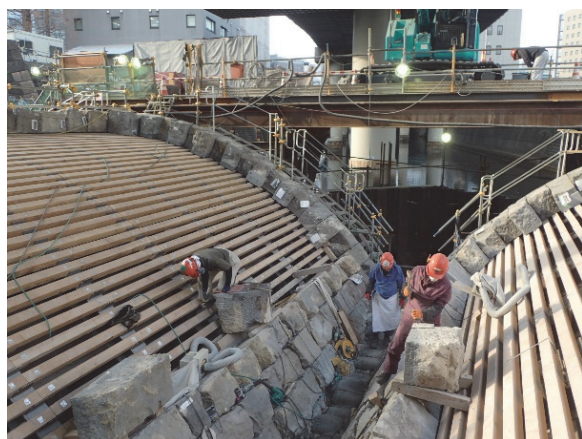
Restoration situation

The basic policy for restoration was to preserve and restore the masonry arch and the wooden foundation, and to preserve the original technique and original components. For this reason, a policy of total dismantling and repair was adopted, and steel-framed supports were installed. If reinforcement was necessary, care was taken to ensure reversibility.

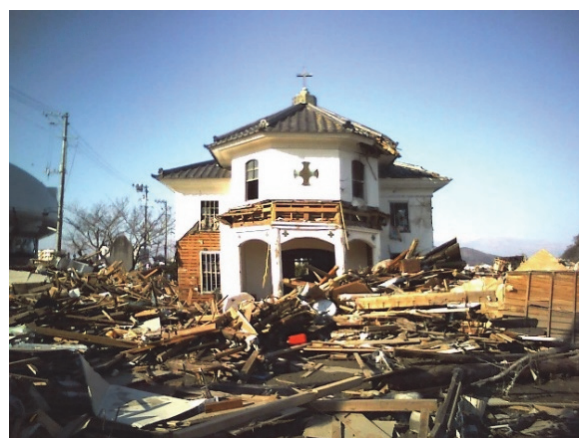
The Great East Japan Earthquake caused devastating damage from the tsunami. Fortunately, the building did not collapse or wash away, but the tsunami passed through the interior, damaging most of the fixtures. Many interior and exterior wall finishes peeled off, exposing the sublayer of the building. Drifting ships caused external physical damage to the east side of the building. Structurally, it was miraculous that only the middle of a two-story-post on the north side was broken. The south and north external sides of the building were more severely damaged, and the entire structure is tilted to the northwest. In addition, the roof eaves (and the *nokijabara* or the cornice) and the cornices around the portico were missing, wall finishes were spalling, many fixtures at the exterior openings had fallen out, the round columns of the portico were

South View after the disaster, March 2011

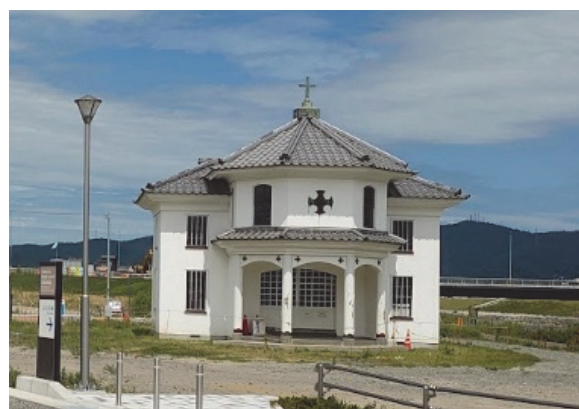
View after restoration work, August 24, 2022

and May of 2014. The dismantled materials were stored in four prefabricated warehouses set up in the parking lot of the Ishinomaki City Buried Cultural Properties Research and Arrangement Storage Facility, and then moved and stored in the former school building of Minato Daini Elementary School. The same location before the damage was set as the place for the reassembly. JCHC was commissioned to conduct a reconstruction design plan from December 2015 to June 2016, based on a survey conducted during the dismantling work. The "Ishinomaki City Modern Architecture Preservation and Maintenance Research and Study Expert Committee," of experts deliberated and decided on design specifications and other details. Takumi Co., Ltd. was contracted by Ishinomaki City to undertake the work, and JCHC was commissioned to supervise the construction work.

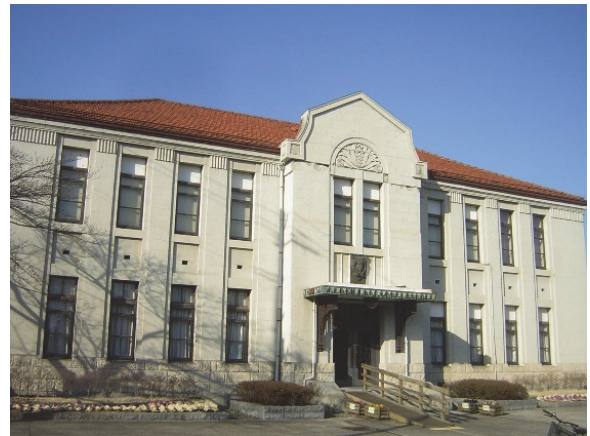
View after the recovery

struction methods. To improve seismic performance, the following measures were taken: (1) building a new foundation, (2) placing horizontal braces on the second floor, (3) placing laminated wood (500mm x 200mm) beams at the top of the masonry walls, (4) inserting high strength steel bars ($\phi 23$, prestressing (PS) = 50 KN, 47 bars) into the masonry walls, and (5) supporting the pediment with a steel frame. The Ministry of Education, Culture, Sports, Science and Technology's Disaster Recovery Project for Public Social Education Facilities was used to finance the recovery work.

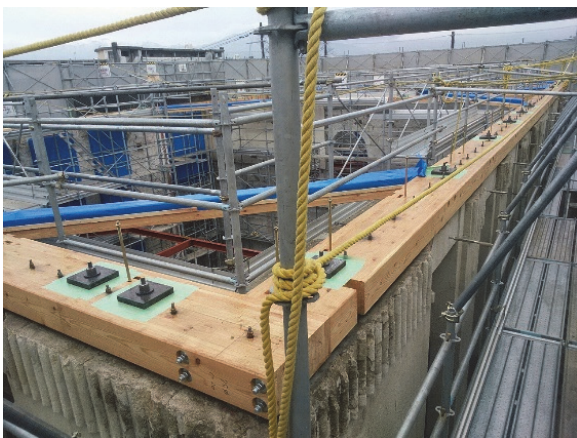
Laminated wood beams above the walls

Since there are reports that reinforcement with rigid reinforced concrete induced damage during the 2009 L'Aquila earthquake, laminated wood from Fukushima Prefecture was used for the beams above the walls. Since these laminated wood beams supported the tops of the high strength steel bars, the loosening of the prestress over time became an issue. In addition, monitoring of the prestressing value of the installed high strength steel bars is being monitored as of 2022.

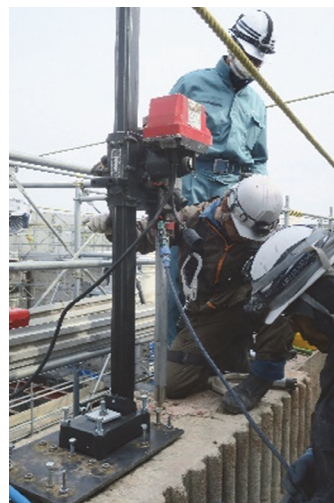
Drilling holes in the masonry wall

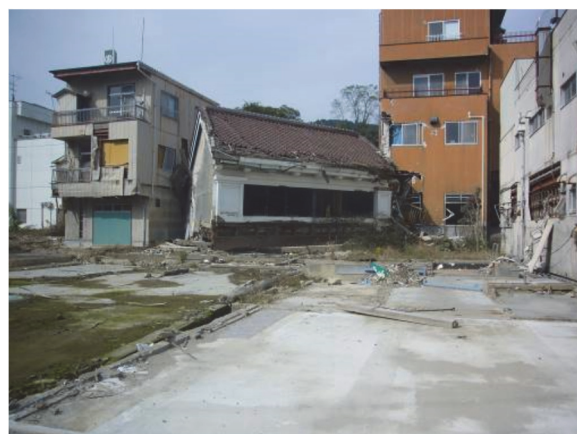
The first floor was washed away by the tsunami of the Great East Japan Earthquake, and the second floor was swept away to the north about 30 meters from its former location. The house was temporarily moved to the pre-disaster site and cured until the land readjustment project policies were established and restoration became possible. In the end, the restored building was moved approximately 8m west of the pre-disaster site due to land conversion and site shape changes. The restoration work was completed in September 2016, the first of the six cultural property sites in the Kazamachi district.

The tsunami swept the first floor away and pushed the second floor about 30 m north

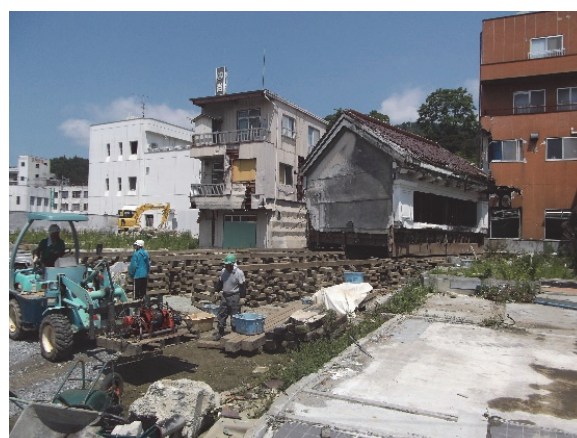
The remnants were rolled back close to their original location

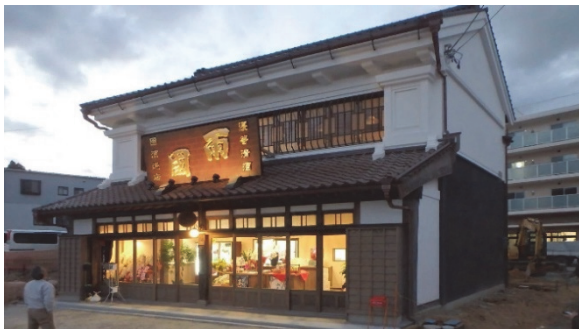
After restoration (September 2016)

First, the rescued second-floor components were dismantled and stored, and at the same time, a search and investigation of the lost materials was conducted. Original materials were reused as much as possible. The remaining roof trusses, second-floor posts, beams, girders, baseboards, rafters, floorboards, walls, ceiling materials, copper grids, and some other materials found in the surrounding area were all reused, and the lost first-floor posts, floor joists, and severely damaged eaves were replaced with new materials. The exterior finish was, in principle, restored. All of the exterior plastering,

however, was newly replaced, and the newly constructed stairwell was sprayed with a ricin finish to distinguish it from the original materials. For the roof, decorative end-tiles and recovered tiles were reused, and the rest were collectively used for the shed roof. The ridge design was restored to the *sei-gaiha* or repeating wave style using old photographs as a reference.

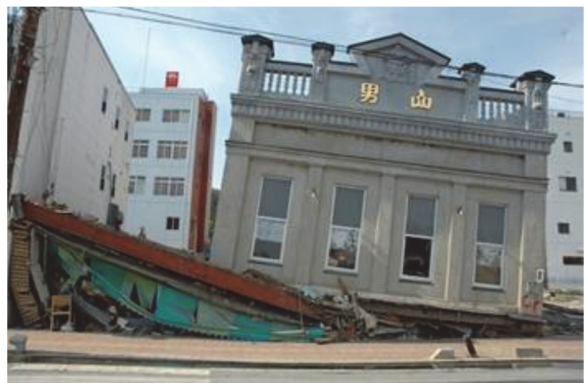
The first and second floors were swept away by the tsunami of the Great East Japan Earthquake, but the third floor remained, slightly encroaching into the neighboring land. Until the land readjustment project policies were established, and making restoration work possible, the remains of the building were temporarily moved to their pre-disaster location and protected. The restored building was finally relocated 10m east of the pre-disaster location due to the land replacements and changes. The restoration was completed in June 2020, the fifth of six cultural property restoration projects in the Kazamachi district.

The tsunami swept the first and second floors away, leaving the third floor

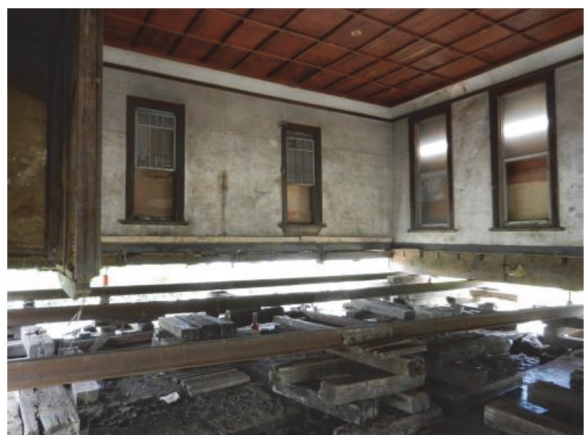
Preparing the rails to roll and move the remaining building part

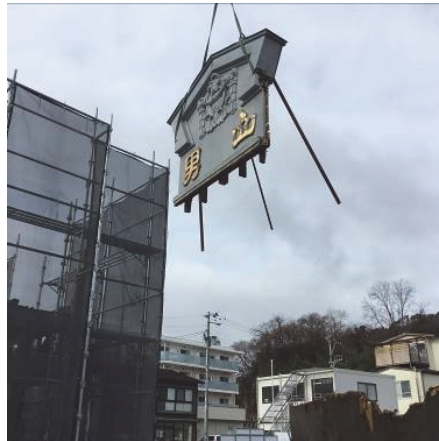
Rescuing the pediment of the third floor to be stored

In order to maximize the reuse of decorated chamber walls with a washing finish of stucco and pediments, the building was dismantled on a large scale, and a steel base reinforcement technique was developed to reinstall these decorated chamber walls within the frames.

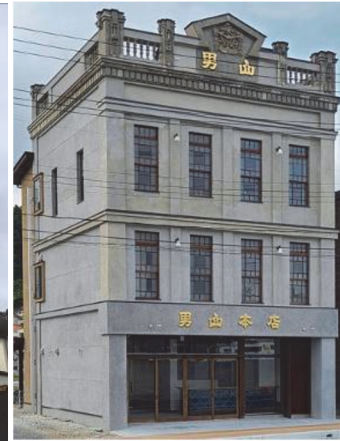
After restoration (June 2020)

In principle, the exterior of the building was restored: as the same materials were used to replace lost exterior walls, and the urethane coating that was originally applied to the exterior walls was

washed away to reveal a washing finish of stucco. Referencing old photographs, the fixtures were restored to their actually original wooden frames, not the frames used before the disaster. The exterior walls of the newly constructed staircase and elevator were sprayed with elastic ricin finish to distinguish them from the original materials.

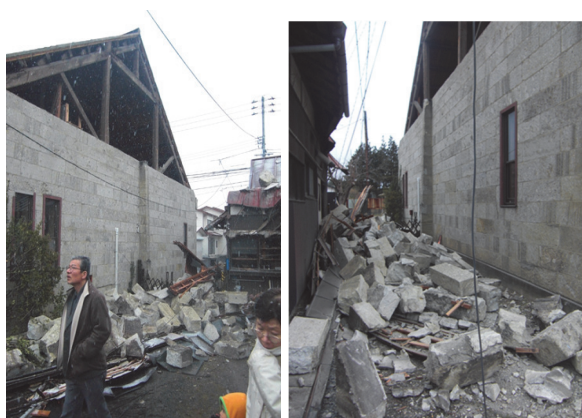
**Former rice storing and milling house
(collapsing stone walls)**

The upper part of the stone constructions (which had no reinforcements) collapsed during the Great East Japan Earthquake. The upper part of

the collapsed gable wall was later repaired by replacing it with a board wall. The building was closed after the disaster, but it is currently being renovated to be used as a *sake* brewery. For the process, reinforcements with RC foundations and steel frames are underway.

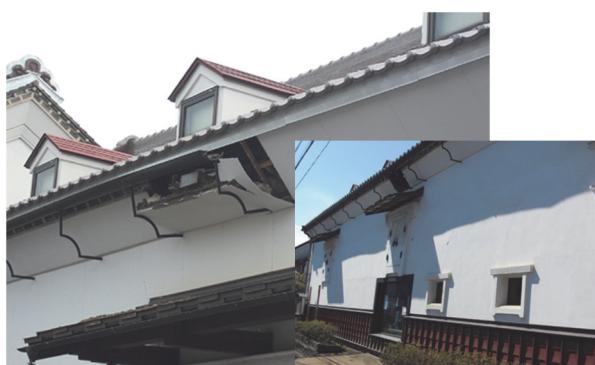
**Former sales warehouse
(inclined building and damaged eaves)**

The building was tilted 1/30 radian in the beam-to-beam direction by the Great East Japan Earthquake. In addition, the eaves were damaged. Subsequently, the tilting was forcibly corrected using wires, and the roof trusses were reinforced with wood. However, the March 16, 2022, the Earthquake off the coast of Fukushima Prefecture struck again, damaging the eaves and falling roof tiles. The building is used as a store and office.

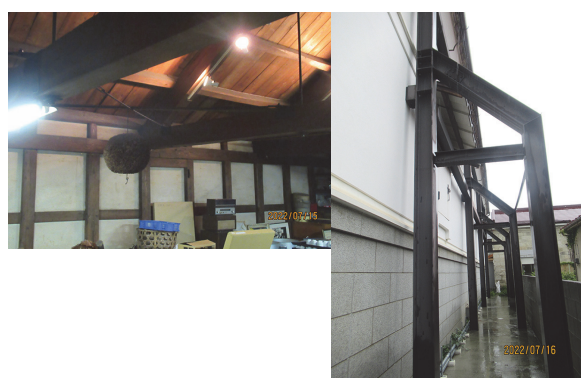
Steel buttress and truss reinforcement to increase horizontal rigidity in the former sake brewing warehouse and sake starter house

The roof truss is a Western-style queen post structure. With a girder length of 27 m and a beam length of 16 m, it is one of the largest mud-walled storehouses in the Tohoku region. The building was not structurally damaged by the Great East Japan Earthquake, but underwent seismic reinforcement because it will be opened to the public as a *sake* folk art museum. The seismic reinforcement included adding steel buttresses and steel braces to the roof trusses to ensure horizontal structural rigidity. When the buttresses were designed, structural calculations were made with the design load as a base shear factor of 0.4.

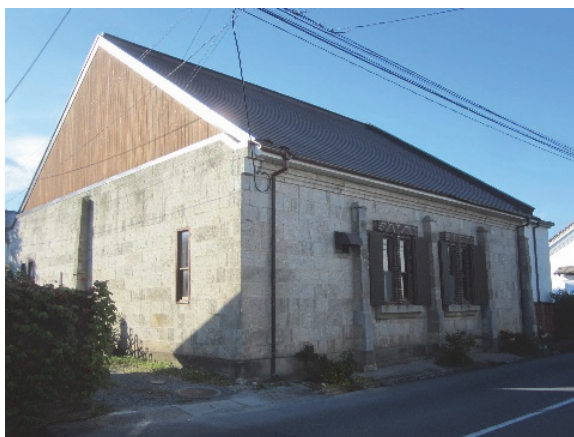
Former rice storing and milling house (board wall repairs)

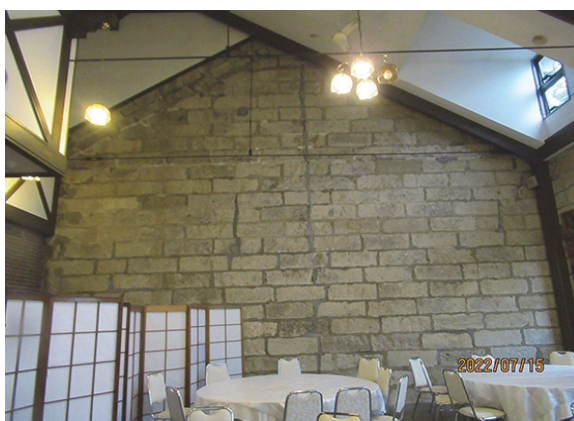
The repeated crack damages by the February 16, 2022, the Earthquake off the coast of Fukushima Prefecture (Former rice storing and milling house)

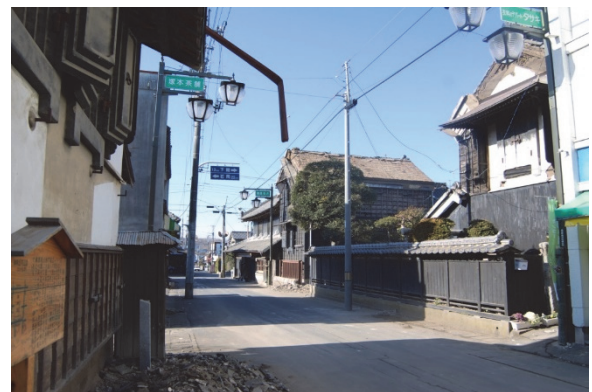
**Conditions of disaster-struck traditional buildings
(Photo provided by Sakuragawa City)**

Japan Earthquake, with an intensity of 6. Two mud-walled storehouses and one stone masonry storehouse collapsed, and more than 80% of the 106 traditional buildings in the Important Preservation District were damaged, as were most of national registered tangible cultural properties located in the vicinity. The damage to most historic buildings was limited to roof tiles or clay roofing slipping and cracking, and mud walls collapsing, with little damage affecting the structural safety. The mud-walled storehouses in particular, which have a strong presence not only in this area but also in other historic towns in the northern Kanto region, suffered much damage, including damage to the 200-300 mm thickness fire-retardant mud walls and to the *kagemori* and *hachimaki*, which are characteristic elements of mud-walled storehouses. On the other hand, the damage to historic buildings that had been regularly maintained tended to be small, underscoring the importance of regular maintenance in the management of historic buildings.

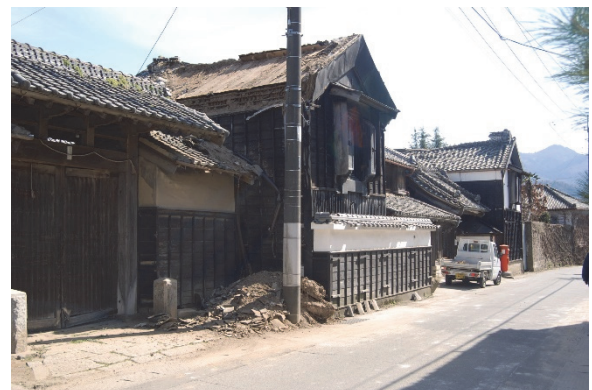
**Conditions of a damaged registered cultural property building located outside of the preservation district
(Photo provided by Sakuragawa City)**

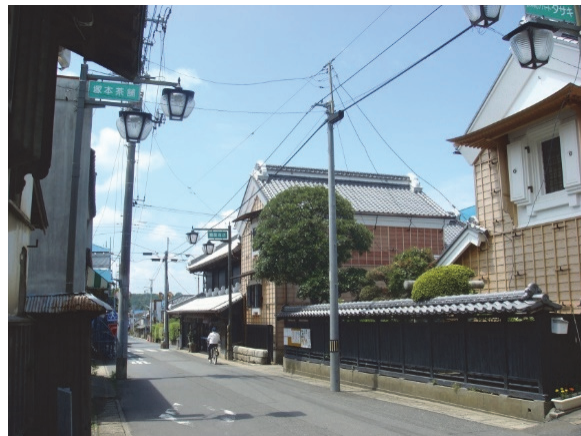
After the restoration of the traditional buildings
(Photo provided by Sakuragawa City)

For traditional buildings in the preservation district, the above-mentioned generous subsidy system was provided, and repair using traditional construction methods was the basic policy. On the

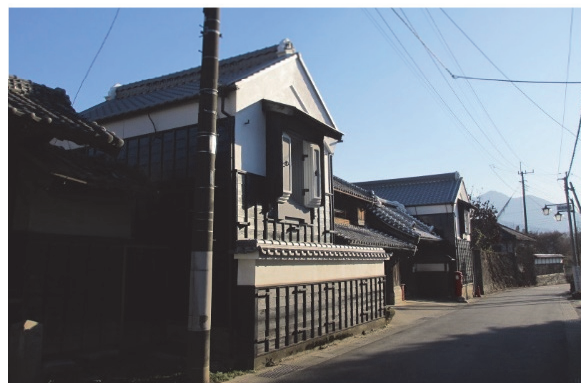
After the restoration of the registered cultural property building located outside of the preservation district
(Photo provided by Sakuragawa City)

other hand, structures that form historical scenic beauty were allowed to be repaired using metal joints and conventional construction methods as long as the traditional design of the exterior remained like the original.

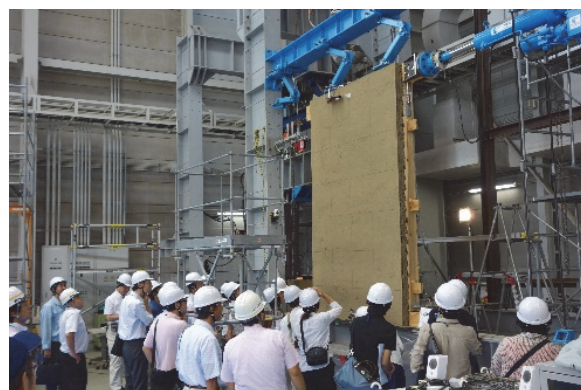
Production of mud walls and horizontal load testing

Nationwide, examples of seismic studies on the performance of mud wall warehouse buildings are scarce. It was necessary to accumulate technologies to enhance their seismic reinforcement performance and to train local engineers to become familiar with these technologies. In response to this, in collaboration with local craftsmen, the committee evaluated the structural performance of mud walls in the northern Kanto region, verified the methods and effectiveness of repairing damaged mud walls, developed seismic reinforcement design, and created guidelines for their design and construction.

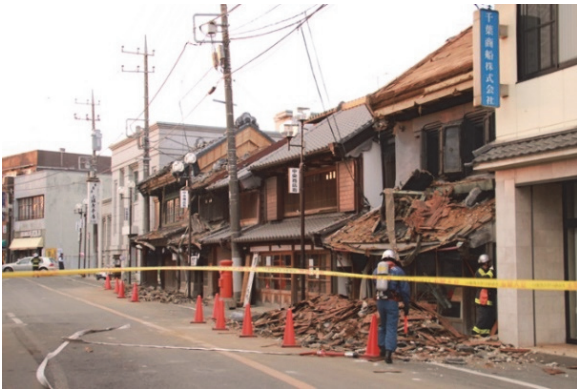
Damage to the townscape
(Photo provided by Katori City)

historic buildings, but buildings with solid foundations maintained their integrity and their superstructure sustained no damage. In contrast, buildings that were not built on solid foundations suffered damage to their superstructures, in some cases as the foundations moved apart. In addition, buildings where only the footing of the main building had been repaired to the solid foundation suffered more damage, through a separation caused between the main building and the eaves.

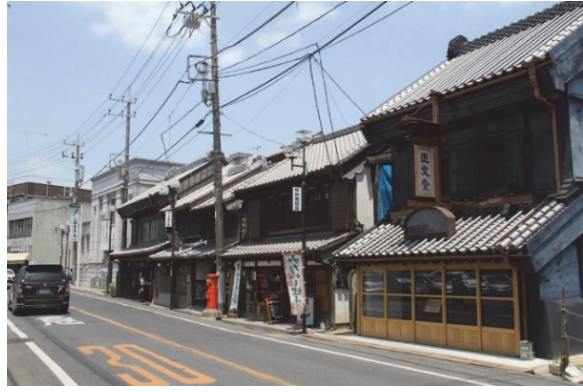
Restoration of the townscape
(Photo provided by Katori City)

The originally planned repairs of the traditional buildings was almost completed in two years by allowing the use of modern materials and construction methods for the foundation and other parts of that would not affect the overall landscape. These repairs were carried out on the assumption that traditional construction methods would be used in the major repairs to be made later.

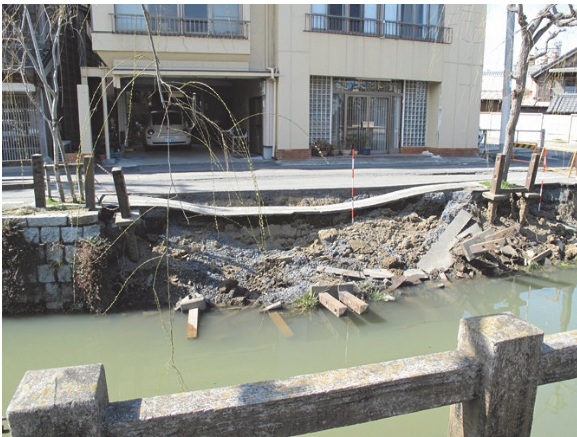
Damage to the revetment in the preservation district
(Photo provided by Katori City)

In the Sawara Preservation District for Groups of Traditional Buildings in Katori City, repairs have been conducted since before the earthquake to replace the foundations even of traditional buildings with solid foundations. This work was carried out to protect the foundation stones and the foundations themselves from the ground moisture because the *choshi* stone material used there this sandstone, which is highly water-absorbent and brittle. However, the Great East Japan Earthquake disaster had a different effect. The earthquake moved the revetment of the Ono River to the river, causing lateral flow and soil-structure subsidence at the foot of the

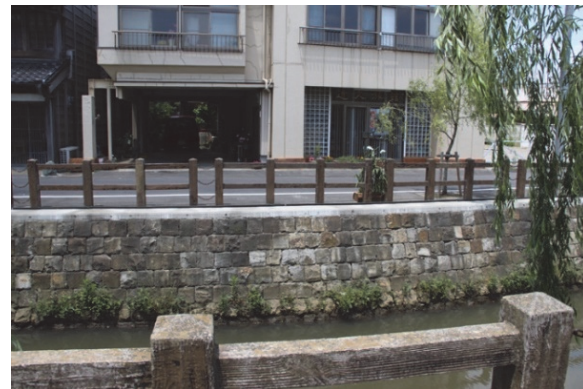
Restoration of the revetment in the preservation district
(Photo provided by Katori City)

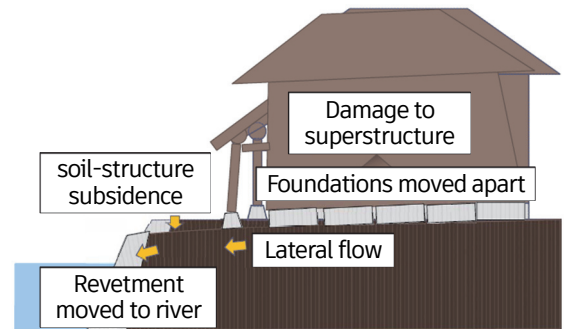
Image of damage to the buildings due to ground settling

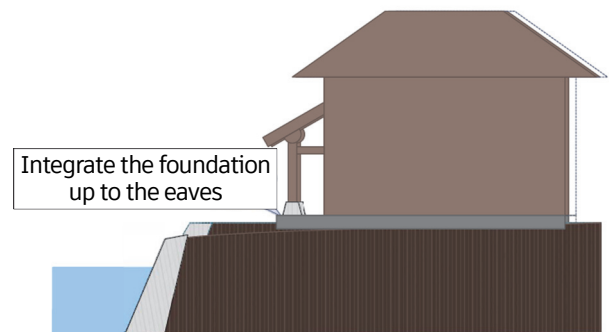
Image of the effect of having a solid reinforced foundation

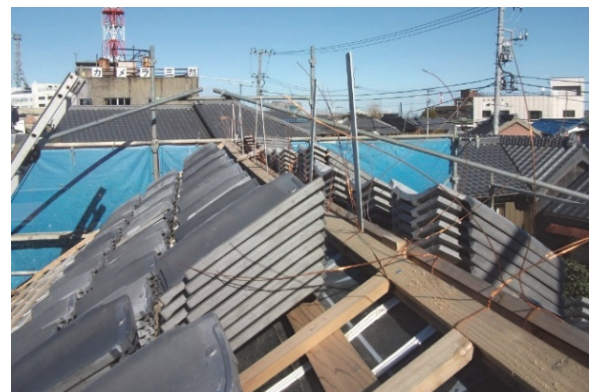
An example of repairing the roof ridge tiles using the guidelines (Photo provided by Katori City)

Regarding the repairs of the buildings where the foundation and eaves separated, they were connected using post-construction anchors. In addition, to prevent the roof tiles from collapsing, which was the most common type of damage, safety measures were taken during the recovery process, including connecting all flat tiles and ridge tiles with guide wires, following the "Standard Design and Construction Guidelines for Roof Tiles" (issued by the All Japan Tile Contractors Association). This method helps avoid affecting the appearance of the roof tiles.
