EARTHQUAKE DISASTER PREVENTION OF CULTURAL HERITAGES - EXPERIENCE AND DEVELOPMENT IN JAPAN -

**August, 2023
ICOMOS Japan**

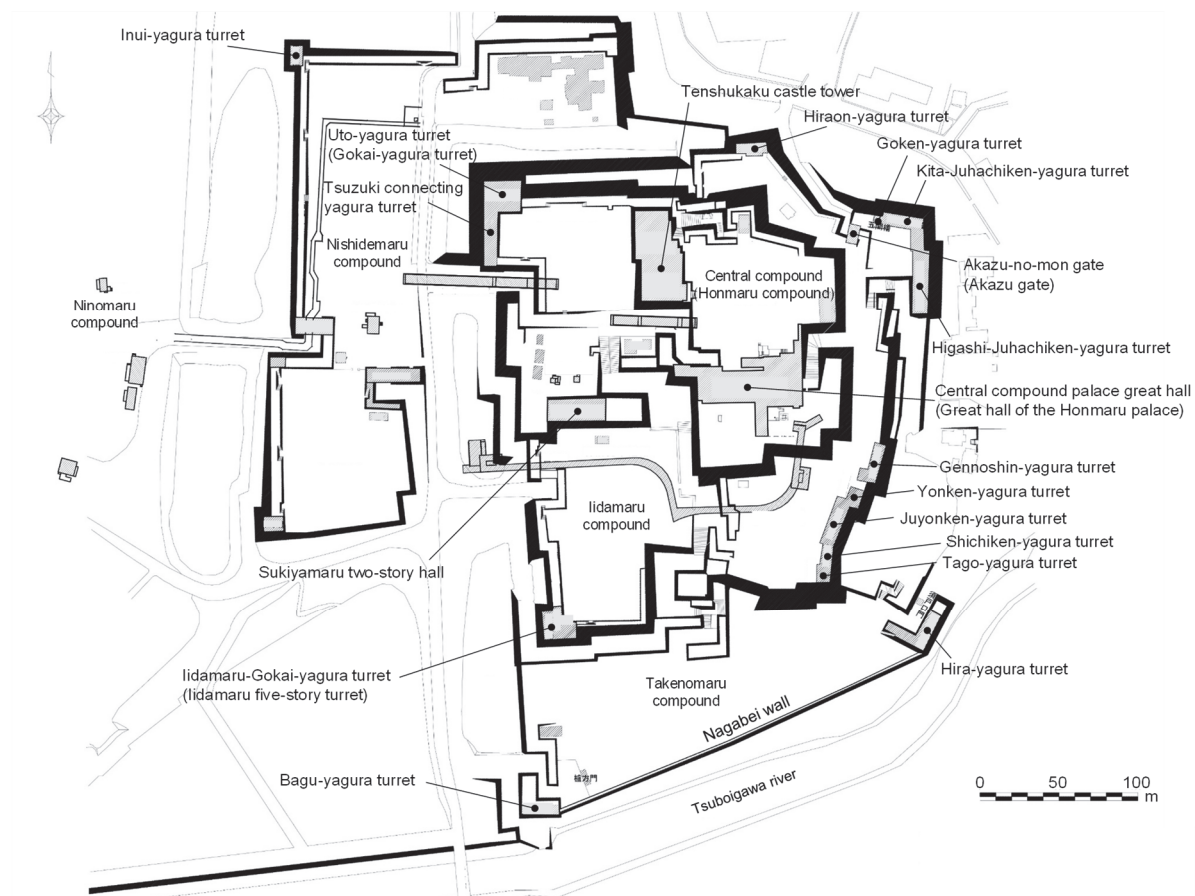
Overall layout

Kumamoto Castle has 973 stone wall segments covering approximately 79,000 m². Of these, 229 segments, or approximately 8,200 m² collapsed due to the earthquake, which is approximately 10% of the total area. If we add the areas that were assumed to require partial repair due to loosening or bulging, we will get 517 segments or approximately 23,600 m², which is approximately 30% of the total area. Naturally, the damage figures will fluctuate as the recovery project progresses, but fortunately, there have been almost no secondary collapses due to aftershocks. On the day after the foreshock, aftershocks were still severe, and the staff was scattered at emergency posts, such as evacuation centers, so the initial survey was limited to a brief preliminary level; then the main shock occurred before a full-scale assessment could be conducted.

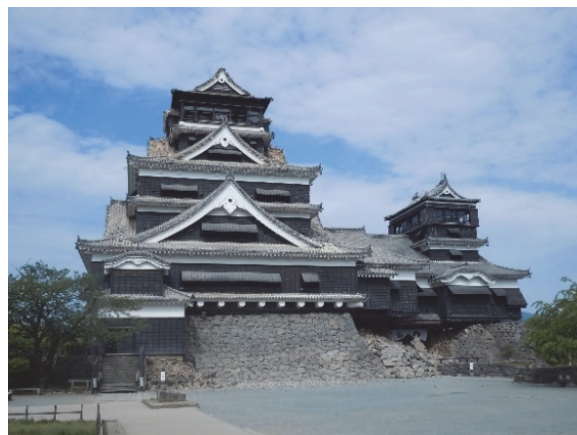
The large and small donjons are steel-reinforced concrete reconstructions (buildings recreating the historic external appearance) completed in 1960. Most of the roof tiles on the top floor of the main donjon have fallen off, damaging the tiles on

Damage to the Tenshukaku castle towers

the lower floors. Inside the top floor, the base of the posts was severely damaged, and many cracks have developed in both the concrete walls and floor. The top floor of the donjon was therefore dismantled and rebuilt. During the recovery work, seismic retrofitting was conducted by reducing the weight of the roof and installing braces and dampers. Efforts

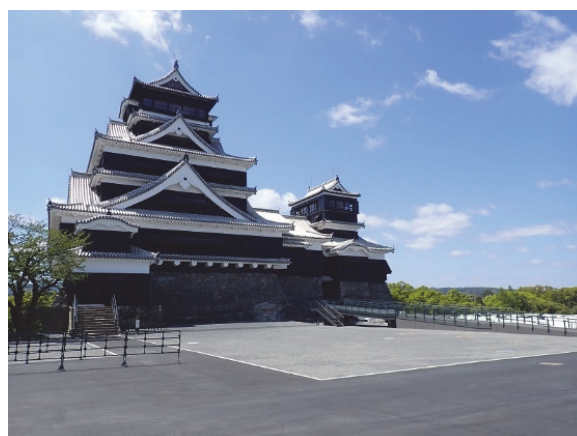
After the restoration of the Tenshukaku castle towers

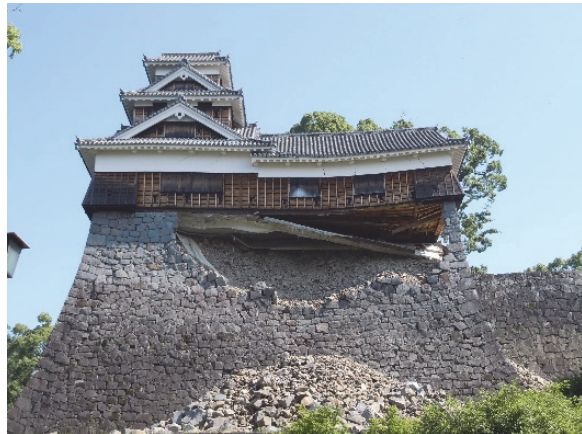
Earthquake damage to the Iidamaru-Gokai-yagura turret

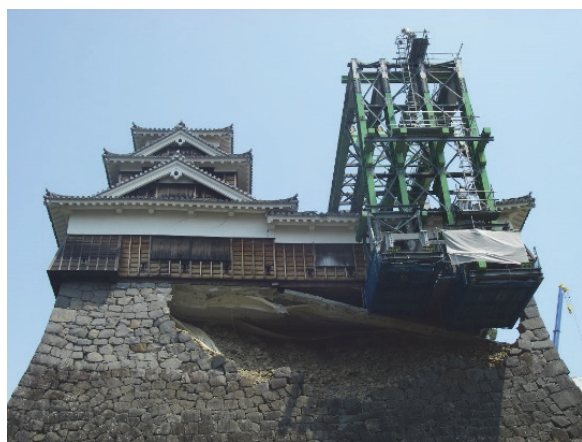
Preventing the Iidamaru-Gokai-yagura turret from collapsing

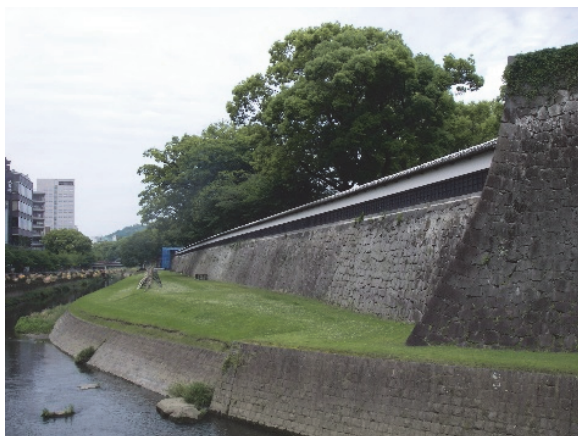
After completion of restoration work of the Nagabei wall

to have been reconstructed by the Japanese Army. The western half was tilted by a typhoon in 2015, and the eastern part collapsed by the 2016 earthquake and was completely dismantled as part of the recovery process. The stone walls were not severely damaged and were not repaired. The damaged supporting stone pillars were also repaired, and an archaeological excavation of the foundations was carried out. Stainless steel braces were newly installed as seismic reinforcement. Repairs were completed in January 2021 with a subsidy from the Agency for Cultural Affairs (Important Cultural Properties Repair Project, Disaster Prevention, and Presentation Adaptive Reuse Project).

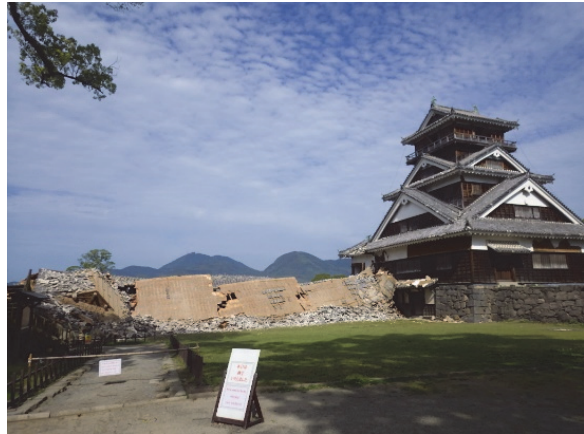
It consists of a five-story turret and Tsuzuki-yagura or continuation turret built at the northwest corner of the central compound. The Tsuzuki-yagura turret collapsed along with the inner stone wall. The fence also suffered significant collapse along with the stone wall. The turret and fence were recovered, as well as the collapsed stone wall. The stone wall under the Gokai-yagura turret (five-story turret) was not seriously damaged, but it was deemed necessary to repair the turret with full-scale dismantlement and reassembly of original structures due to damage such as the tilting and uneven settling of the building and the broken posts. The high stone walls are currently undergoing a study of their conservation, and work on the Gokai-yagura turret is ready for dismantlement having a covered protecting awning since 2022. Funding is provided by a subsidy from the Agency

The Uto-yagura turret after the earthquake

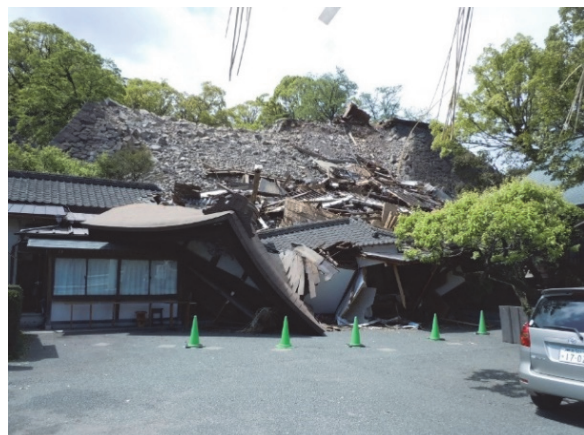
Single-story turrets line the northeast side of the East Takenomaru. Higashi-Juhachiken-yagura turret and Kita-Juhachiken-yagura turret suffered major collapses of the stone walls of their foundations, followed by the collapse of the buildings. Goken-yagura turret escaped collapse, but its walls and posts were severely damaged and tilted. The funds are being provided by Agency for Cultural Affairs subsidies (for Important Cultural Properties repair projects, disaster prevention, and presentation adaptive use, as well as for the "History in Motion!" Comprehensive Rehabilitation of Historic Sites).

Damage to the Higashi-Juhachiken-yagura turret by the earthquake

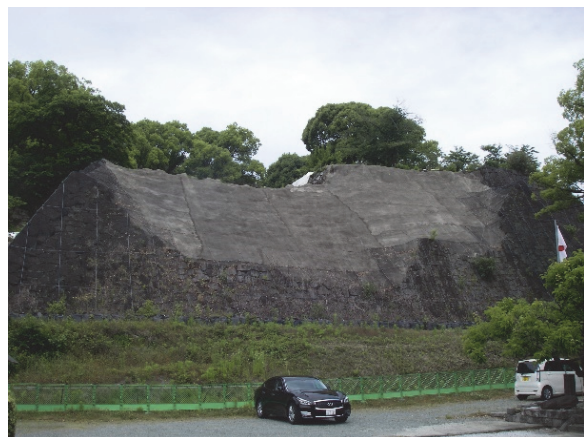
Stone wall of the Higashi-Juhachiken-yagura turret (after dismantling)

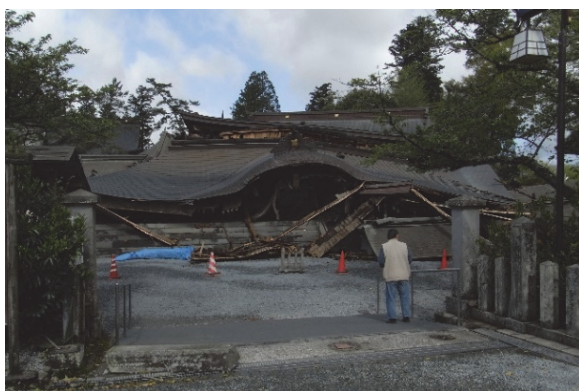
Tower Gate
(Right after the earthquake damage occurred)

The Kumamoto Earthquake damage situation was as follows: the Tower Gate was a three-bay, one-door, two-story, double roofed structure with a very heavy upper part and the posts were not adequately connected to the beams, leading to excessive distortion caused by the main shock, which exceeded the building's capacity. Combined with the weight of the upper layer, the lower layer collapsed towards the north and the upper layer twisted clockwise towards the west side. At Miyuki-mon Gate and Kangyo-mon Gate, slight distortions occurred throughout the building, causing damage

The repair policy was to treat the Tower Gate with complete dismantlement and reassembly of

the original structures, perform partial repairs on all damaged parts of the other gates, and provide necessary retrofit to ensure seismic reinforcement to withstand a seismic intensity scale equivalent to that of the main shock. The overall construction process is as follows: from FY2016 to FY2018, the Tower Gate was to be dismantled, stored, and investigated, and restoration with complete dismantlement and reassembly of the original structure (Phase 1) was to be carried out. Assembly work on the Tower Gate began in FY2019 and is still in progress, with completion scheduled for FY2023.

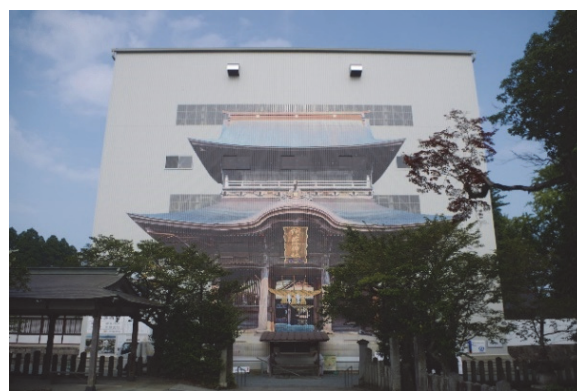
Tower Gate (August 2022)

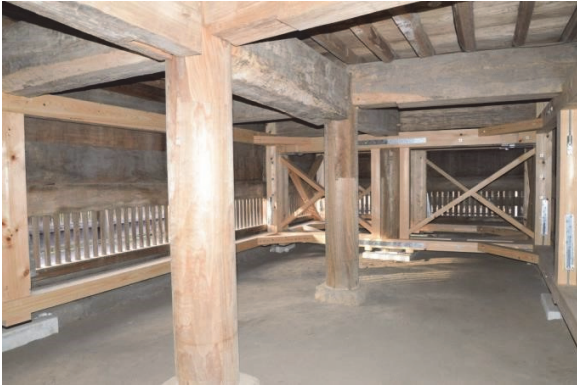
Wooden staff reinforcement under the Shrine floor

Seismic reinforcement of the shrine was performed by installing wooden braces under the floor to ensure seismic resistance performance. The collapsed Tower Gate was repaired by a new method using rods made of aramid fiber, used for the first time for repairs to wooden constructions of cultural property buildings. The motivation was to reuse broken posts and corner rafters as much as possible. In the process of repairing the building, a large number of old ink writings were discovered on the original building materials, revealing the names of the carpenters involved in its construction, their hometowns, and the places where the lumber was produced. As for social inclusion and contribution efforts, the shrine invited local high school and university students in the field of architecture to pro-

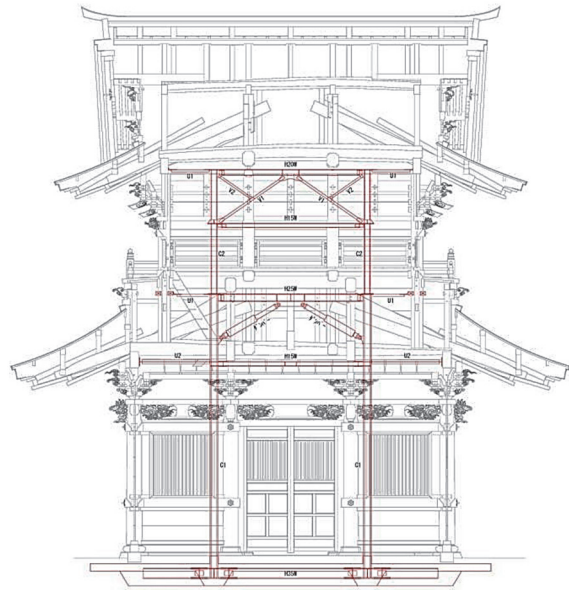
Seismic reinforcement plan of the tower gate

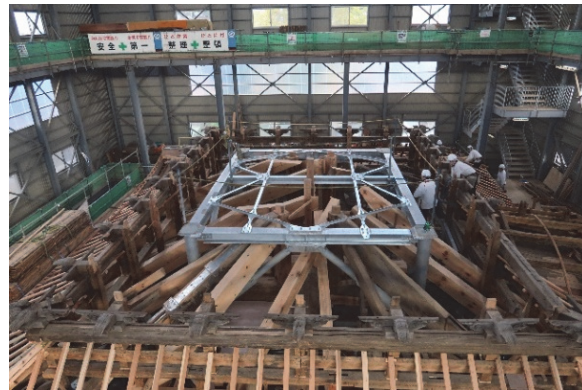
Steel Seismic Reinforcement Frames and Dampers, Tower Gate interior

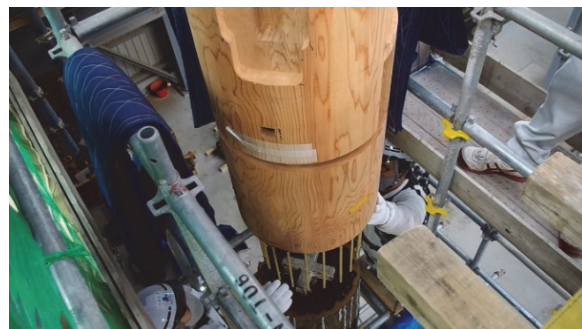
Joints at the top of the posts using aramid rods

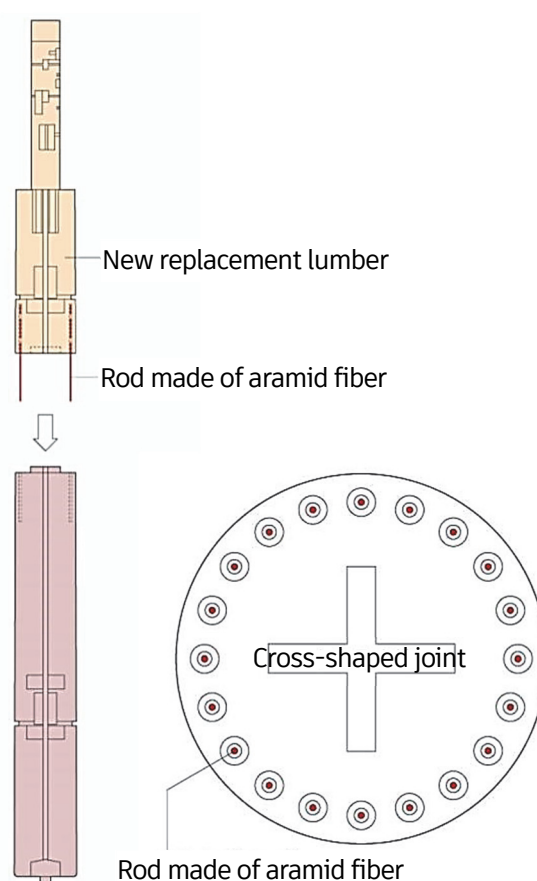
Schematic diagram of the joints at the top of the gate columns using Aramid rods

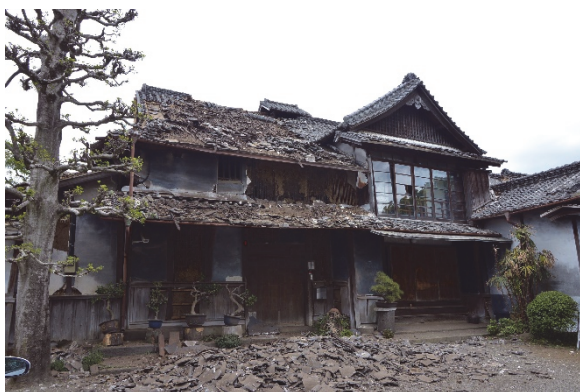
Damage to the main building: South front (West side tiles have fallen. The frame is largely tilted.)

The main building is structurally divided into the following three parts: the earthen floor wing, the *tatami* room wing for receiving guests on the south side, and the residential wing on the north side. Each part of the building suffered damage, such as loosening of joints. The northwestern part of the main building was repeatedly remodeled, and there was a lot of damage to the building due to the makeshift way in which wooden members are assembled in this wing. On the other hand, the shafts of the long lintels had not yet fallen off, although the plugs inside the post had failed. The stable's west exterior wall had fallen off, and it tilted heavily toward the road on the west side. It is believed that this was due to the fact that the shafts had been damaged by termites and rotting before the earthquake.

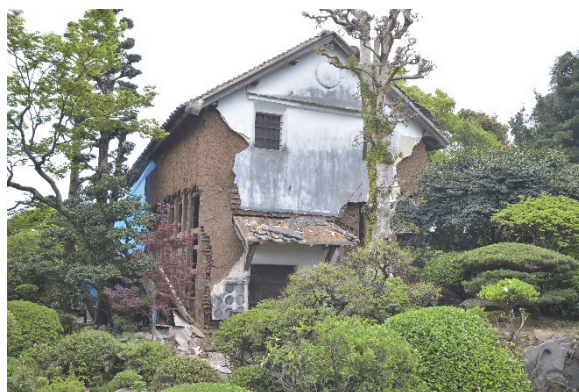
In Nakanokura storehouse, a row of posts was displaced from the foundation stone, and the main frame was tilted towards the west. In addition, most of the mud walls fell down, the ridge of the roof collapsed, and most of the roof tiles slid off the roof. The back gate collapsed onto the west side of the road, blocking the road, and was dismantled by local residents. The west side mud wall of nagayamon gate collapsed, causing the shaft to tilt. Most of the roof tiles of the attached shed slipped off. The stone wall on the north side of the property

Damage to the Nakanokura storehouse: From the northwest

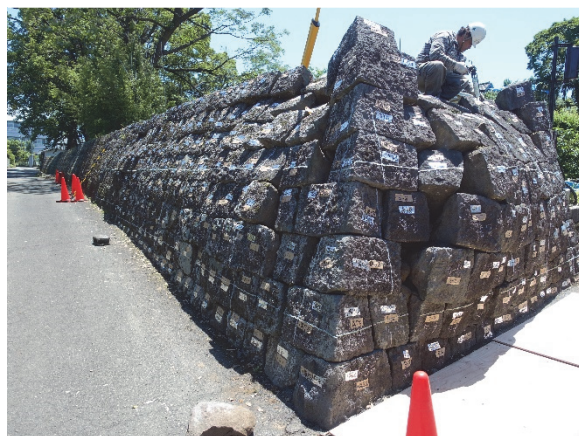
Damage to the stone wall

partially bulged and collapsed near the corner layers, and some of the top stones were knocked out and toppled over.

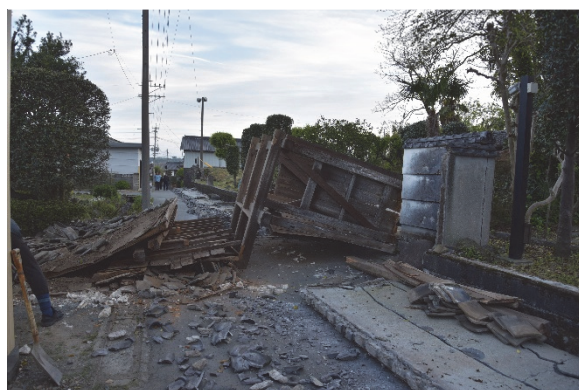
Damage to the back gate

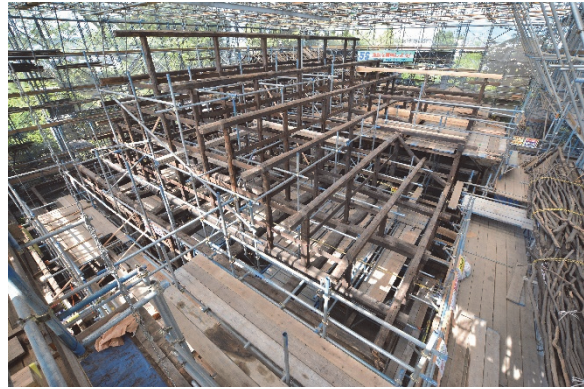
Assembling the main building's earthen floor wing (up to the truss and purlins)

Reinforcement details: The joints of the three wings in the main buildings were securely joined on all sides using hardware and structural plywood. Hold-down hardware and corner hardware were used to prevent pulling out. RC foundations were installed in the earthen floor wing to hide the structural members from view. Fabricated channeled

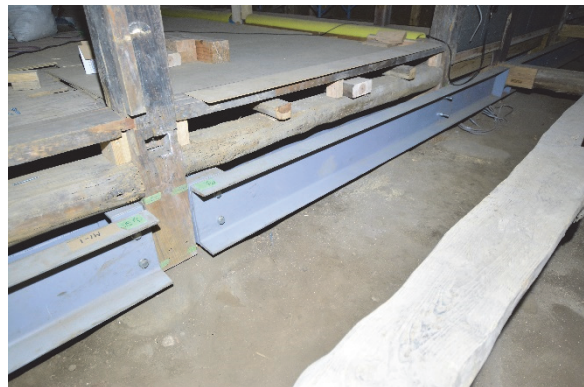
Channeled steel hardware installed for reinforcing column legs at the boundary between the earthen floor and tatami floor wings

steel hardware was used to prevent column breakage under compressive forces. The roof on the north side of the earthen floor wing was reinforced directly with horizontal braces because, as mentioned above, it was an extended roof part and showed evidence of significant shaking as a result of damage. In order to solve the lack of horizontal bearing capacity, reinforcement walls were placed between the back and the floor to concentrate the

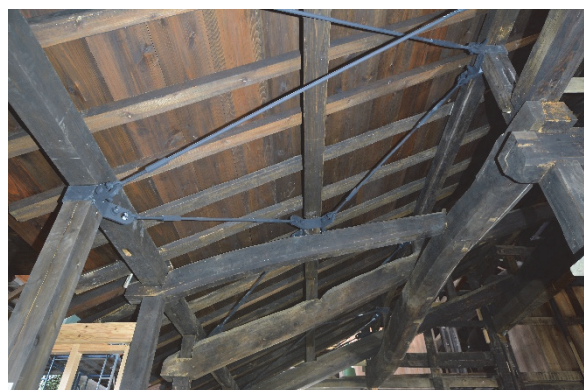
Horizontal braces installed on the north roof of the earthen floor wing

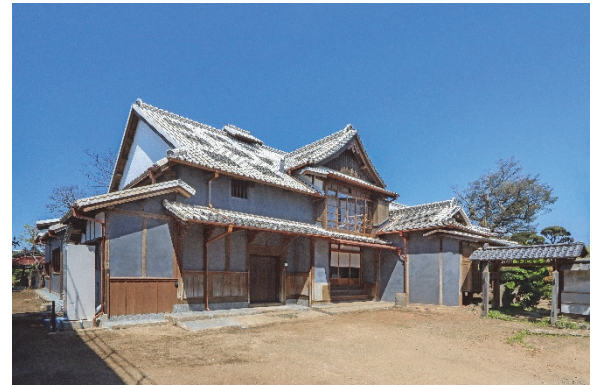
**Completion of the restoration work:
the main building**

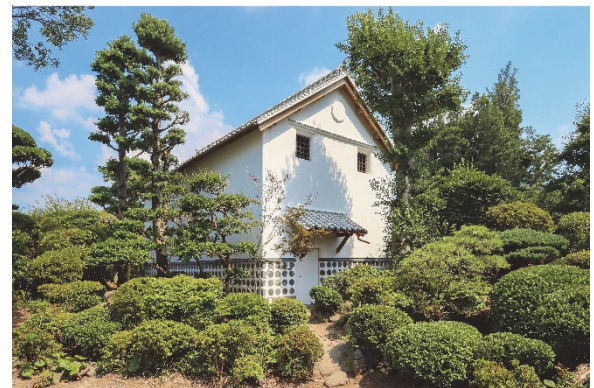
**Completion of the Nakanokura storehouse:
the main building**

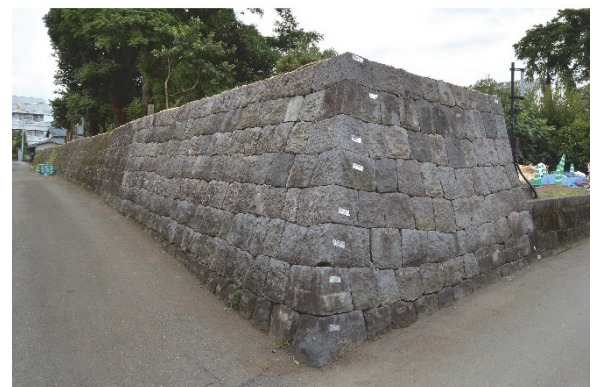
Stone wall reinstallation completed

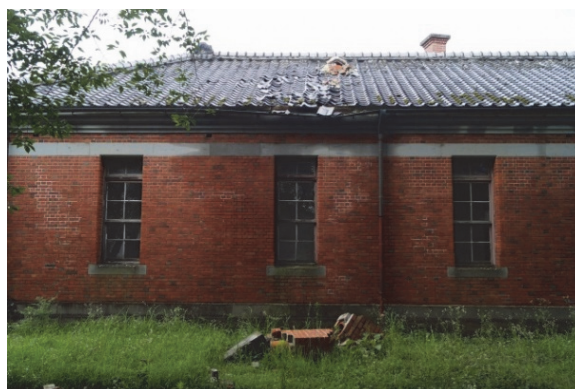
Chemical Laboratory, the broken and fallen chimney

After the damage caused by the Kumamoto Earthquake in April 14 and 16, 2016, emergency response work included chimney removal (November of the same year), temporary reinforcement of (#4) (completed in October 2017), temporary reinforcement of (#1) and (#2) (completed in March 2018), followed by permanent recovery of (#3) in March 2018, the same work on (#1) and (#2) in December

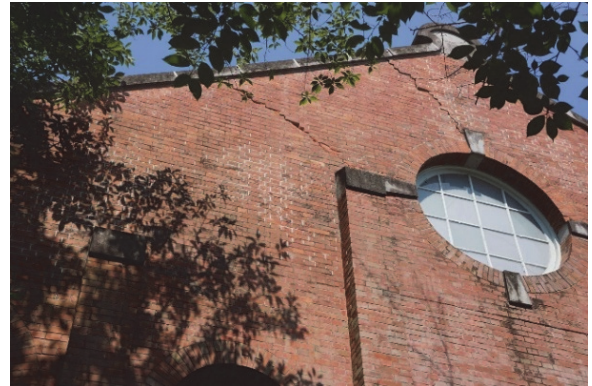
Common damage to these four buildings in the Kumamoto Earthquake were cracks and misalignment of the frames. In (#1), (#2), and (#4), the cracks can be observed entering at 45 degrees from the corners of the openings. In (#1), a large crack appeared at the junction between the interior wall dividing the classrooms and the exterior wall in the east-west direction. In (#4), at the height of the window sill, both the upper and the lower structures were cut and displaced. Additionally, it appears that the east-west gable wall might have been severed from the north-south wall at some point and subsequently resettled, particularly noticeable towards the top section. In (#1) and (#2), where the chimneys are located, there is evidence of chimney breakage on the roof surface, and a broken chimney causing damage to the roof. In (#1) and (#2), the arches above the corridor were also cracked. The second floor of (#1) was particularly badly damaged, with the lime plaster of the arch falling and some of the brickwork collapsing. In addition, in (#4), part of the roof truss was detached, and some of the surrounding timbers were damaged.

The Experimental Factory for Mechanical Engineering, cracks entering at an angle from the round window in the gable wall

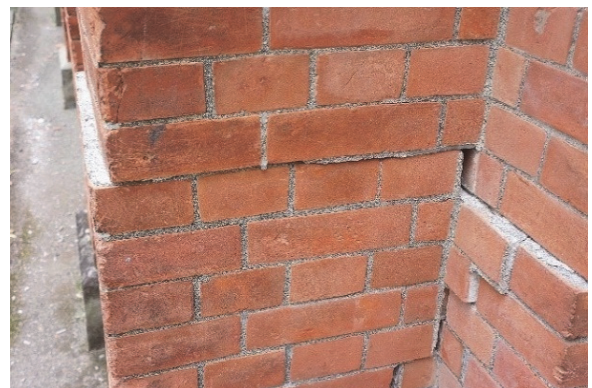
The experimental factory for mechanical engineering, displacement of the brick pillar

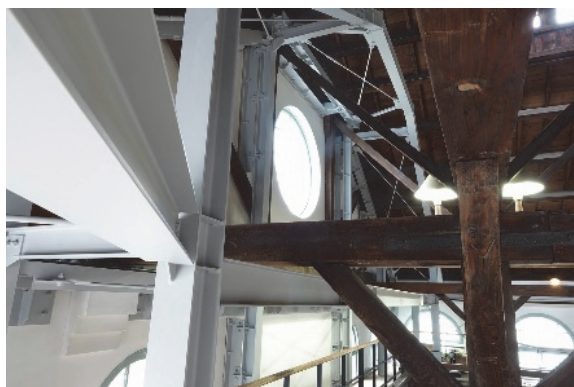
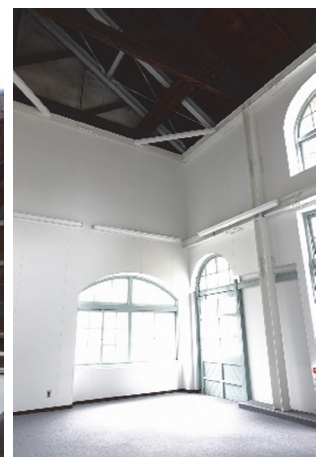
The experimental factory for mechanical engineering, steel reinforcement after the recovery

2021, and the same work on (#4) completed in February 2022. The policy for the recovery was basically to use the same materials and construction methods as the ones used before the disaster. In addition, structural reinforcement was applied to improve seismic resistance performance, as well as the soundness of the members. The brick frame was reinforced by inserting tensile members and reinforcing the aramid joints in all cases (#1)

through (#4), and the steel frame was reinforced in cases (#3) and (#4). As for reinforcement of the horizontal structure, ceiling bracing was installed in (#1), (#2), and (#4). Furthermore, reinforcements with tensile material insertion (horizontal direction) and carbon fiber sheets were used to increase the resistance capacity of the arch beams in (#1). As a result, although the steel frame was exposed at the rear of (#3) and inside of (#4), the interior and exterior appearance of the building as it was before the disaster was largely maintained.

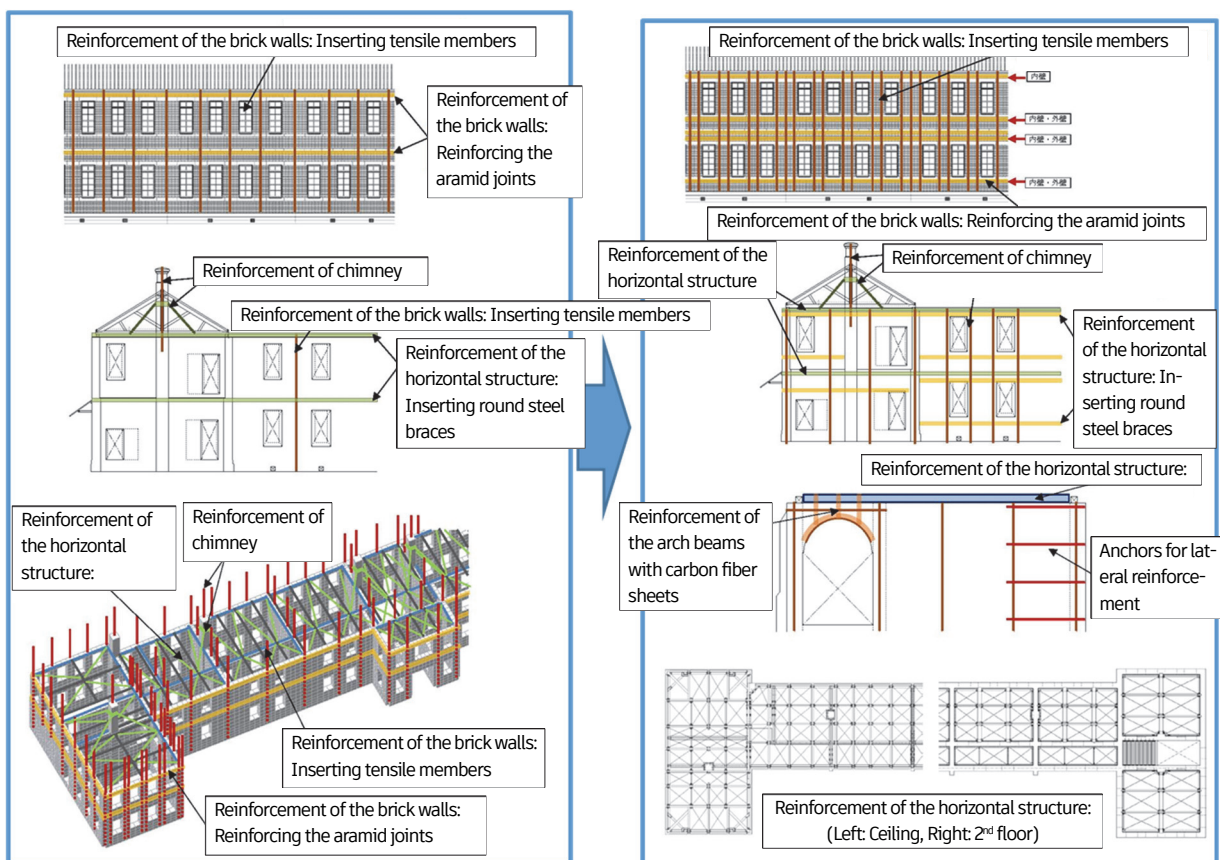
Fifth High School Main Building (Left: Reinforcement plan before the Kumamoto earthquake, Right: Reinforcement plan based on the earthquake after the Kumamoto Earthquake)

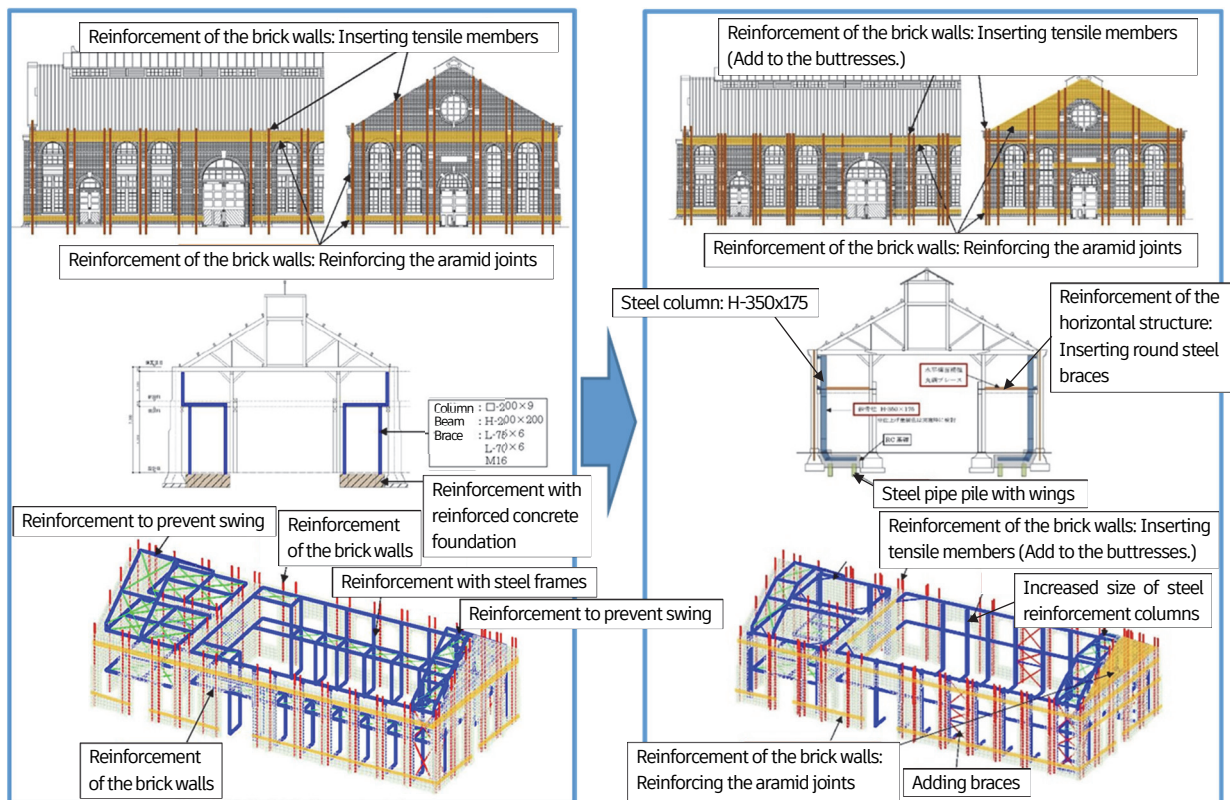
Kumamoto University Faculty of Engineering, Former Fifth High School, the Experimental factory for mechanical engineering (Left: Reinforcement plan before the Kumamoto Earthquake, Right: Reinforcement plan based on the earthquake after the Kumamoto Earthquake)

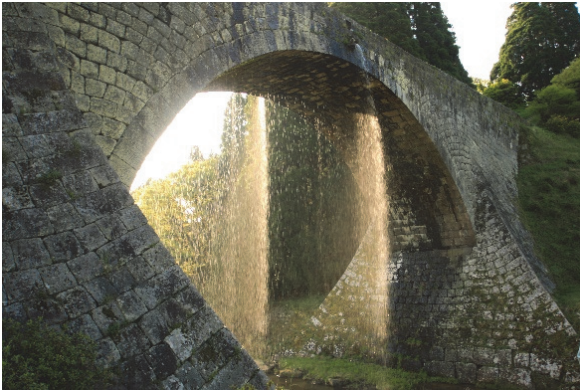
After the earthquake, leakage from the arch bridge

Direct damages caused by the Kumamoto Earthquake included leakage of water due to lime plaster damage at the joints of the through-water stone ducts, cracks at the joints of the water intake and the water outlet, bulging of the handrail stones above the bridge wall stones, and ground cracks observed in the covering soil between the wall stones and the through-water duct. In addition, the inspection revealed cracks in a section of the red clay *tataki* tamping in the direction of the bridge axis along the wall stones, settling, and damage by Japanese termites to the wooden pipe (made of pine wood). Furthermore, just before the repairs were completed, the heaviest rainfall ever recorded in Yamato Town (39mm per hour) occurred on May 7, 2018 (Heisei 30), causing 93 of the wall stones and handrail stones on the upstream right bank to collapse. Some of the fallen stones were found to have surfaces chipped and peeled due to losses and

Replacing joint lime plaster: Identified leakage points through water flow tests, and repointed the joints based on Tsujunkyo Bridge specifications and the Tsujunkyo District Land Improvement District's maintenance and management records.

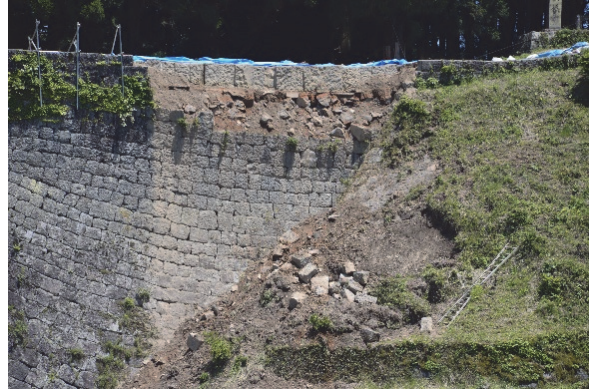
Collapsed stone wall due to heavy rain

bulging up to the early Meiji period when the reinforced stone wall was added. In order to prevent future displacement and collapse, geotextile was laid on the back of the wall and reinforced by bonding it to the wall stones with metal fittings.

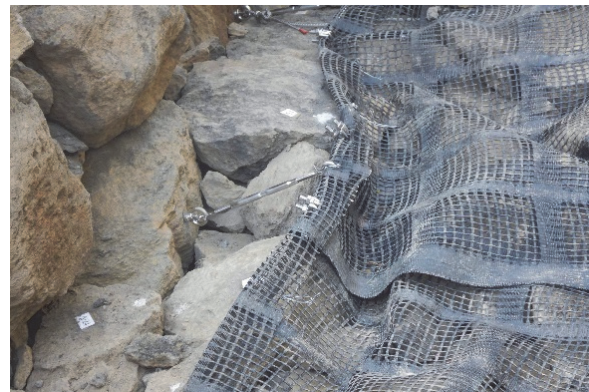
Tightening connections of the geotextile

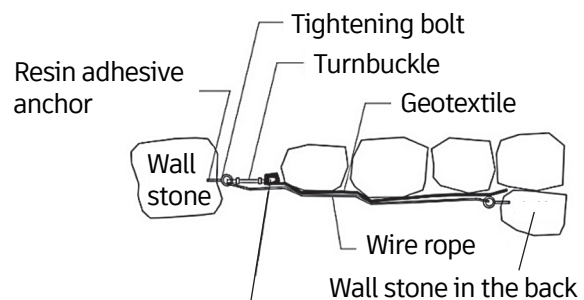
Cross-sectional view of geotextile

The end is folded geotextile and wrapped around a 9 mm thick, 500 mm long metal rod and hooked to a turnbuckle.

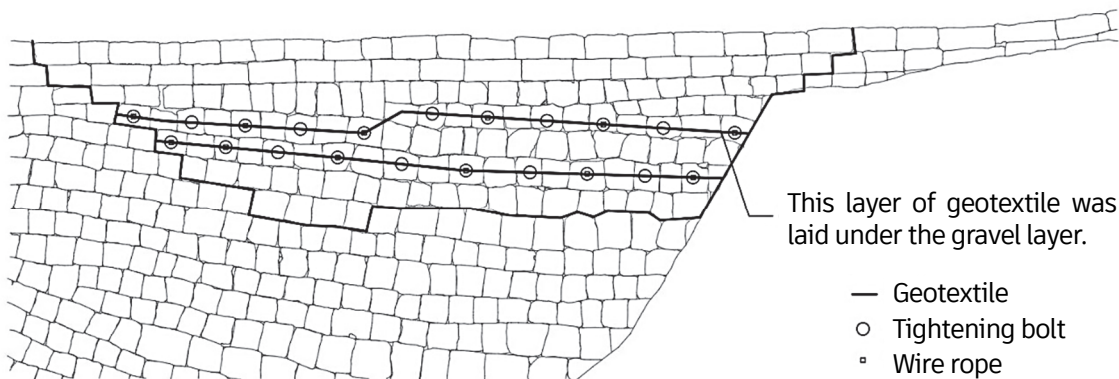
This layer of geotextile was laid under the gravel layer.

The diagram shows the scope of the geotextile installation

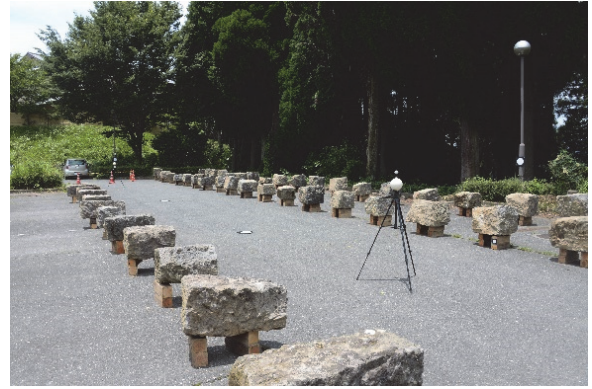
3D survey of collapsed stones

Using a laser survey, UAV photography, and 3D survey with a gigapixel imaging system, the existing condition before and after the Kumamoto Earthquake was compared, then the extent of cracks, displacement condition of the stone walls and the bridge deck were quantified. A 3D survey of the stones that collapsed due to the heavy rain was conducted to simulate masonry, and the original locations of 92 out of the 93 stones in the wall were identified. Furthermore, after the construction was completed, interviews were conducted with the builders, experts, design and supervision staff, and the client to document the characteristics of the stone walls and backfill. The goal was to preserve and share their knowledge and experiences for future generations, creating an oral history archive.

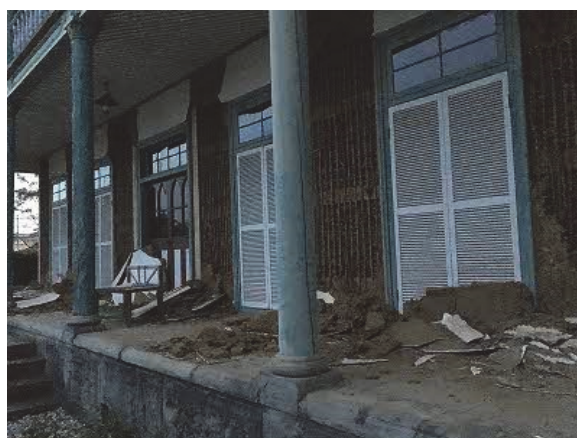
Damage from the foreshock (front)

During the Kumamoto Earthquake, the fore-shock (April 14) severely damaged the inner and outer walls (finished with lime plaster and stucco walls). It was then collapsed by the main shock (April 16).

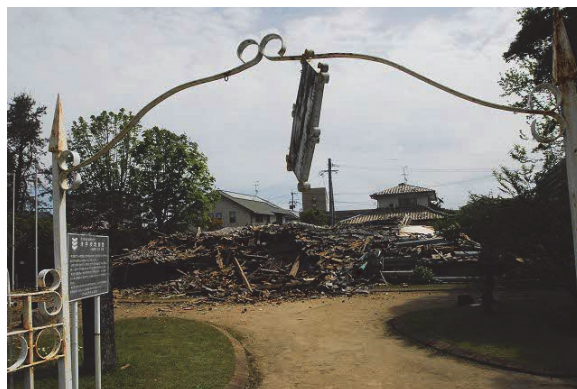
Damage from the main shock (front) Totally collapsed

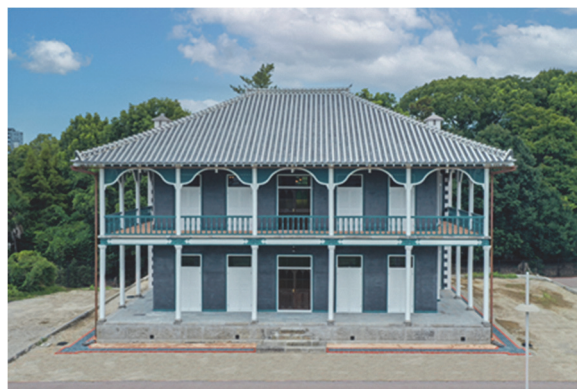
After the completion of the restoration (front)

In addition to restoring the building to its pre-disaster appearance, seismic reinforcement was performed. Reinforcement works encompassed several tasks, such as soil improvement under columns, implementation of a reinforced concrete mat slab foundation, installation of steel columns, steel

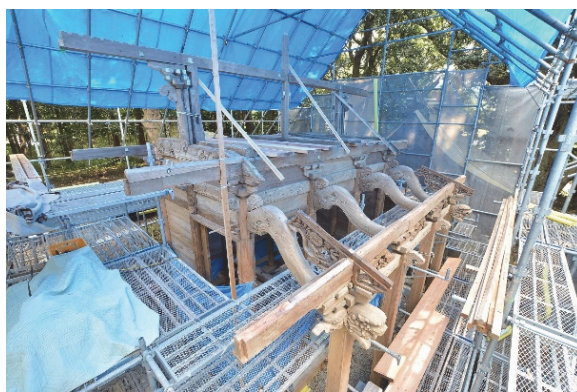
Reassembly in progress:
Hachio-sha Shrine main hall

The restoration plan determined that the main shrine of Hachio-sha Shrine, Worship Hall, and their foundation would undergo a full scale dismantlement and reassembly of original structures.

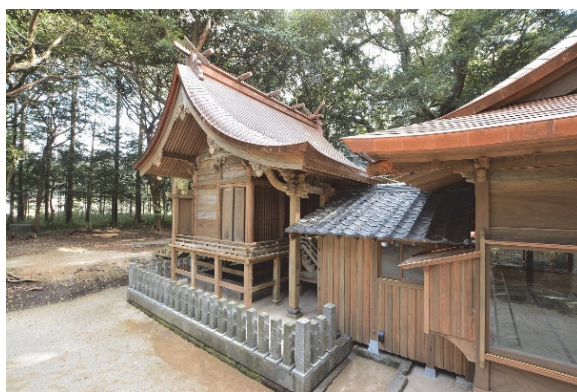
Exterior view of the main hall after recovery work

The main shrine foundation and platform were reinforced, and the framework was repaired without using excessive structural reinforcement to ensure that the members were firmly connected to each other, in accordance with traditional construction methods and specifications. Since the roof trusses were structurally deficient with huge cantilever beams, the truss was reconfigured with introduction of such structural elements such as *doi* girders, struts, and corner cantilevers. The reuse rate of the original wood was 80%. Amamiya Shrine was re-erected and partially repaired.

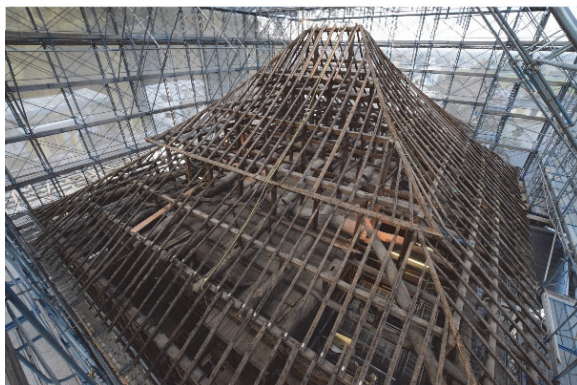
Roof dismantlement in progress, Kaijo-ji the main hall, view from the northeast

Drafting of the implementation plan began in June 2018, and the repair work began in June 2019 and has been completed by the end of December 2021. The main hall was repaired with partial dismantlement and reassembly of original structures due to partial damage to most of its components, while the components of the roofed porch, mud walls, and failed roof tiles had already been removed during the emergency work. In principle, the building was restored to its pre-disaster appearance, but some modification were introduced in the restoration process. These included restoration of the outer sanctum and open veranda, replacement of aluminum sashes with wooden fixtures and fittings, and restoration of the pantiles of the main roof. Seismic reinforcement was also carried out. As a result of seismic reinforcement assessment, some of the walls were converted into seismic re-

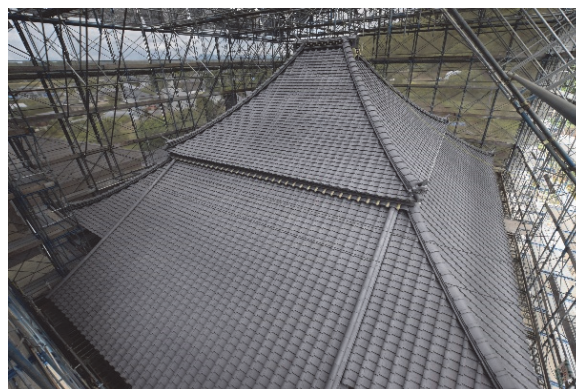
After roof restoration, Kaijo-ji the main hall, view from the southwest

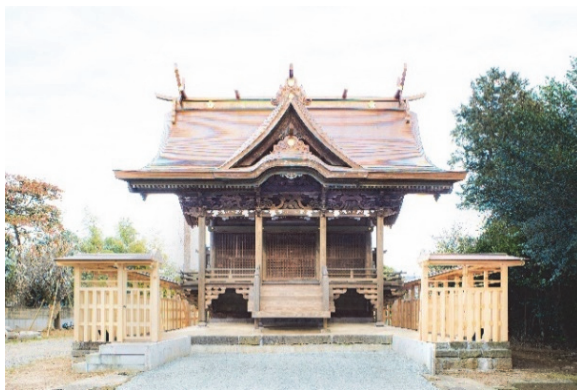
West Front of the Shrine: After completion

As it is a town-designated cultural property, the same type, method, and finish were used for the new supplemental materials, following the basic repair policy for cultural properties. The materials that could be reused were grafted or fletched.

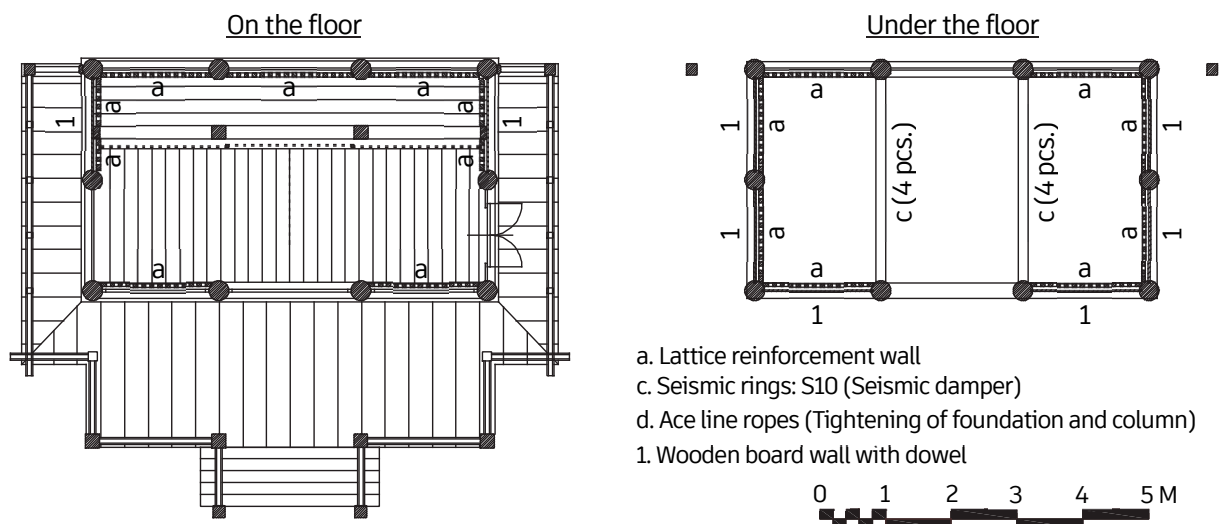
Reinforcement outline plan

c. Seismic rings: To improve longitudinal restorative capacity, 8 rings are to be installed on the 4 front and rear center columns and on the floor and foundation beams.

d. Ace line ropes: the columns were tied to the concrete foundations at six locations to prevent them from slipping and falling off the foundation stones.

e. Installation of piles and concrete foundation: Since the site stands on soft ground, the 10 steel piles are to be installed up to 15 m below ground surface under the columns. RC footing foundations and underground beams are to be turned on top of the piles.

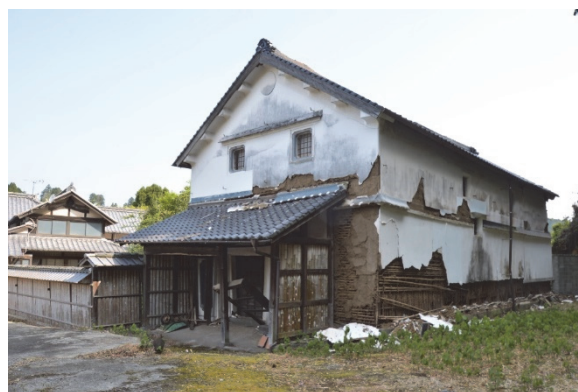
Damage to the warehouse

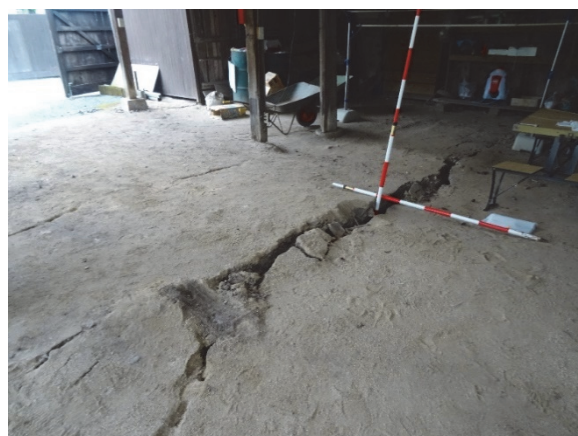
Three cracks have emerged across the barn, the main building, and the warehouse extending broadly in east-west direction on the site, indicating that the building shook significantly in the north-south direction and that the ground shifted in the south direction. As a result, the frames have been dislodged from the foundation stones in many places. However, this displacement is primarily attributed to the shifting of the ground, rather than the frames themselves shifting. The roof of the main building had been reroofed and was mostly sound, but some of the walls had collapsed substantially and many fissures and cracks were also apparent. By and large, therefore, the damaged walls were not in sound condition. In the frame of the building, the posts are partially inclined, and there are many places where they deviate from their intended or designated positions. Cracks under the main building have caused the ground to shift in the north-south direction, causing the main living room *otoshigake* lintels and *kamoi* tie beams to fall out or come off. The warehouse had cracks running through the interior. The foundation stone and the frames were greatly displaced due to ground movement, and the beams were pushing the posts, which could have collapsed. The gates have roof tiles that have slipped off, and the front gate, which is a *yakuimon* style gate, leans heavily toward the front (west) side. The middle gate had been reinforced with bracing, so it fell over while maintaining its structure as a whole. It is interesting to note that the traditional construction, which does not bond building elements to the foundation stone, is more resistant to collapse.

The ground crack in the barn

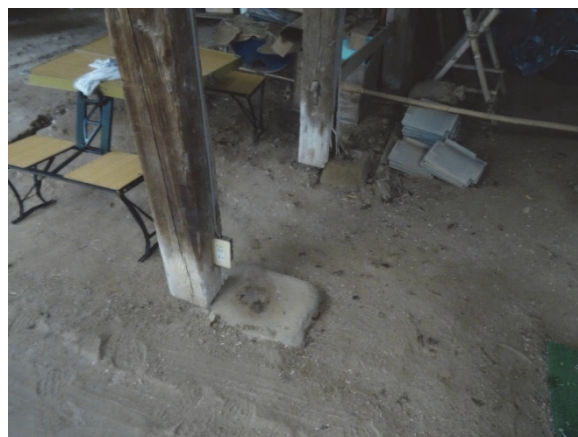
The displacement of the frame post and the foundation stone

The repair work began in the fall of 2017 with a subsidy from the Agency for Cultural Affairs, and was completed in February 2019. The main building was not repaired in a drastic manner, but rather under a partial repair policy. Posts that had tilted due to cracks in the ground were re-erected, some walls that had collapsed were repaired, the top coat of the tatami room walls was repaired, and fixtures and fittings were adjusted. The front gate had its

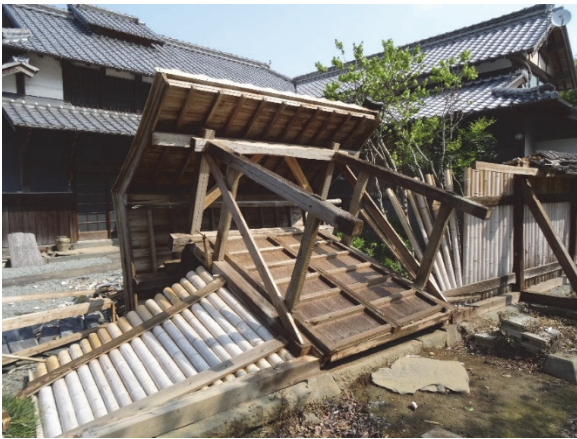
Collapsed middle gate

columns rectified, walls repainted, and fixtures and fittings adjusted. The middle gate had fallen down, so it was rectified, and roof tiles were replaced. The rear gate was partially reroofed with no damage to the shaft. The barn had a large crack and the frames were so deformed that it was appropriate to repair it with partial dismantlement and reassembly of original structures, but the repair was only partial, and a wall was added for reinforcement. The miso

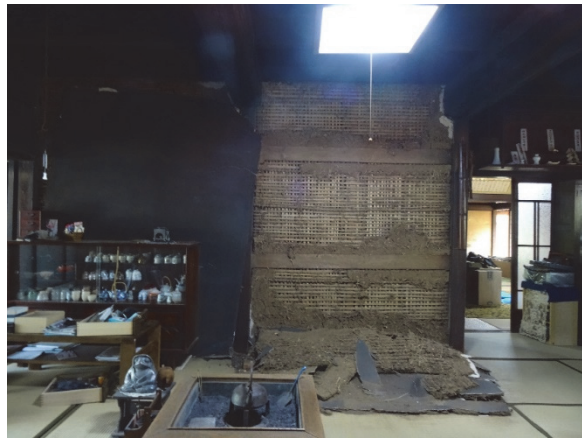
Collapsed living room interior wall of the main building

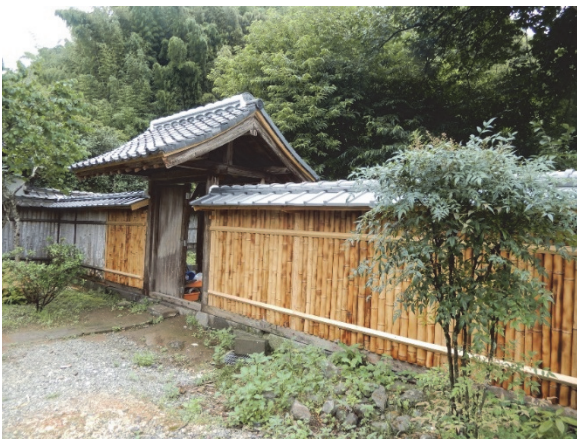
**The middle gate and the eastern fence:
after restoration**

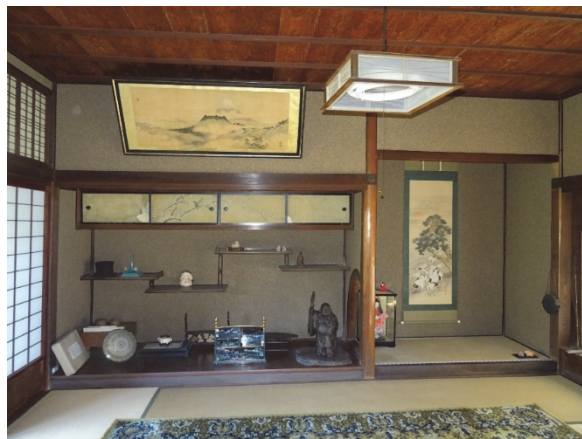
**The receiving room of the main building:
after restoration**

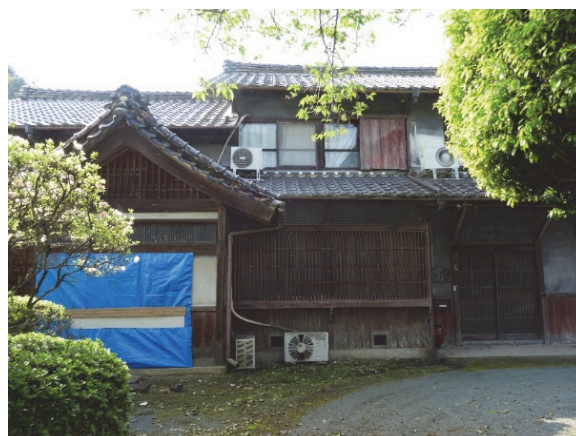
The roof was in extremely good condition, with only some damage to the ridge, as the roof had been replaced prior to the earthquake. The frames were in a sound condition, although the building had returned to its original position at the second earthquake, indicating the severe displacement during the foreshock. Partial collapse, cracks, and peeling of the lime plaster overlay were observed on the walls, and the stairway to the second floor was displaced to the west.

Exterior of the building after the earthquake
