EARTHQUAKE DISASTER PREVENTION OF CULTURAL HERITAGES - EXPERIENCE AND DEVELOPMENT IN JAPAN -

**August, 2023
ICOMOS Japan**

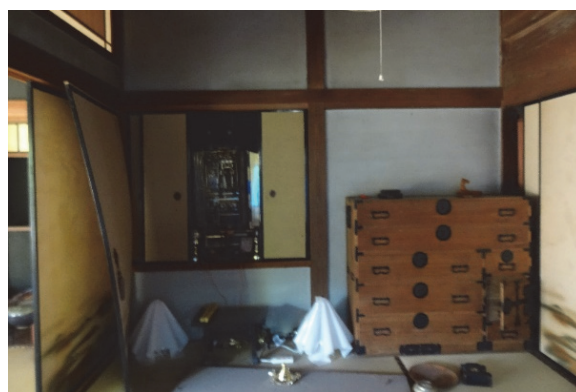
Interior of the building after the earthquake

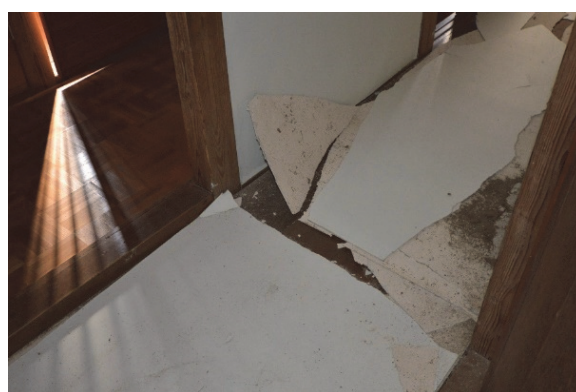
**Interior of the building after the earthquake
(collapsed wall top coat)**

Repairs began in March 2018 and included repair of damaged roof sections and reinforcement of collapsed wall sections with structural plywood. Fixtures and fittings such as *fusuma* screen sliding doors, *shoji* sliding doors, and glass doors were repaired. Since frosted glass was not manufactured, it was converted from another building and used. The walls were lime plastered in light grey tone on the interior and dark grey tone on the exterior, with a dark green sand-slip finish in the reception room area. Since there was almost no deformation of the frames, no major structural reinforcement was performed. After the construction was completed in September of the same year, the lighting, kitchen, and air-conditioning systems were rehabilitated, which is not the work eligible for public financial assistance.

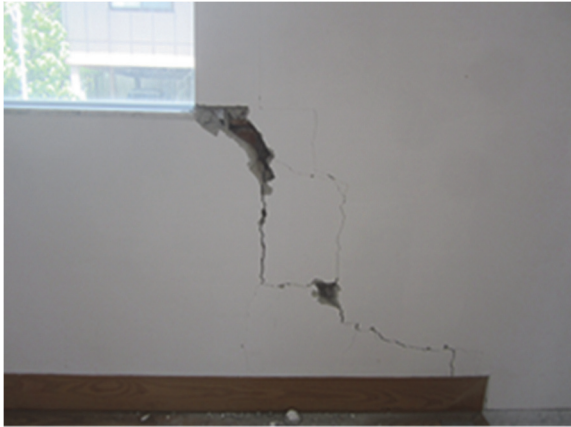
The Kumamoto Earthquake caused cracks in the brick walls. The cracks were mainly around the openings and corner edges. One notable characteristic of masonry constructions during earthquakes is the deformation of the wall corners, and cracks

were observed in this building as a result of such deformation. Shear cracks were also observed on the interior lime plaster walls. No uneven settlement or residual displacement of the building structure was observed. As for damage to non-structural elements, a portion of the wooden board ceiling fell. The exterior walls were finished with cement tiles in the Taisho era, which were peeling from the wall surfaces.

Damage to the wall

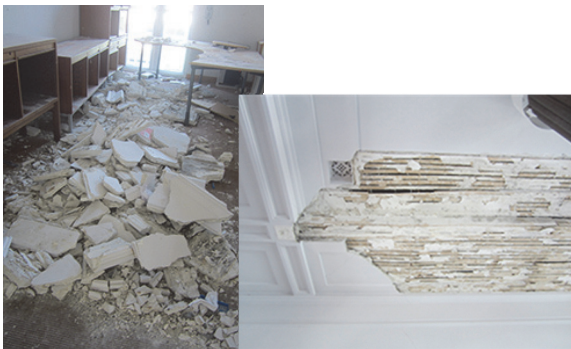
Damage situation

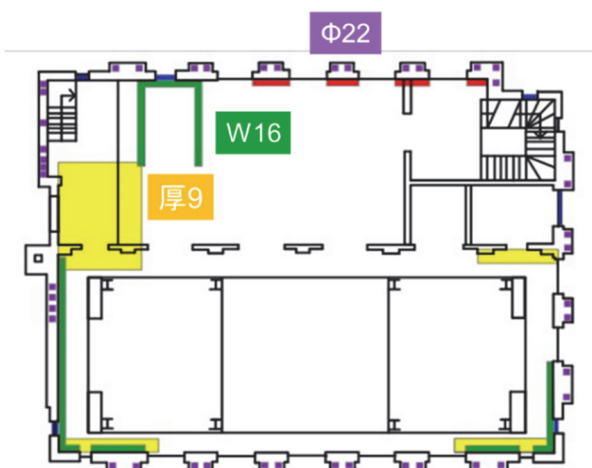
Structural reinforcement outline plan

- Reinforcement of horizontal structure
- Addition of reinforced concrete wall
- Closure of openings
- Addition of reinforced concrete frame
- Insertion of deformed steel bar

to implement seismic reinforcement. Here, the concept of "transitional reinforcement" was introduced, and a seismic reinforcement design was proposed to meet the 0.6 safety index value required by the Building Standards Act, with a target of 70% of that value. This is because the existing standard is made for reinforced concrete constructions and does not take into account the structural characteristics of brick constructions, and it is anticipated, that a reasonable evaluation method for seismic reinforcement of brick constructions will be developed in the future. Moreover, implementing the proposed reinforcement design to meet the current code requirements would have a significant impact on the interior spaces and would compromise the historical and design values of the building. Therefore, the decision to set a lower target was made with the agreement of the owners. For earthquake-resistant reinforcement, the foundation structure was reinforced, deformed steel bars were inserted into the brick walls, minimal opening closure and concrete reinforcement methods were employed, and the horizontal structure of the catwalk area was solidified.

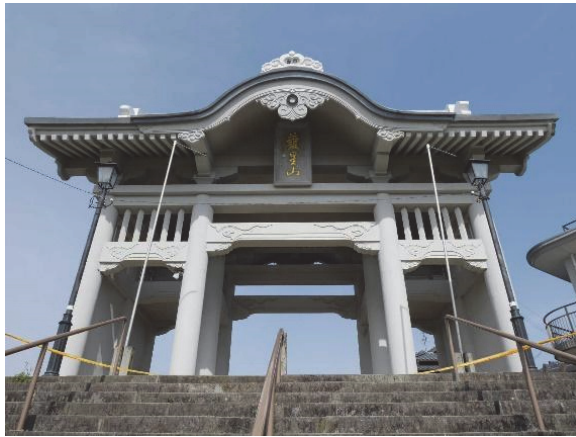
Front (east side) at the time of the disaster

The Kumamoto Earthquake occurred twice in Kumamoto City at 21:26 on April 14 and 1:25 on April 16, 2016. A visual survey conducted in May of the same year revealed (1) bending cracks near the joints between the columns and intermediate beams, (2) detached elbow joints, (3) damage near

the bases of the columns, and (4) shear cracks, confirmed on both gable side walls. Subsequent detailed visual inspections in 2018 and 2020 revealed deterioration, concrete loss, and cracks over 0.2 mm wide. Cracks were especially noted around GL+5600mm, and many of them were over 2.0 mm wide, found at the joints between columns and beams. In addition to these cracks, large sectional explosions and defects were observed in the beams, and some of the rebar was exposed.

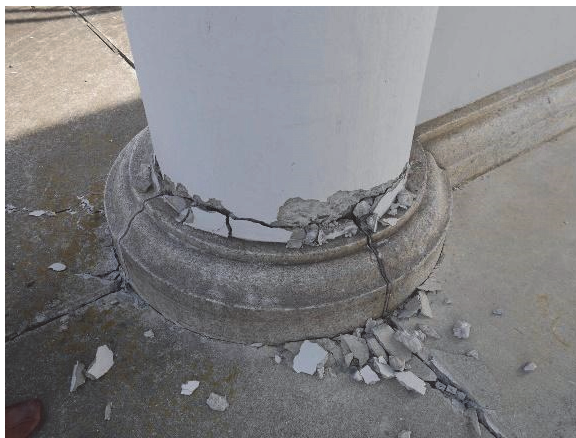
**Damage near column bases
(columns in the northwest corner)**

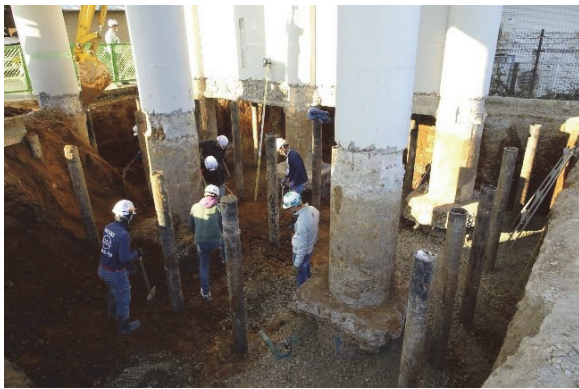
Underground conditions (column bases, footings, cast-in-place piles, additional steel pipe piles)

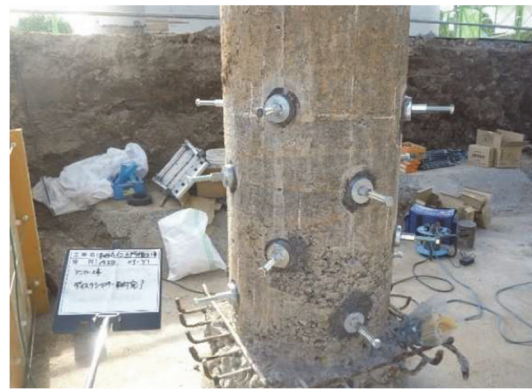
Disc shear key to join the columns to additional footings (Photo courtesy of Den Arch.& Eng. Office)

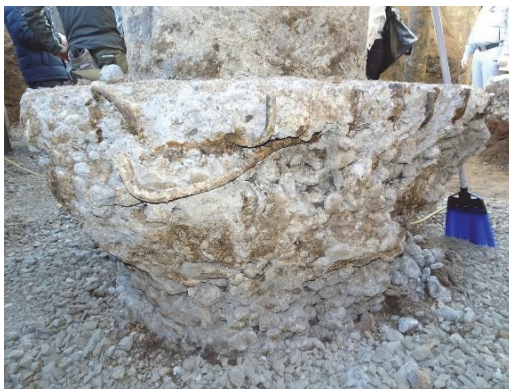
Reinforcing steel bars in the footings and piles driven in place directly under the footings

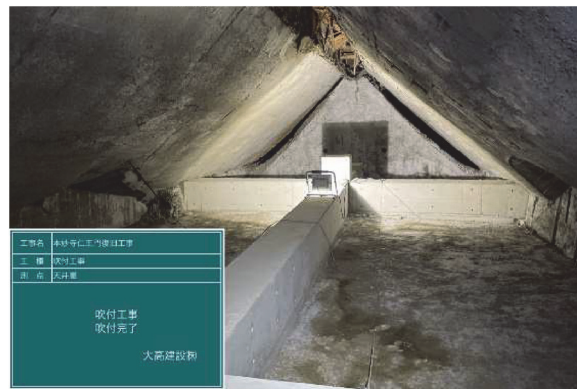
Reinforced concrete beam installed in the attic space (Photo courtesy of Den Arch.& Eng. Office)

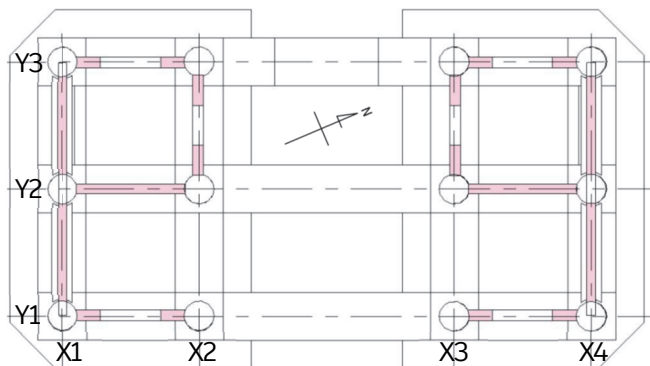
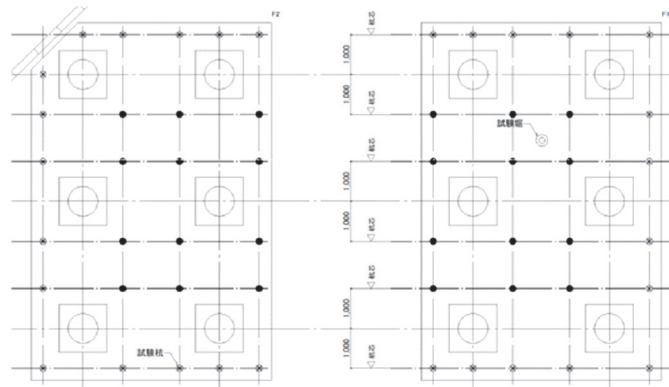
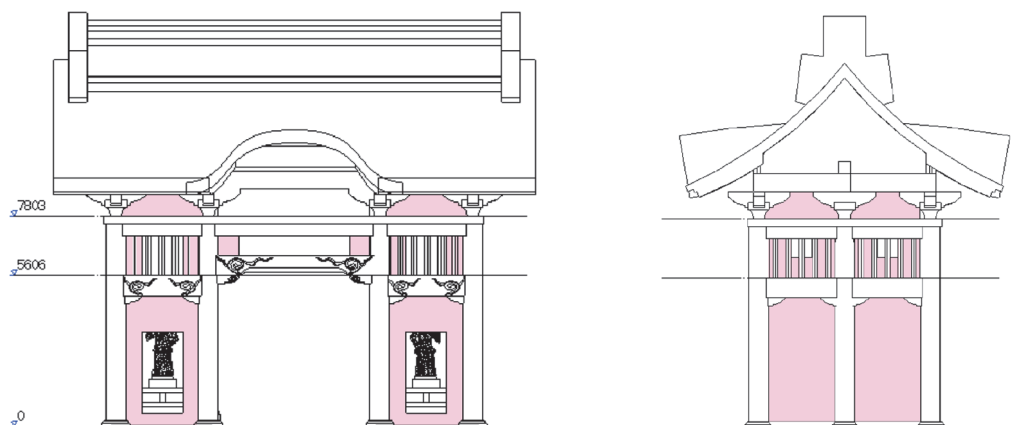
Layout of the added RC wall (first floor, subfloor plan) (Prepared by Den Arch.& Eng. Office)

Layout of the added RC footings and steel pipe piles (Prepared by Den Arch.& Eng. Office)

Elevation of the final reinforcement proposal (left: flat side (east side), right: gable side)
(Prepared by Den Arch.& Eng. Office)

After reviewing the results of the seismic assessment of the building and the seismic ret-rofit plan, reinforcement and maintenance work was carried out on the building frame, focusing on the changes described on the layout shown on the right. [Gable side: south and north] [Flat side: east and west] Reinforced concrete walls were added to the upper part of the beams (with some openings). [Center, X direction] Reinforced concrete walls were added between Y2 and Y3 on X2 and X3 lines (with partial openings). [Center, Y direction] Reinforced concrete walls were added between X1 and X2 and between X3 and X4 on Y2 lines. [Ceiling SL floor] Reinforced concrete beams were added on X2, X3, and Y2 lines. [Foundation] 53 steel pipe piles were added. Re-inforced concrete footings were added to the gate, surrounding 6 columns on each side of the gate.

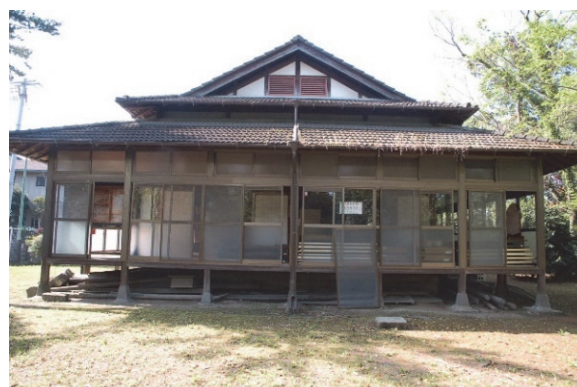
Overall view after the earthquake (the building was not so rigid that the shaking did not dislodge the foundation strut stones)

walls fell, but they were among the elements that were expected to be repaired. The outer columns were on strut foundations, but their low rigidity paid off: they shook so much that they did not displace from the underfoot, and no columns were stepped off. Instead, the walls, fixtures and fittings were severely damaged.

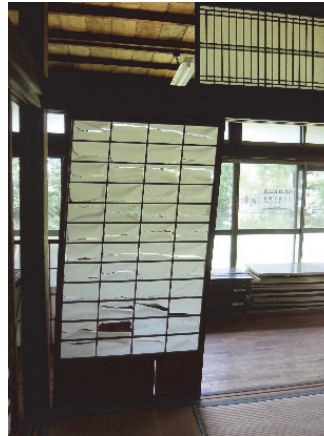
Estimated to have shaken up to $1/12$ radian based on residual deformation of the shoji

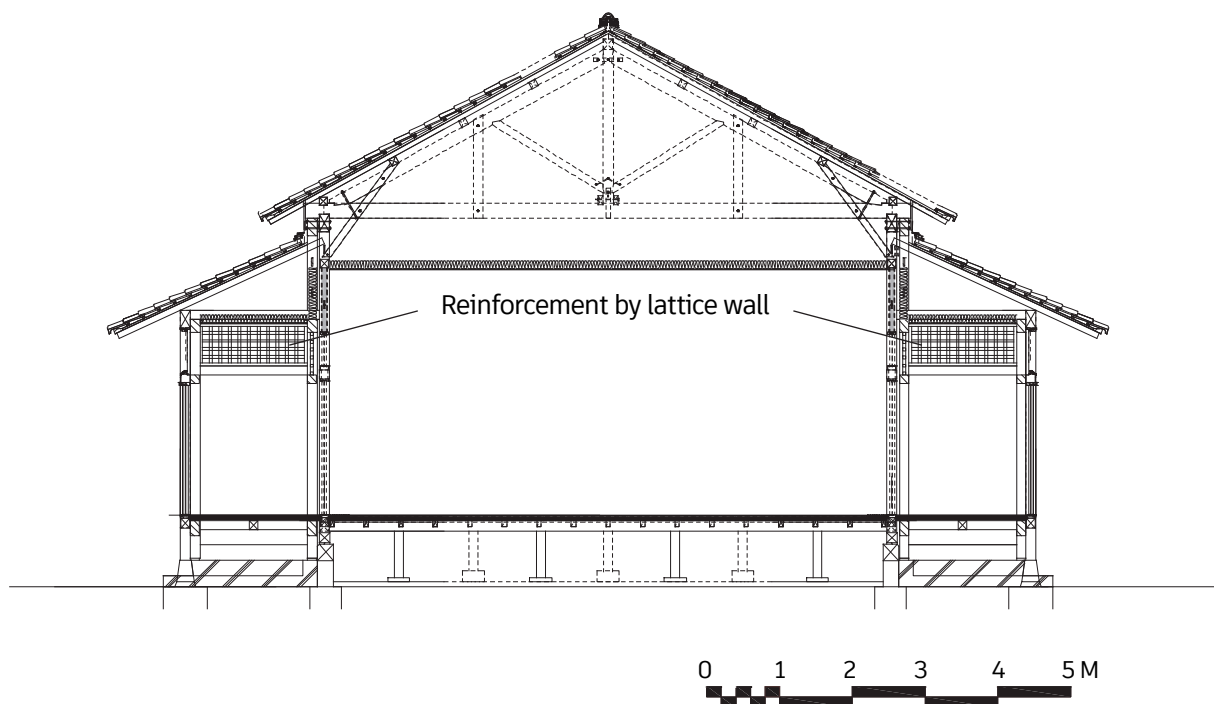
Outline of seismic reinforcement plan

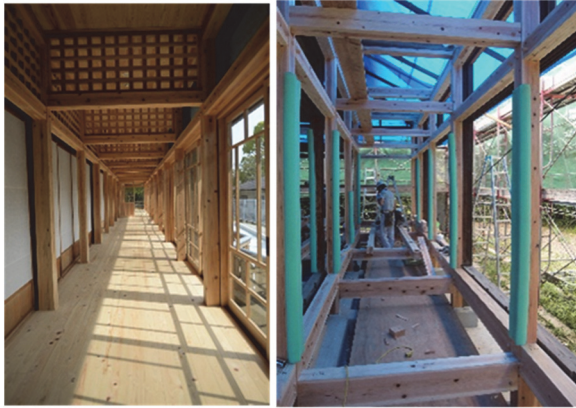
Reinforcement by lattice wall (Add lattice grid at the top opening section. The footing is rigid and takes up a lot of strength.)

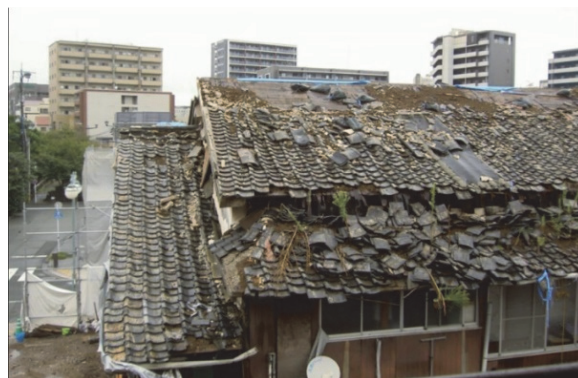
Damage to the main roof

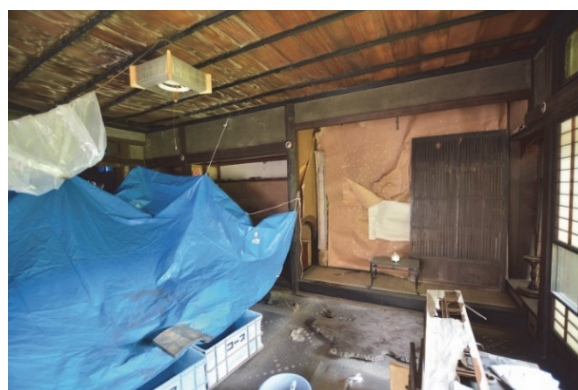
Damage to the reception room in the first floor

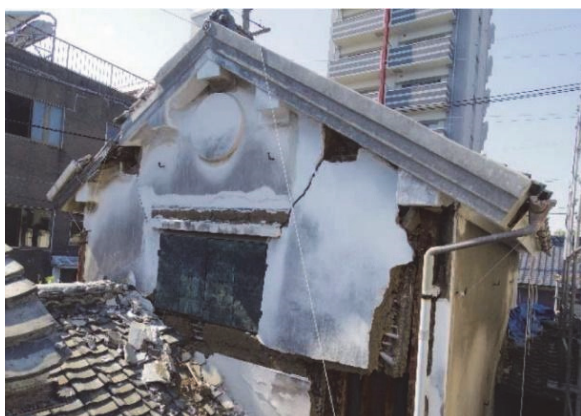
mantling of a neighboring house. Most of the damage was caused by collapsed roof tiles and lime plaster walls as well as tilted buildings due to the deformed shafts, fixtures, fittings, and crushed parts that were damaged by ants. The subsequent rainfalls caused leaks that facilitated widespread mold growth, progressively damaging houses and household goods. At that point, the damage was within the range of possible conservation if viewed on a building-by-building basis. However, when viewed on a 13-building basis, the required cost and energy were expected to be enormous, and the owners considered dismantling the houses, only leaving some parts standing.

The warehouse (south side) immediately after the Kumamoto Earthquake

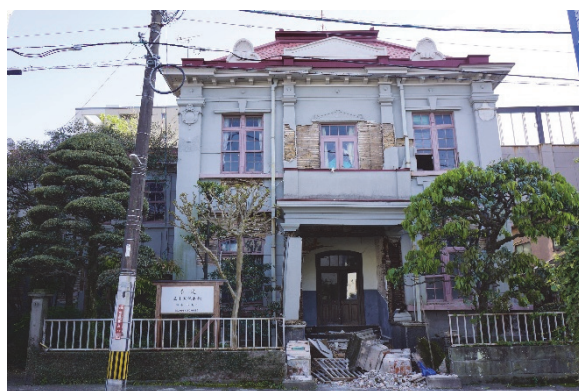
Although the house did not collapse from the main shock, localized damage was observed, including the loss of a column in the entrance porch and the partially collapsed exterior walls, which revealed extensive rotting and termite damage to the wall base and structure. In addition, the interior lime plaster walls collapsed to such an extent that the owner had to spend an inordinate amount of time for cleanup, which became a psychological burden. Because of the height of the building and the design of the vertical windows, the lime plaster

of the walls was nearly 3 meters high, even without the waist wall, and when the building shook, the entire lime plaster slid off and hit the floor, much like an iceberg collapsing. It is easy to imagine the horror felt when the remaining parts of the building suddenly collapsed, threatening the owner's desire to bequeath the house to the next generation.

After the disaster

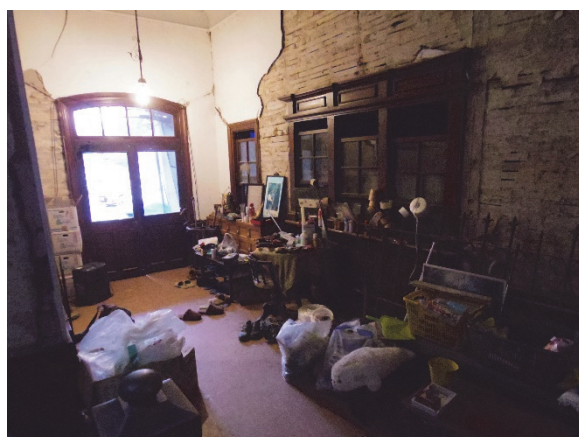
Room after the disaster

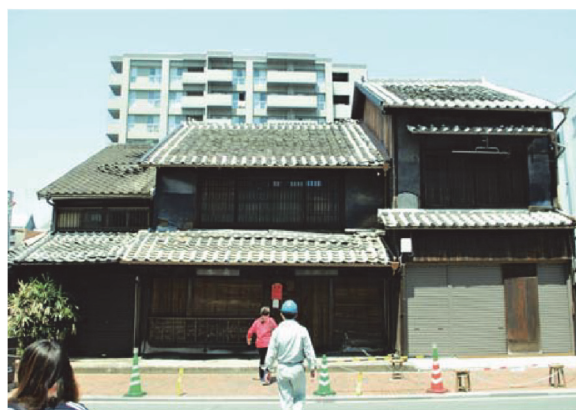
The storefront, including the *battari shogi*, had few columns, which opened the structure up. This design choice led to local deformations during the main earthquake shock. In addition, the buildings clustered on the site vibrated individually, which resulted in joint damage, falling roof tiles, and collapsed mud walls, changing the building's atmosphere. This damage challenged the efforts made by the owner to keep the building standing. At this point, however, the building did not show signs of collapsing and was thus deemed to be technically fit for conservation.

Front view immediately after the disaster

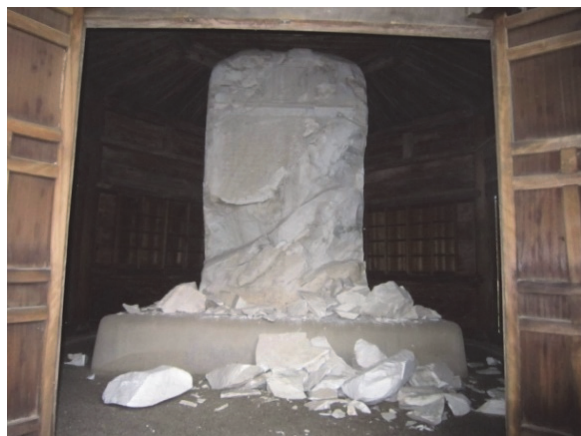
The seismic intensity of the Great East Japan Earthquake in Mito was just lower 6, and the east-facing monument was shaken more severely in the front-back direction than in the left-right direction. The Hakkedo remained was mostly undamaged, but the Monument of Kodokan had numerous cracks in various parts of its body. The central part of the body was fragmented in various pieces from the upper right to lower left, which were scattered on the base stone and in front of the monument. The body of the monument, which was approximately 320 cm high, inclined about 4 cm forward, and created a gap between the stone body and the concrete base backing. The causes of the damage are: (1) the Kansuiseki marble had internal cracks due to the heat received at the time of the Hakkedo Hall fire, and the cracks could not be strengthened deeply enough with the repair technology at that time in 1953, (2) the concrete on the back of the monument body prevented its collapse, but it

The heavily damaged Stone Monument of Kodokan

leaned from behind, causing the stress to concentrate at the bottom front so that one part of the body collapsed. The surrounding stones also fell apart, which was also considered to have been induced.

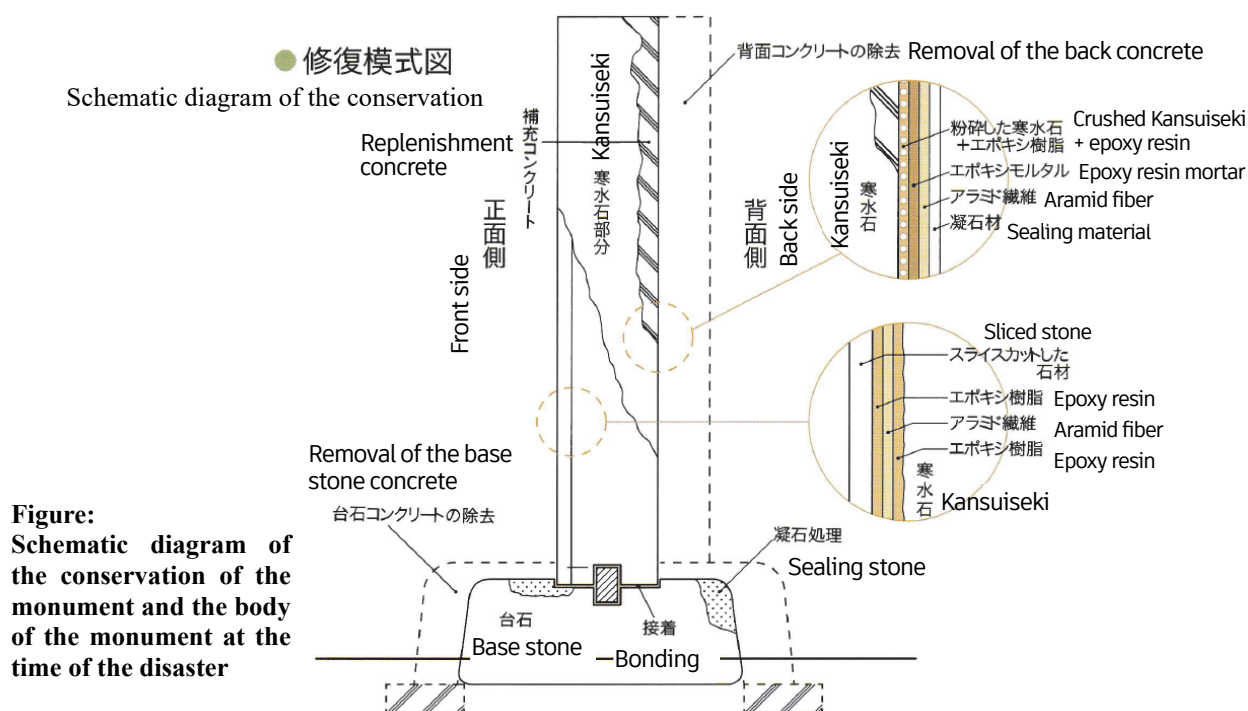
Figure:
Schematic diagram of the conservation of the monument and the body of the monument at the time of the disaster

in both halves, stainless steel bolts were inserted, and epoxy resin with middle viscosity was used to secure them together. At the back of the monument, after the concrete was removed, the cracks were stabilized with resin and smoothed with epoxy-type pseudolithic substance. Then, aramid fibers with tensile strength were attached to the cracks, and the pseudolithic substance was applied and polished to finish. The conservation work was completed in the fall of 2013. This restoration was financed by the national government.

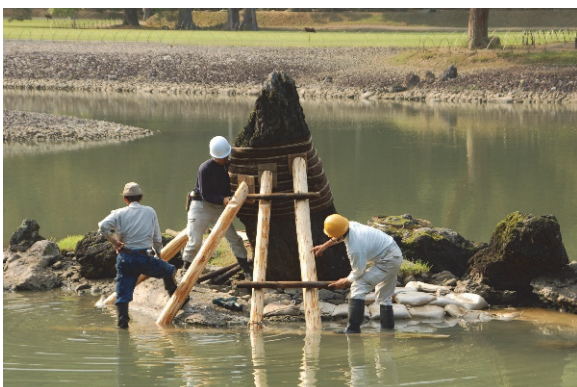
The Great East Japan Earthquake disaster that occurred in March 11, 2011 and its largest aftershock (April 7, 2011) caused the standing rock to tilt approximately 8 degrees (up to 34 cm). The damage was confirmed at the end of May 2011, just before the 35th meeting of the World Heritage Committee in Paris to discuss the cultural heritage of Hiraizumi. Aftershocks were ongoing, so emergency treatments were taken to prevent the stone from collapsing. The Agency for Cultural Affairs reported the damage to UNESCO, while the town of Hiraizumi launched an emergency repair project and a maintenance guidance committee. Under the advice of the guidance committee, a survey and excavation of the standing rock and the island were conducted in 2011, and based on the results, a repair policy was formulated and repairs were carried out over 2011 and 2012.

When the emergency support was installed

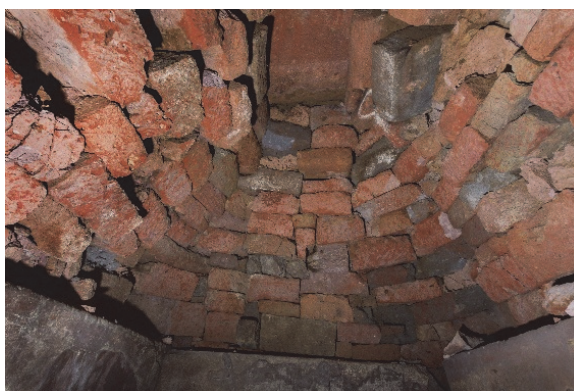
Located on the Futagawa fault zone, the site is close to the epicenter of the main shock, which registered a seismic intensity of upper 6. As a result, numerous cracks were found in the mound, and the stone chamber, including the stone barrier on the back wall, suffered extensive damage, with stones cracking and falling off.

Damage inside the chamber (Photo provided by Kashima Town)

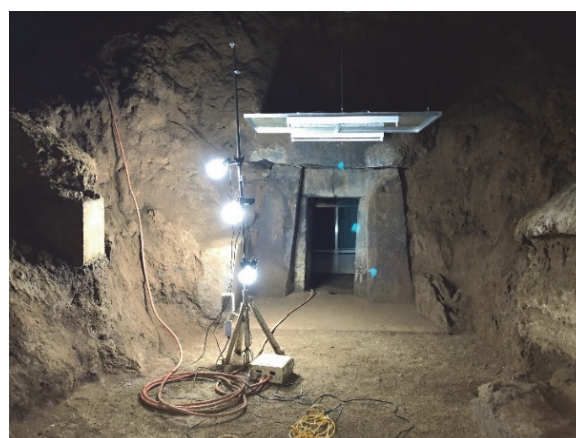
Part of the mound collapsed due to the earthquake, and earth and sand covered the floor of the ante-chamber and corridors. In addition, part of the stone materials of the chamber collapsed. The dome of the protection facility is cracked and the foundation is damaged.

Situation after removal of earth and sand
(Photo provided by Tamana City)

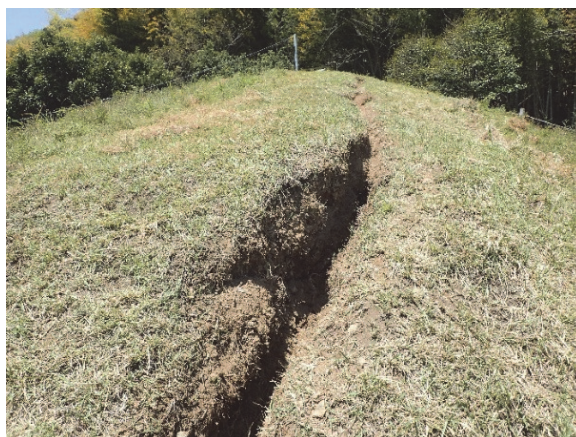
The earthquake caused damage to the stone chamber: some of the stone materials broke and a part of the decorated walls collapsed. The broken and fallen stones caused earth and sand to flow in. In addition, water leaked into the stone chamber from a crack in the mound that underwent maintenance.

Cracks in the mound
(Photo provided by Tamana City)

The decorated chamber walls are damaged and must be carefully restored so as not to damage the painted chamber walls. The damaged stones are to be kept in the stone chamber without forcibly joining them. The damage in the stone chamber is to be assessed from various angles by comparing the results of a laser survey and the drawings at the time of initial maintenance work. Then, after understanding the characteristics of the stone materials and the current environment, measures inside the stone chamber will have to be considered to prevent further weathering, dew condensation, and damage to the stone material. For the mound, geological surveys such as boring, radar exploration, and electrical exploration were conducted in 2020. Based on the results of the water leakage monitoring and of the geological survey, the cause of the leaks in the stone chamber will be identified, and a

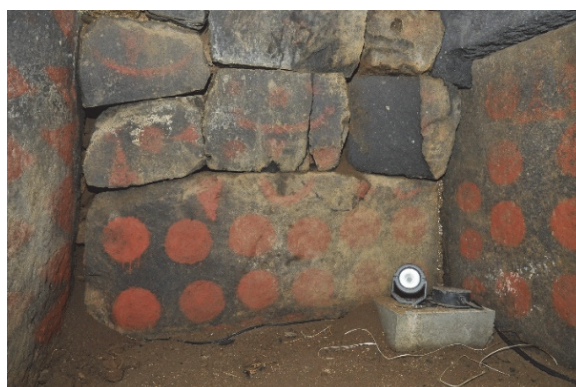
Decorated chamber walls with stone peeled off
(Photo provided by Tamana City)

method of recovery will be studied.

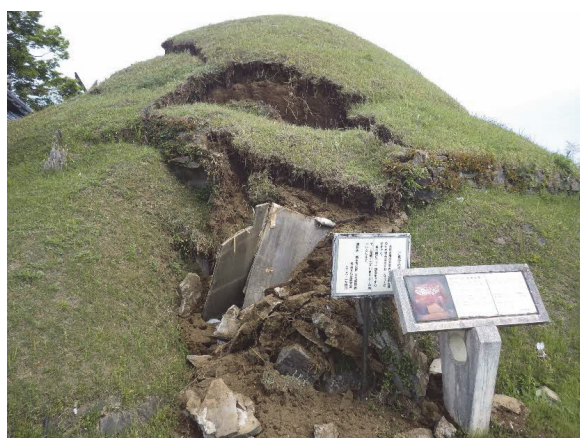
the corridor collapsed, the side wall of the front chamber was knocked off, and the stone blocks of the main burial chamber cracked and fell off.

Collapsed soil blocking the entrance to the stone chamber (Photo provided by Kumamoto City)

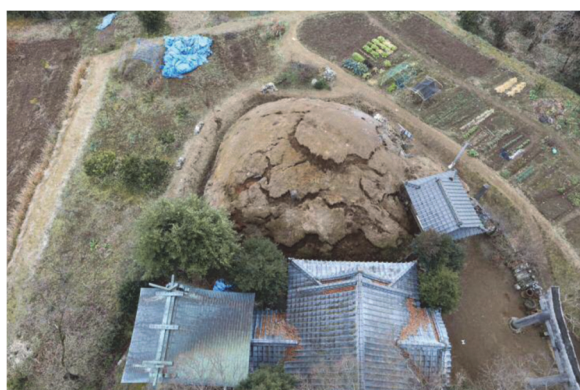
Damage to the mound (Photo provided by Kumamoto City)

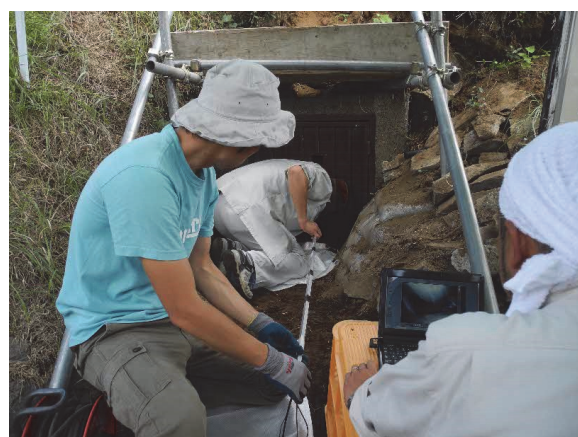
Survey of the interior of the stone chamber using a small camera (Photo provided by Kumamoto City)

Since it was impossible to enter the stone chamber when it was first damaged, a damage assessment of the stone chamber was conducted with the assistance of the Nara National Research Institute for Cultural Properties using a small camera. This allowed us to gain a better perspective for subsequent projects.

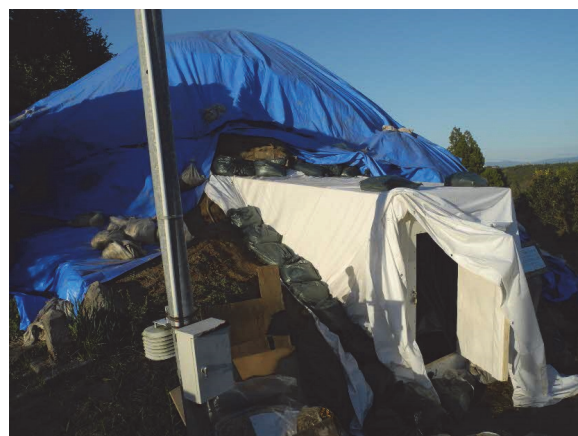
Installation of a windbreak chamber (Photo provided by Kumamoto City)

In 2019, an investigation on the condition of the collapsed corridor ceiling stones confirmed that they needed to be re-stacked. Since the decorated chamber walls could potentially be affected by the changes in temperature and humidity due to direct sunlight and the inflow of outside air, a new windbreak chamber was installed at the entrance of the stone chamber for protection. In addition, the mound was cured with anti-grass sheets to reduce fluctuations in the temperature and humidity of the microenvironment inside the stone chamber. The committee plans to discuss recovery methods based on the survey results in the future.

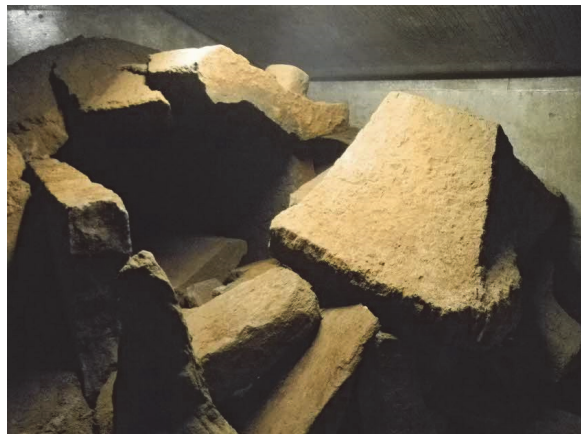
The side walls of the stone coffin collapsed due to the earthquake, and the ceiling stone fell and

was severely damaged. Since the stone coffin is located inside the preservation facility, it is believed

The damaged stone coffin
(Photo provided by Kumamoto City)

After surveying the mound and measuring the stone coffin, recovery methods were investigated. An issue was the difficulty of conducting conservation repairs due to the lack of space in the preservation facility. Mound surveys and excavations were conducted to determine the conditions of the Sandanzuka, Kunugizuka, Biwazuka, and Ryuganzuka tumuli, confirming that the damage was limited to the reconstructed mounds. Regarding the recovery for the Kunugizuka tumulus, the mound scraped as little as possible, and the slope was protected with large sandbags and blocks. For the Sandanzuka, Biwazuka, and Ryuganzuka tumuli the mound soil that had been maintained was restored.

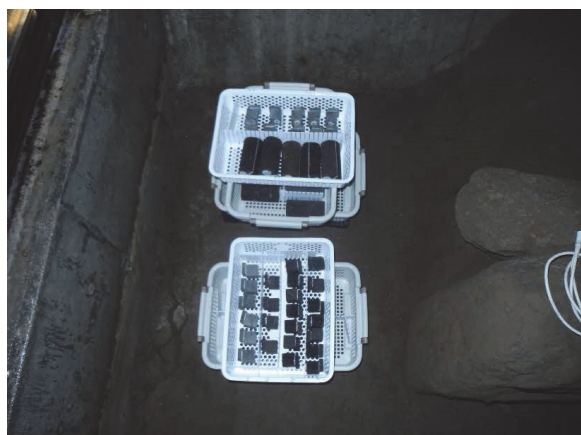
Adhesive weathering tests
(Photo provided by Kumamoto City)

Since the collapsed house-shaped stone coffin is the main target for recovery, continuous research is being conducted to select an adhesive that does not affect the red pigment while maintaining sufficient adhesive strength. Research is also being conducted on the method of adhesion, and on alternative materials for the crushed stones. A recovery method for the stone coffin will be selected based on the results of this research. An environmental survey is also being conducted to ensure that the surface of the stone with line engravings will not deteriorate.

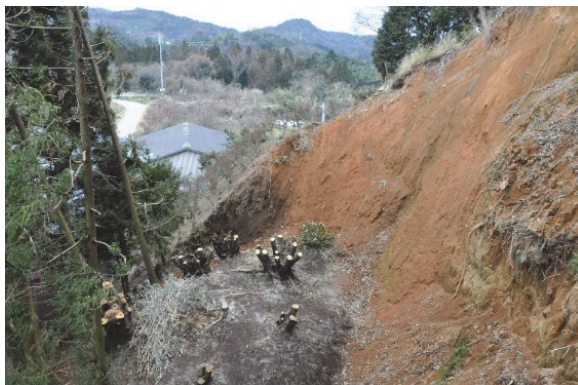
Collapsed soil in the back circle section (from the east) (Photo provided by Uto City)

In the front, a nearby warehouse was dismantled to allow the entry of heavy equipment to remove the collapsed soil. Emergency treatments were then carried out by installing large sandbags to hold the soil in place. In the back, part of the mound slid down in a lump along with a tree. The trees at the bottom caught the mound and there was no damage to the adjacent buildings. In a part of the remaining section of the mound, white clay-like soil, different from the surrounding area, was found, and it is thought to be an exposed part of the grave pit associated with the main mound. In addition, several cracks are still visible around the collapsed area, including large cracks with dozens of centimeters wide and deep. In addition, as of 2022, small-scale collapses and soil runoff continue to occur around the collapsed site and the site remains in unsafe conditions. The damaged areas were covered with plastic sheets for protection.

As of FY2022, the damaged area will be divided into three construction zones for the planned disaster recovery work: i, one for the back and two for the front part. Normally, it would be best to reconstruct the mound and return the slope to the original angle of inclination, but there is no space around the mound to do so. Therefore, in order to stabilize the mound even if the slope remains steep to some extent, the most appropriate construction method will be selected for each site, using reinforced mud walls, long-fiber reinforced earthwork, and large block retaining walls in addition to embankment. This is only a plan, and the final method to be used has not yet been decided.

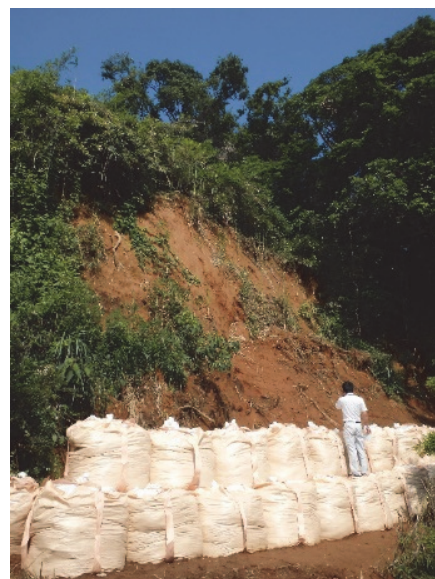
Large sandbags in the front part (from the southeast) (Photo provided by Uto City)

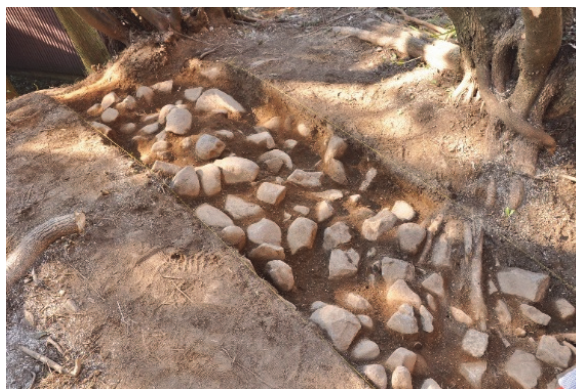
**Paving gravels found in the excavation
(from northeast)
(Photo provided by Uto City)**

Since the collapsed soil in the back of the mound was in a lumpy form that retained most of its original shape, an excavation was conducted there, under the assumption that the information was retained on this part of the mound. The excavation showed that a group of gravels that appeared to be paving stones on the slope of a mounded tomb were also found throughout the collapsed soil. This led to the close certainty that the burial mound used to be paved with gravels throughout.
