Case study

In situ assessment of superficial moisture condition in façades of historic building using non-destructive techniques

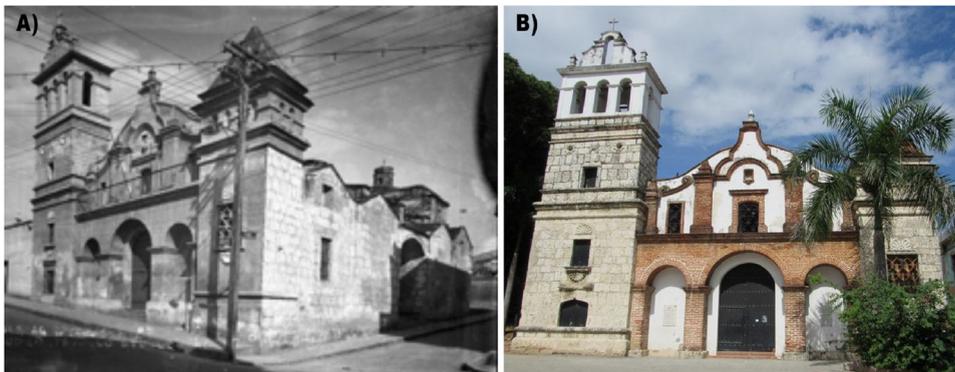
The church has been intervened on several occasions and not all these interventions have been favorable and had modifications in its architecture and structure. In the middle of the 20th century, the exterior plaster was removed from the whole church, leaving it during environmental effects. However, for the neighborhood the church is a reference and very important place; and for the country is a symbolic building because was baptized Juan Pablo Duarte one of the three Fathers of the Dominican Homeland (Fig. 1).

Fig. 1. A) Church at the beginning of the 20th century [27] B) Church in 2017.

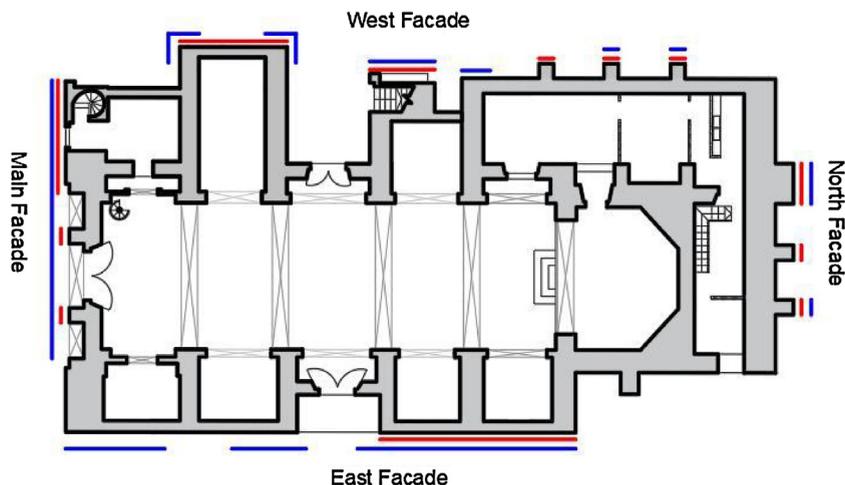
Fig. 4. Study areas with Portable Moisture Tester (Red Lines) and Thermal Camera (Blue Lines).

An area was selected on each facade to measure brick and stone (Fig. 4). For the data collection, a 50 x 50 cm mesh was used and it was measured in each of those points with the portable moisture testes along the façades from ground level to the roof. Before the survey the DELMHORST BD-2100 was calibrated. Once the values were obtained, they were introduced in the program Surfer V15 develops by Golden Software [44]. In this program an interpolation of the data is done to obtain the humidity maps of each façades. For moisture mapping we used the blue color to indicate that the surface is too wet (> 95) whereas red color indicates a sufficiently dry moisture level (0–85) and yellow color indicates a borderline situation (85–95) [42].
