## ***Reawakening the spirit: St. John's Church of Tartu, Estonia***

Kari Avellan  
KAREG Consulting Engineers  
Töölöntorinkatu 11 B  
FI-00260 Helsinki  
Finland  
[kari.avellan@kareg.com](mailto:kari.avellan@kareg.com)

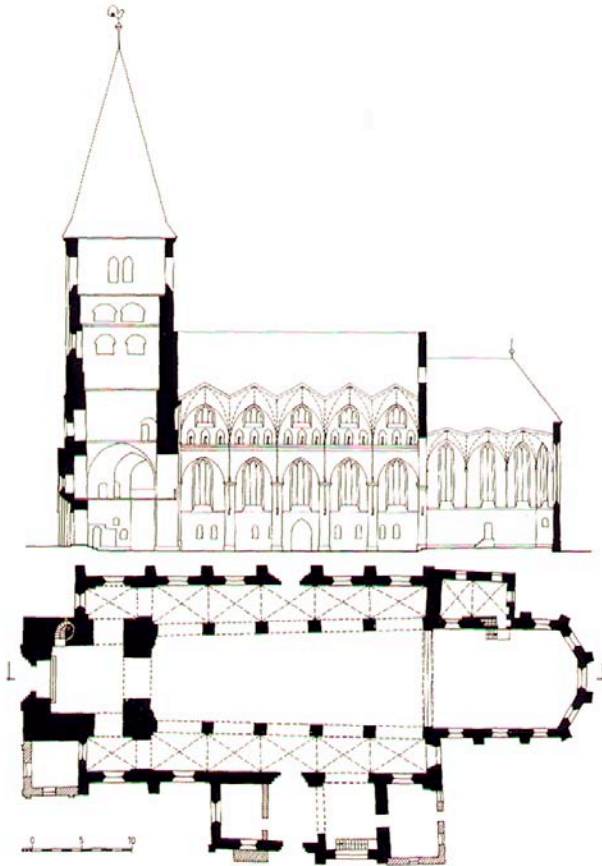
Figure 1. Plan and section of Church.

Amongst the many examples of medieval architecture in Estonia, St. John's Church of Tartu is of special significance (Figure 1). It is the most prominent building of Gothic architecture of the country, and is unique for its terracotta sculptures and decorative details.

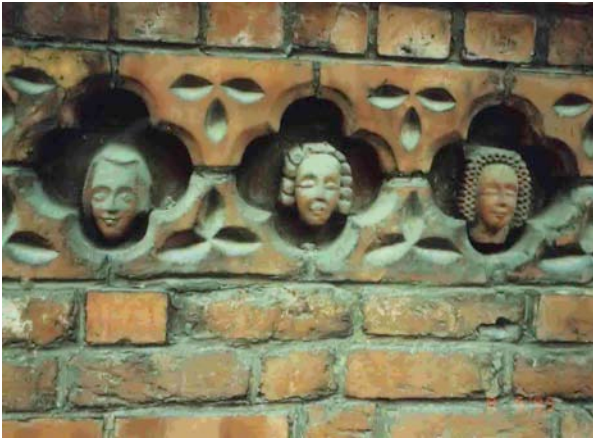
Picture 3. Terracotta figures.

Today the church works as a polyfunctional building: the primary function is a working church, the other functions linked to the main use are being a cultural monument open for the public with exhibited terracotta originals (Picture 3) and being a concert hall as well. The association of St. John's Church and the University congregation combined the ecclesiastical spirit with the academic spirit of Tartu University, founded in 1632.

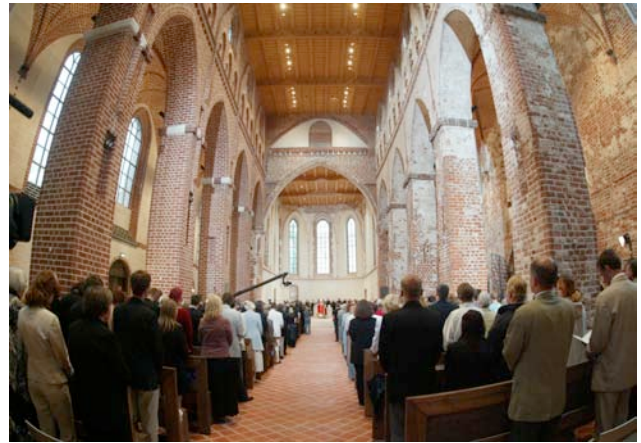
Picture 4. St. John's of Tartu today.

It was the occasion for celebrations on June 29th 2005, as St. John's of Tartu opened, concluding this long and challenging restoration / renovation process of 16 years in which we were involve from the very beginning. The spirit of place has carried over from Catholicism to Lutheranism, from a German speaking congregation to a Estonian one. It has held for over 700 hundred years, and we hope it will continue to take hold
