The Historic Centre of Mexico City

Mexico City
San Ildefonso Museum

Mexico City
Town House on Seminario XII

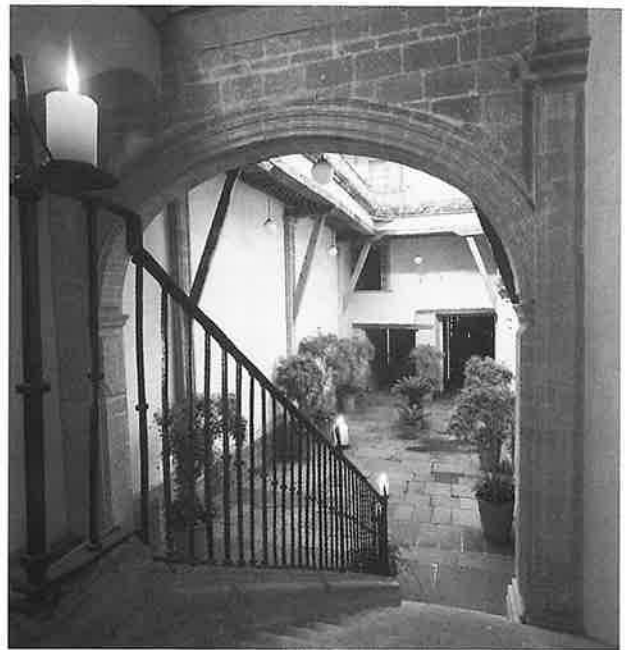
Fig. 5. The stone staircase from the main courtyard
Photograph by Gabriel Figueroa Flores

The sober 'tezontle' façade was adorned with carved stone framed doors and windows. Its ample interior spaces shelter a magnificent stone staircase with wrought iron railings and a flagstoned courtyard where carriages passed to reach the stables. From the balconies one has a superb view of the Cathedral, especially the Sagrario Metropolitano.

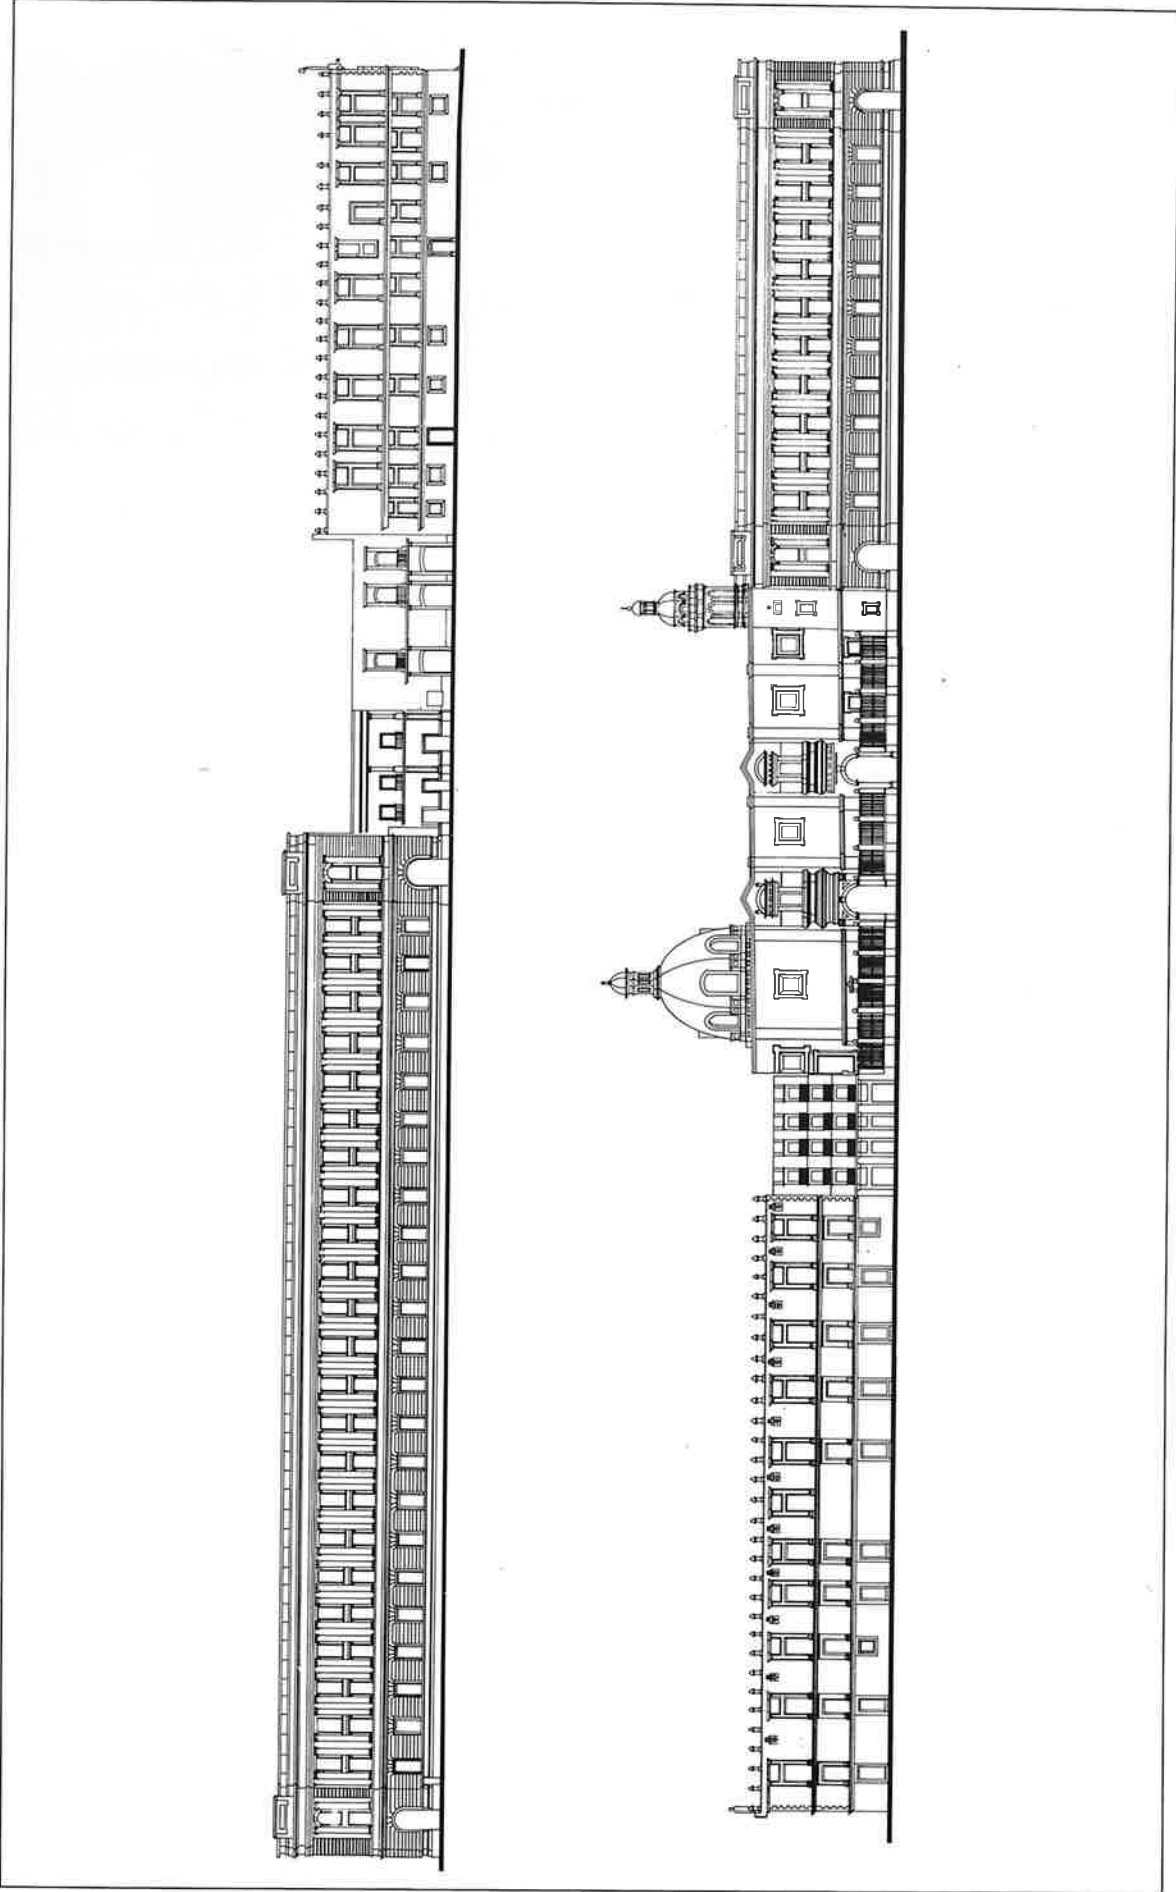
Fig. 4. North elevation on Venezuela, showing the former Convent of the Incarnation on the left; two private houses, dating from the eighteenth and nineteenth century, in the middle; and the former Customs House on the right

Fig. 5. South elevation on Luis Gonzalez Obregon, showing the former Customs House on the left; a modern insertion, and the baroque church and former Convent of the Incarnation in the middle and right
