Inventory of **earthen** architecture

2012
WHEAP

WORLD HERITAGE EARTHEN ARCHITECTURE PROGRAMME

This document has been prepared by CRATERRE-ENSAG
David Gandreau & Leticia Delboy

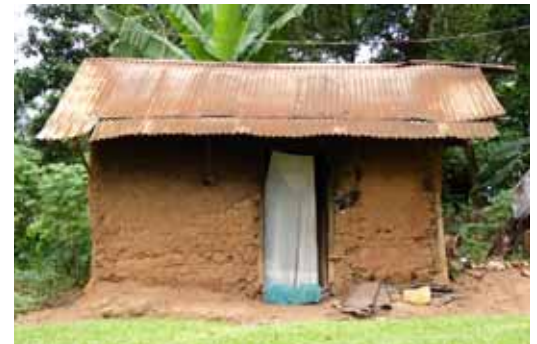
Originally the site was completely built in straw. With the growth of the city of Kampala, this material gradually disappeared, giving way to brick and wattle and daub. There remains only one heavily damaged building reflecting the temporary use of earth as a building material.

House of one of the traditional guardians who watches over the spirits of deceased kings. This is the last earthen house within the property, as all the others have been replaced by burnt brick structures.
© Sébastien Moriset, CRAterre

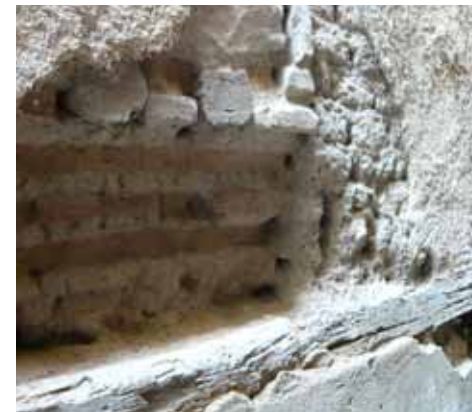
Detail of degraded plaster and of the earth bricks showing underneath

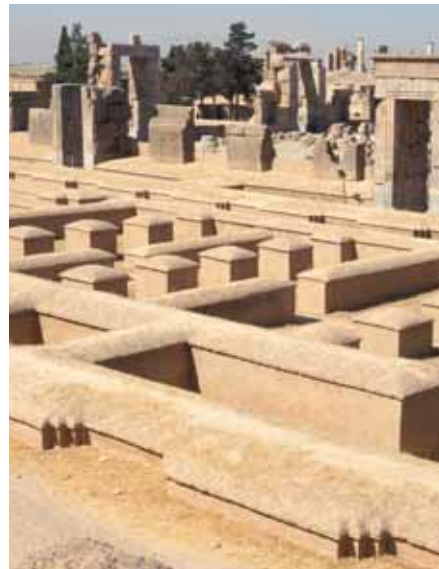
Detail, restored earth walls
© David Gandreau, CRAterre

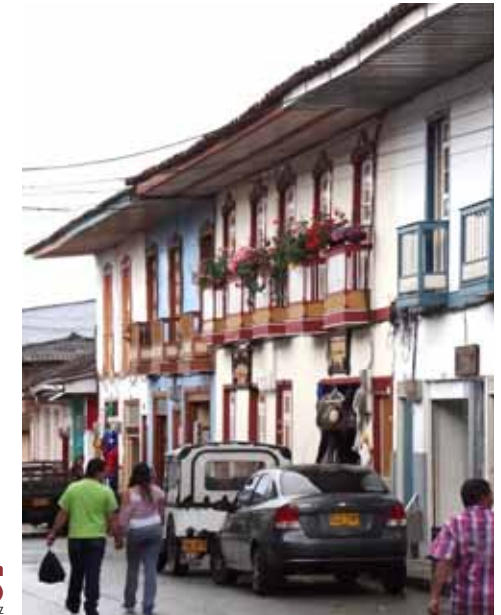
Earth constructions, rammed earth and wattle and daub (bahareque)
