PROCESS OF CHANGE AND MODERNISATION IN OLD PARSONAGES OF FINLAND Anu SOIKKELI*, Brésil / Brasil

**PROCESS OF CHANGE AND MODERNISATION
IN OLD PARSONAGES OF FINLAND
Anu SOIKKELI*, Brésil / Brasil**

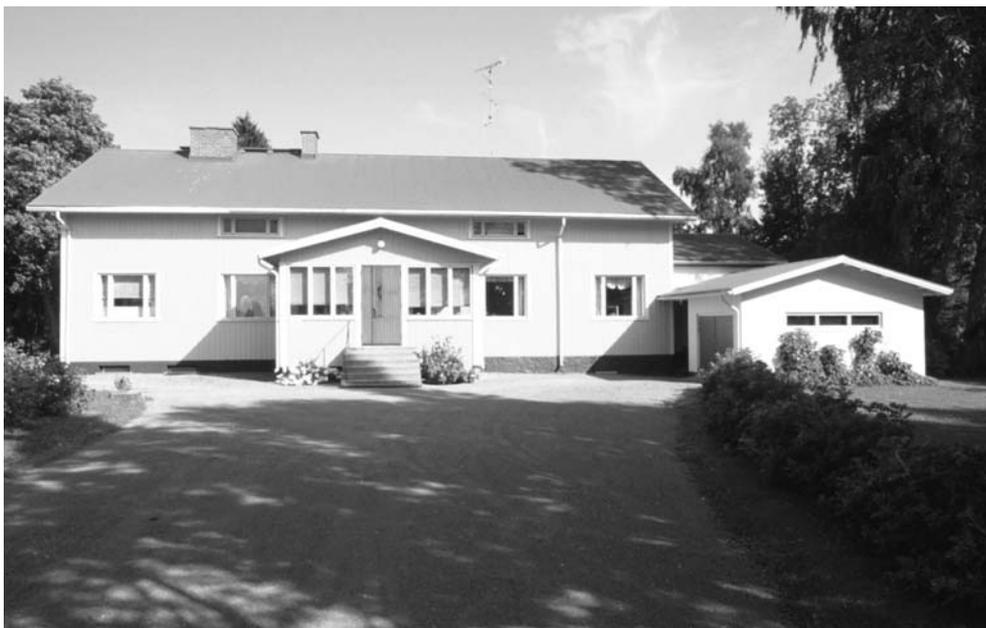
Köyliö parsonage (1845) was renovated in thr 1950's.
It is now difficult to determine when the building was constructed.

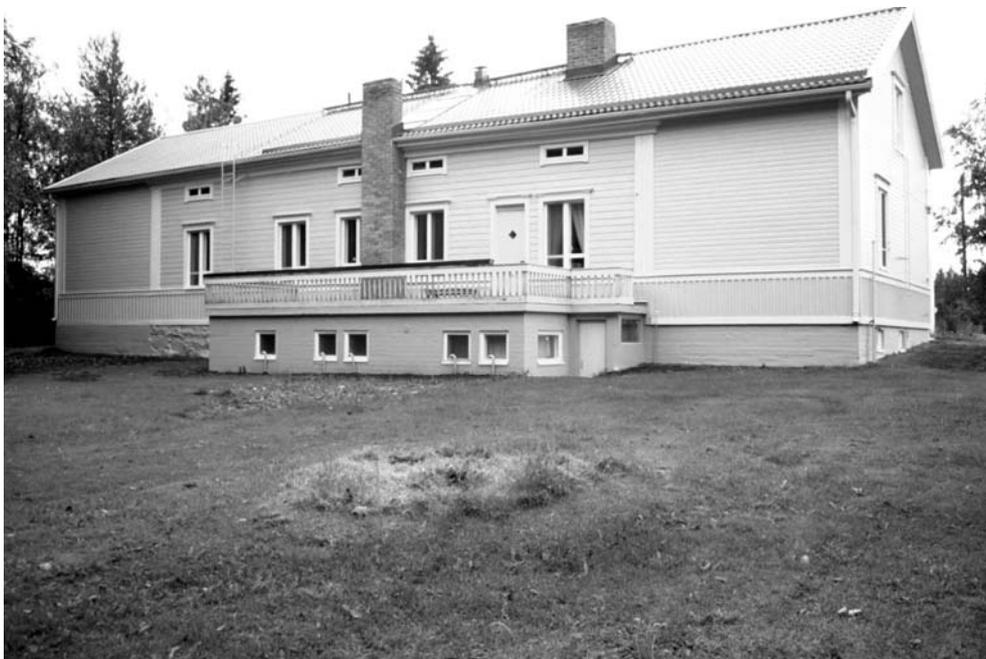
Oulunsalo parsonage (1856) has an underground annexe with some technical facilities.

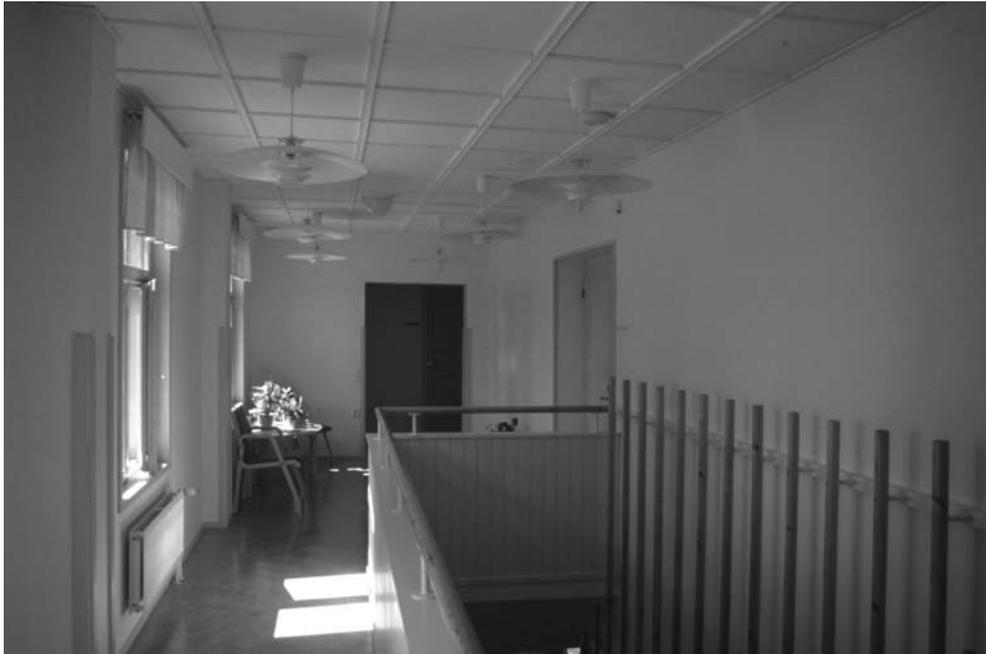
In Alatornio (1786) parsonage, renovation in the 1990's was far too extensive.
Almost all the old materials were dumped, apart from the log frame.
The interior doesn't differ anymore from the new houses of the 1990's.

There are also parsonages whose owners (repairers) have carefully documented the original mouldings, doors, panel widths and profiles on the basis of measurements, samples and photographs, only to tear them all away and replace them with new ones that look old, or to have new wear-proof parts made that match the dimensions of the original. In doing so, they have not repaired the parsonage, but rebuilt it. To achieve the old 'spirit', people have even used new, sandblasted timber.

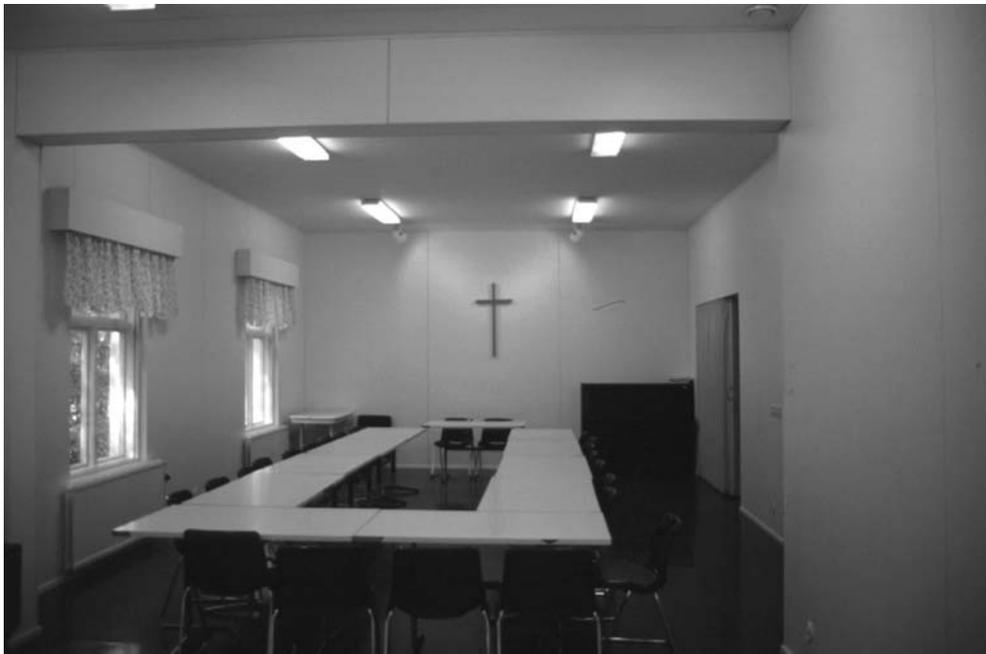
In Jämijärvi parsonage (1856) the desire to renew practically everything has led to
the loss of the original scale and arrangement of space.

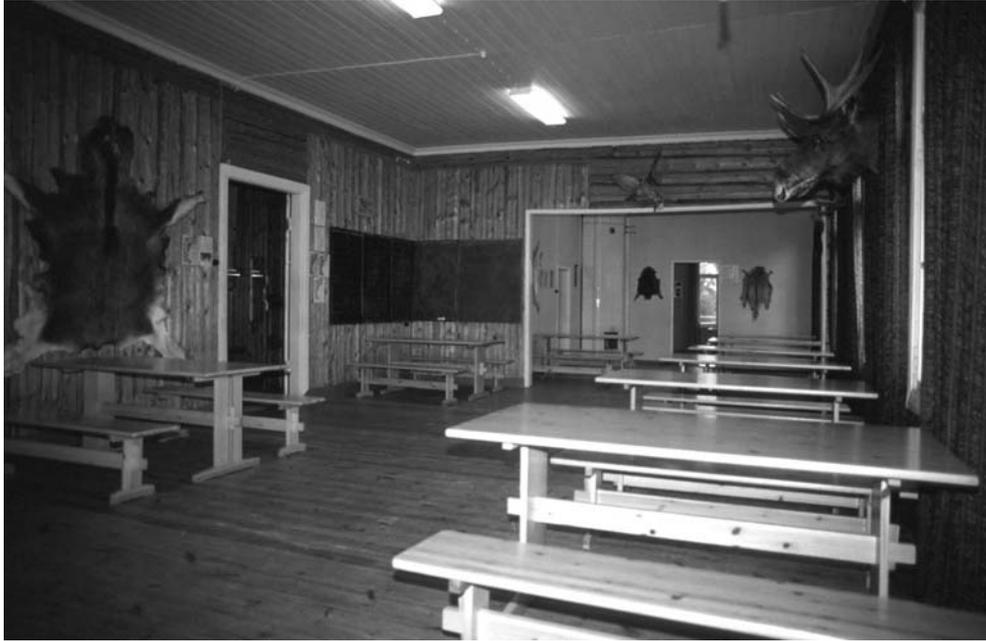
In Hongonjoki parsonage (1899) the interior has undergone irreparable modifications. This change has involved the lacquering of surfaces. In reality, there was already a trend in the 18th century to shun the use of bare timber surfaces in parsonages, since they were considered too peasant-like.

The parsonage owner's beauty and tradition ideals are surprisingly often based on the notions once created by national romanticism, which favoured the use of large, robust timber as building material and emphasised its natural character. It is impossible to change a weather-boarded short-corner building into a red-hearted pine villa from the outside, and the interior may have to undergo irreparable changes. In its less severe form, this change may only have involved the lacquering of painted surfaces. In the worst case, however, the interior may have been sandblasted. After these changes, and echoing the ideals of national romanticism, many parsonages reflect the modern idea of how a rustic building should have looked like, not how it actually looked like. In any case, parsonages were after all something else. In reality, there was already a trend in the 18th century to shun the use of bare timber surfaces in parsonages, since they were considered too peasant-like. Instead, they were covered with paint, glazing or wallpaper to achieve a higher manor-like status typical of the upper social classes, for bare timber was not regarded as capable of conveying this status.
