Standing Structures Report

Cupid's Cay

Governor's Harbor
Eleuthera, Bahamas

UMASS AMHERST CENTER FOR
HERITAGE & SOCIETY

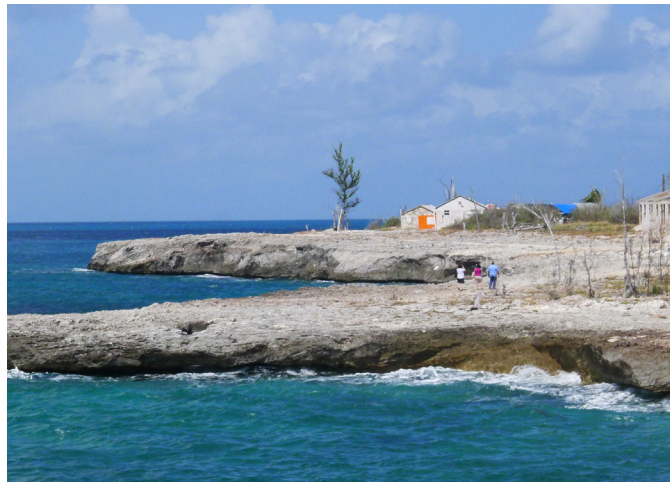
Figure 43 (left): View of the southern shoreline of the Cay showing the erosive action of the wind and waves.

Figure 44 (top): View of the colonial-era road cut into the bedrock.

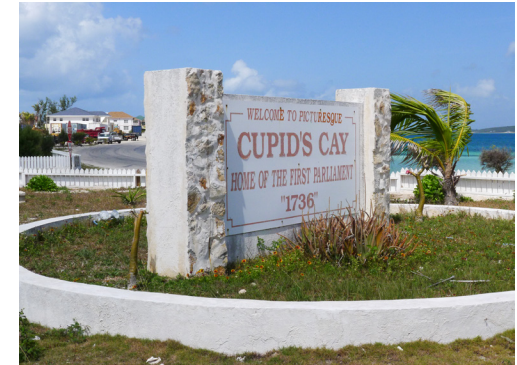
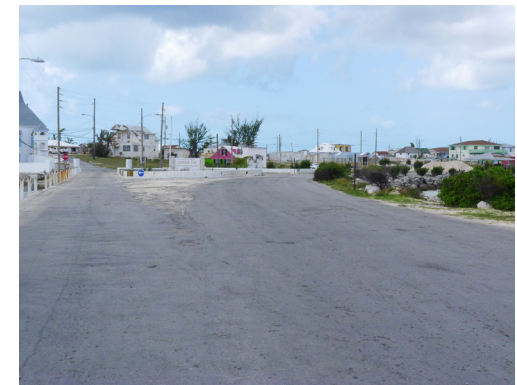
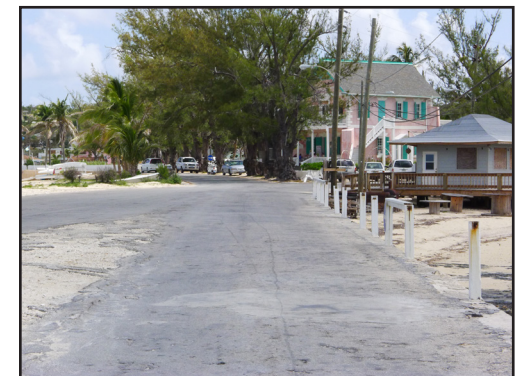
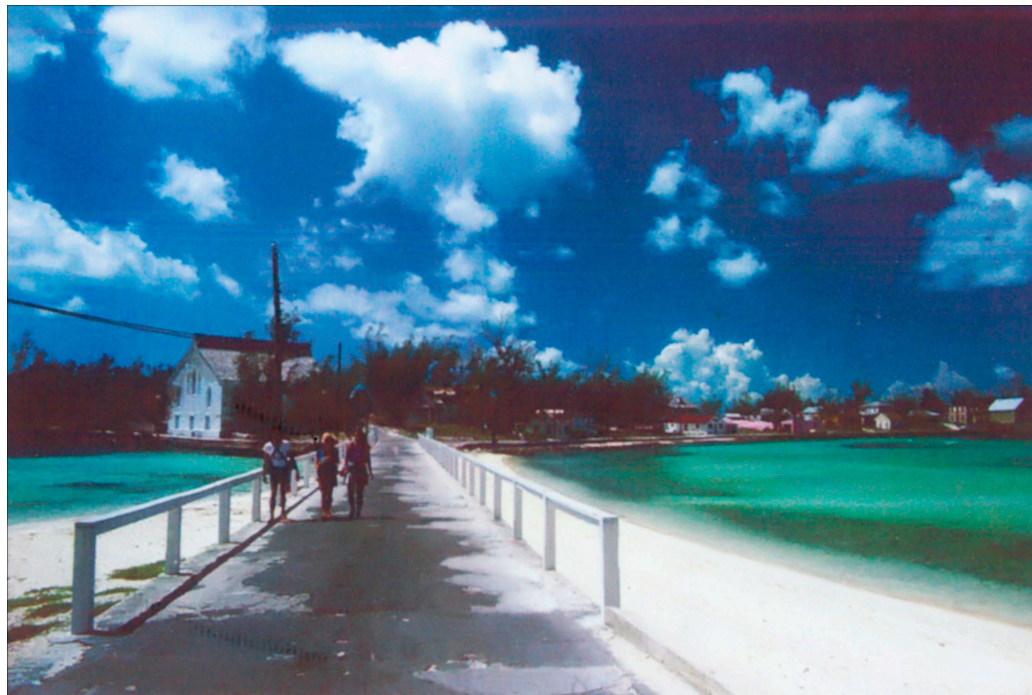
Causeway

Cupid's Cay is accessed from the Town of Governor's Harbor by a causeway with a harbor on both sides. Originally developed as a two lane access, it was widened during the 1970's with dredge fill from the port. Now much wider, the causeway is largely devoid of vegetation. A large monumnet sign marks the entrance to the Cay, along with an associated fenced green space.

Figures 48 to 51 (top right, clockwise): *The entry sign to Cupid's Cay; the causeway looking towards Cupid's Cay; the causeway looking from Cupid's Cay to the Haynes Library; a circa 1970's photo of the casueway.*

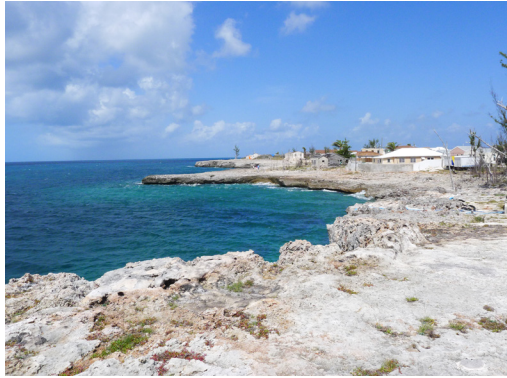
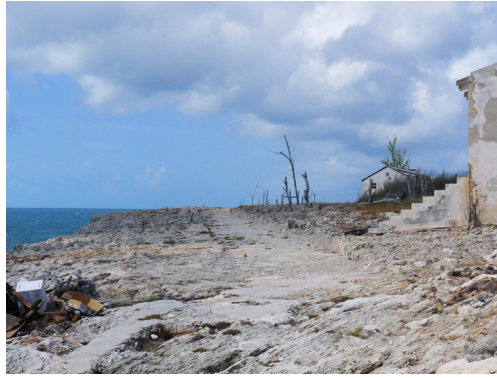
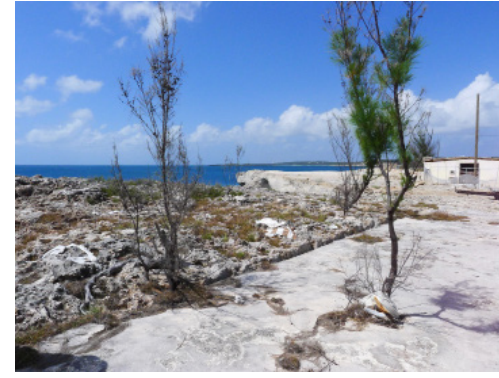
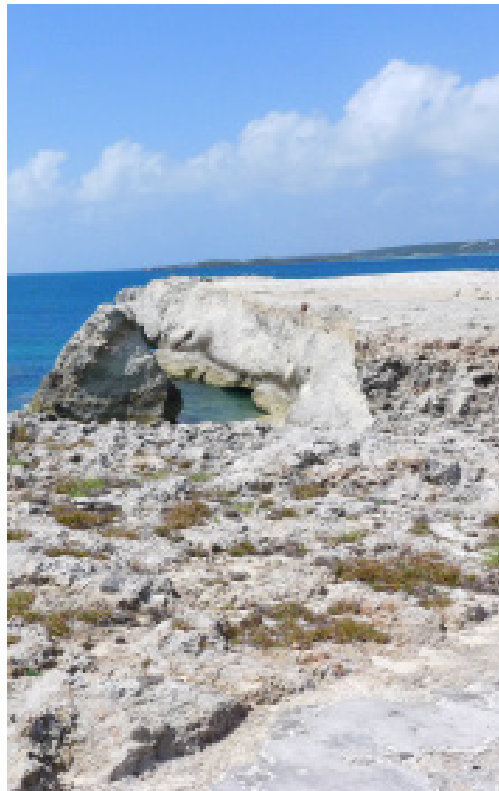
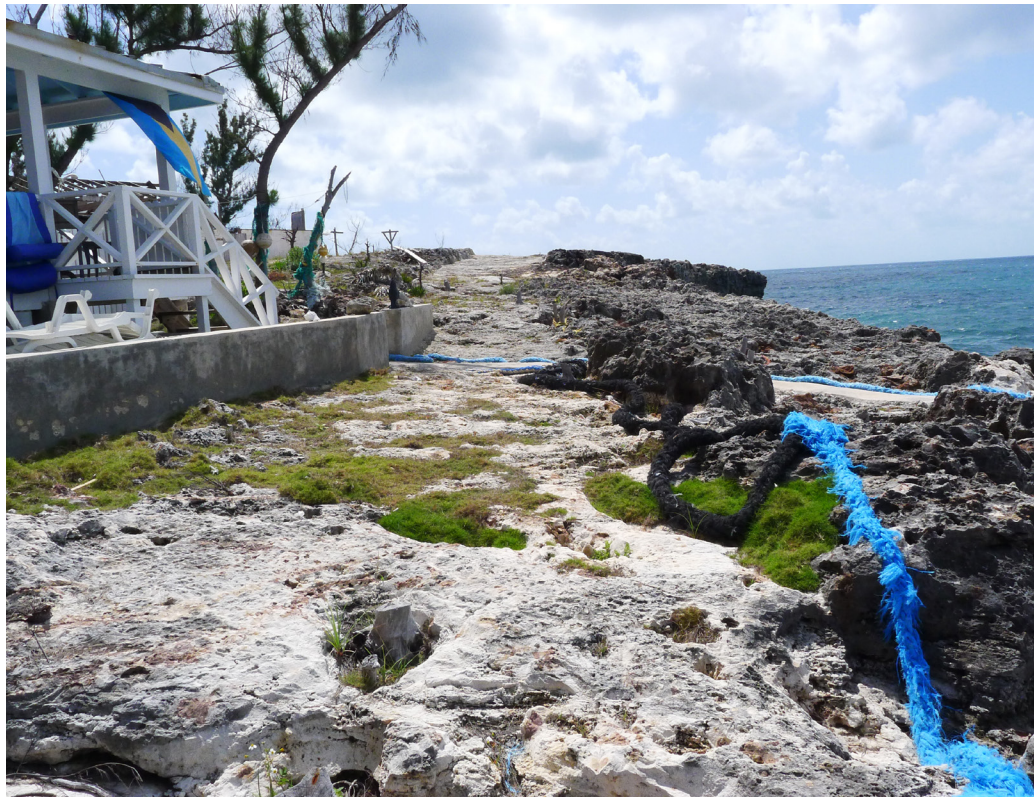
Colonial Road

Original road, now abandoned, providing access to the southern shoreline of the Cay. Figures 52 to 56 (from top left clockwise): view along the southern shoreline; bedrock limestone cuts visible; a smooth portion of the old road - other areas are pitted from erosion; clearly visible colonial road cut along the eastern end of the shoreline; high degree of erosion from the force of the waves.

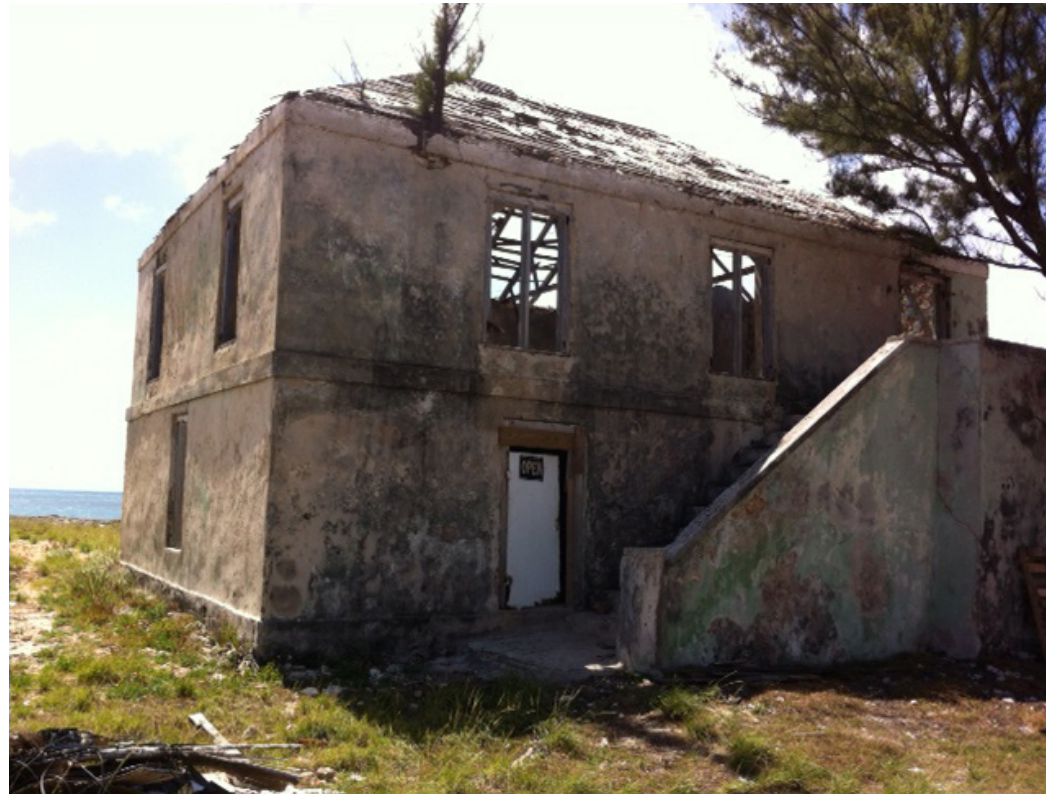
Masonic Lodge

Figures 57 to 61 (top left, clockwise): Northwest facade of the structure; second floor; detail of wooden lintel, window casing and interior stucco over concrete and rubble construction; main, northeast facing facade, showing integral stairway leading to the second floor; detail of the stairway and the main door opening.

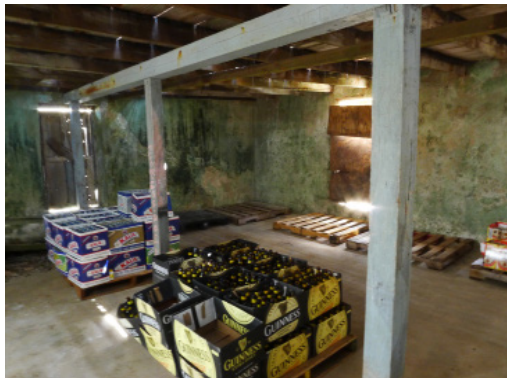
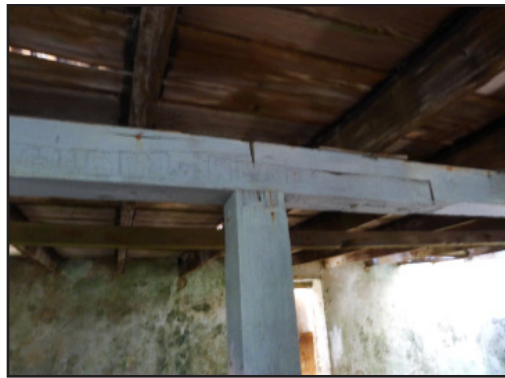
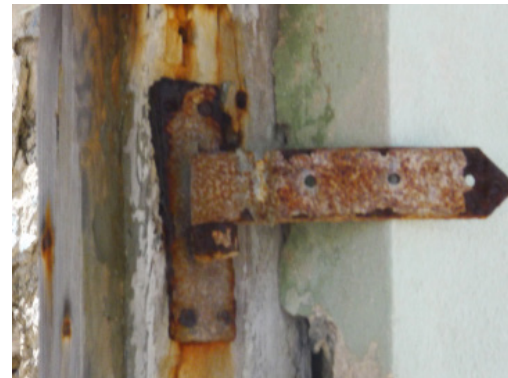
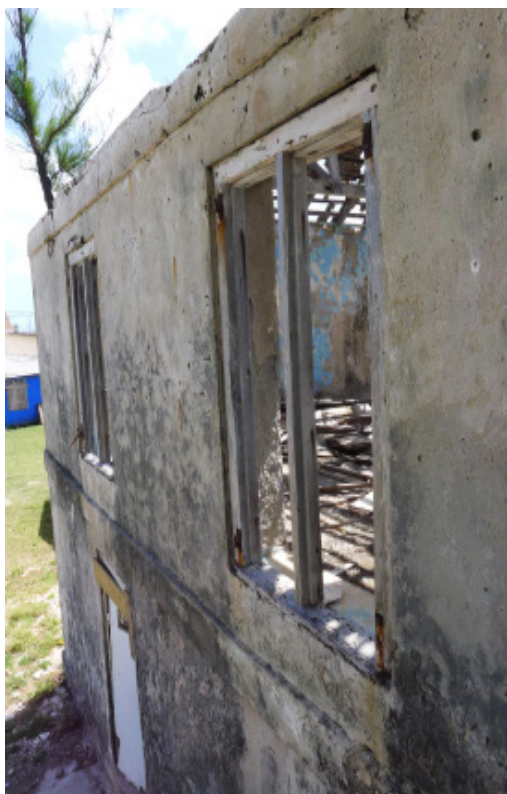
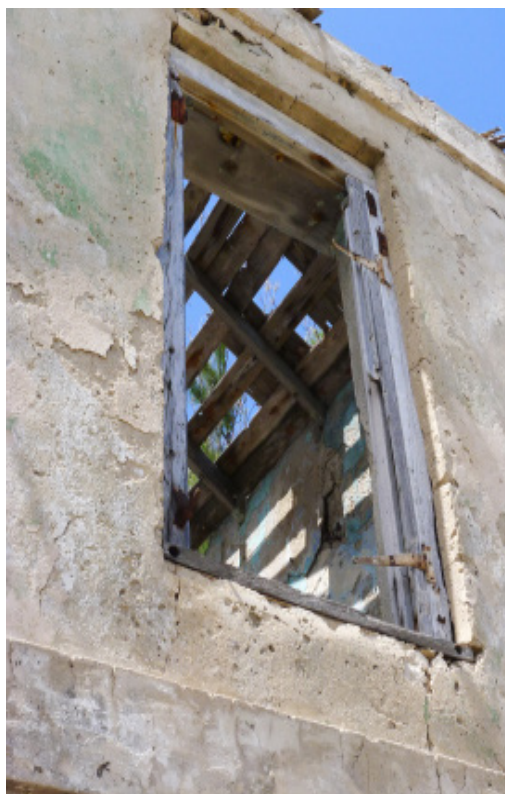
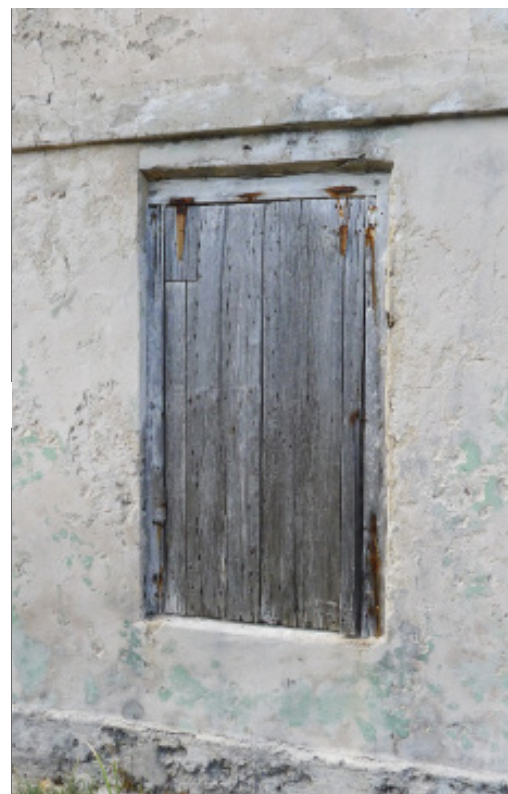
Figures 62 to 67 (upper left, clockwise): First floor showing support structures; detail of the support members; detail of iron strap hinge fastened to wooden window casing on second floor window; window with full wooden shutter on southeast facade; window opening on second floor with shutter strap hinges in place and full wooden window casing; northeast facade from second floor stair landing showing double wooden window casings and remnants of strap hinge fasteners.

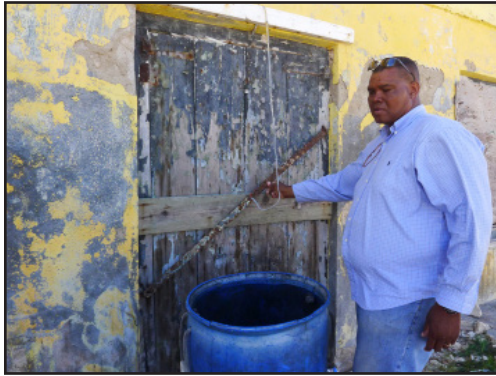
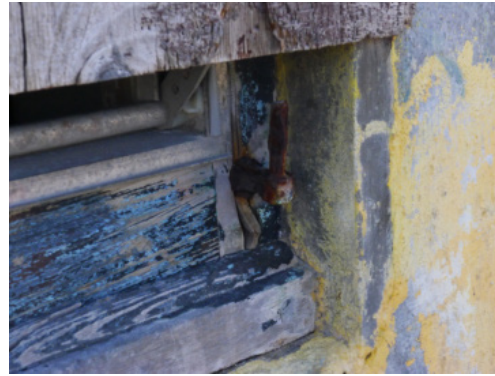
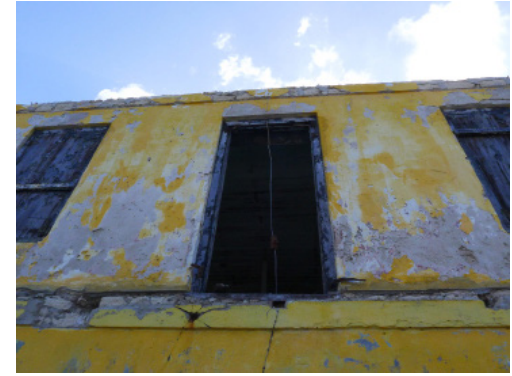
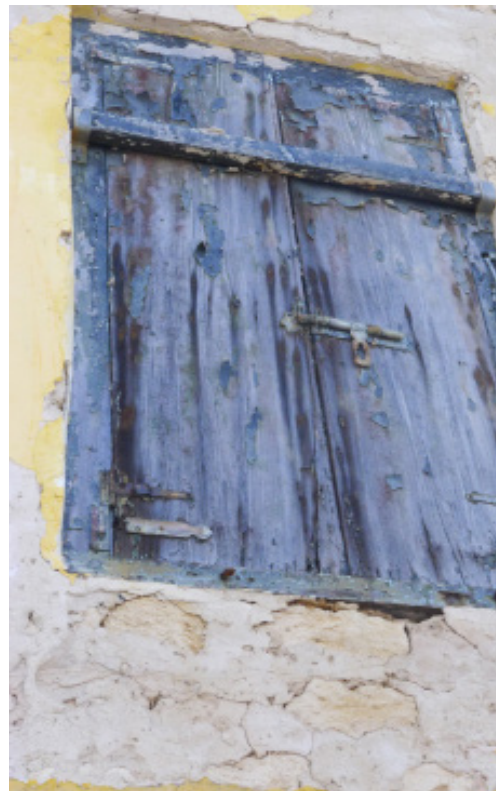
Catholic Residence / Manse

Figures 68 to 72 (from top left clockwise): detail of wooden front door with security bar held in proper location; detail of ground floor window with pin hinge; second floor balcony door; main north facade; second floor window wooden shutters, multiple strap hinges, bolt and bar securing the shutters.

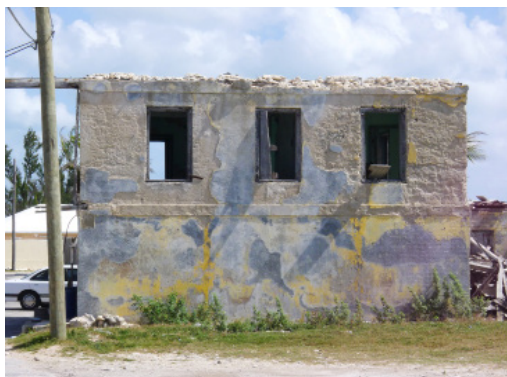
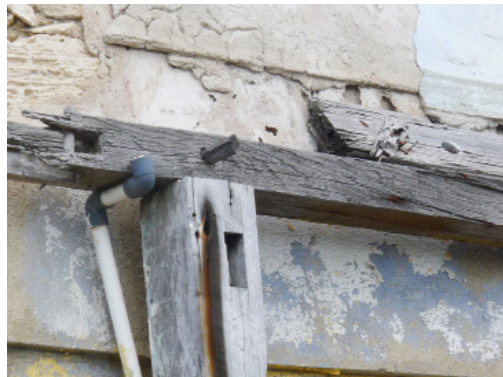
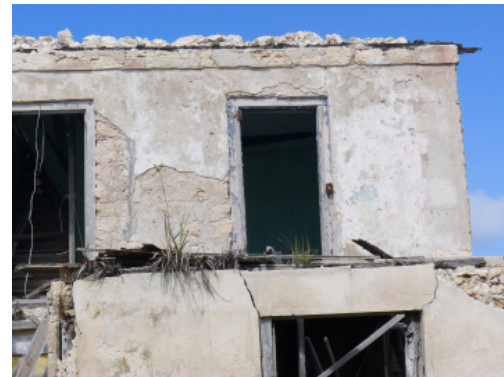
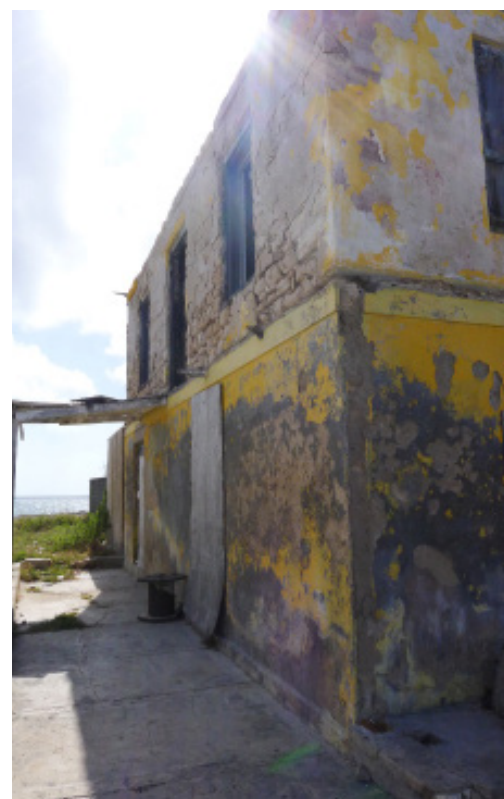
Figures 73 to 77 (from top left clockwise): west facade; detail of mortise and tenon and peg construction of the rear addition; detail of the balcony and openings to the second floor: stairs to the third floor are visible through the central opening; east facade; southern facade showing wooden rubble from the collapsed roof and addition.

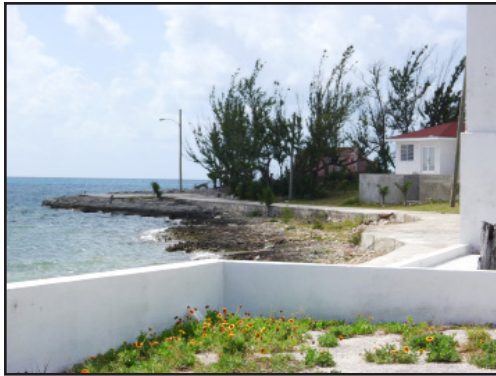
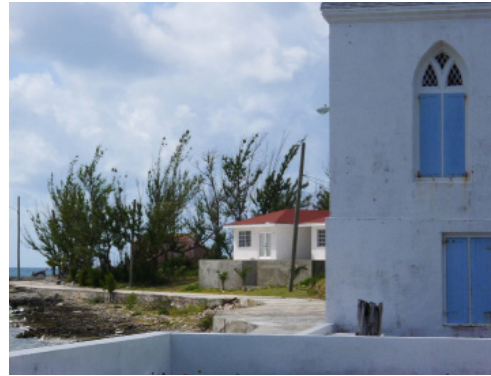
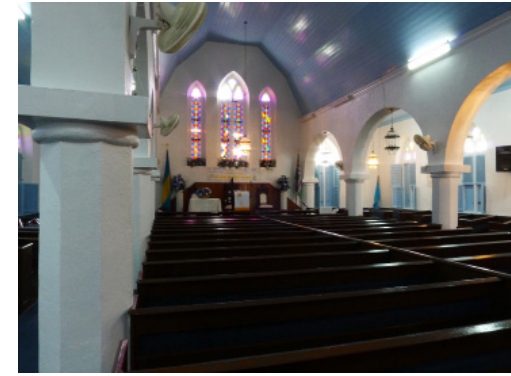
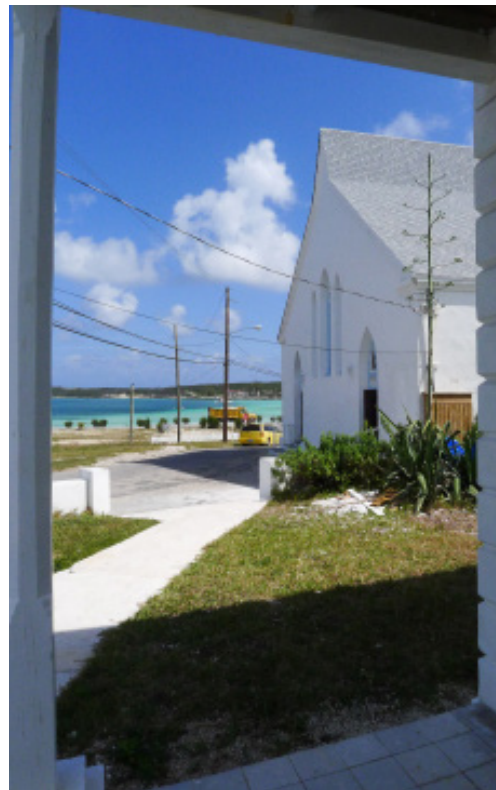
Figures 78 to 82 (from top left clockwise): the Methodist Church backs onto the shoreline on its eastern facade; the distinctive blue shutters in the window openings, stained glass gothic arches above: ground floor windows are rectangular with similar wooden shutters; interior of the central portion of the church looking toward the apse; the north facade of the Methodist Church

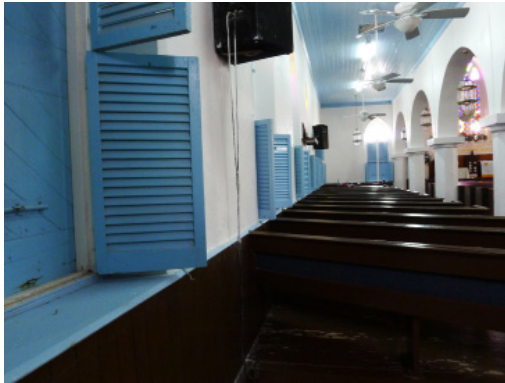
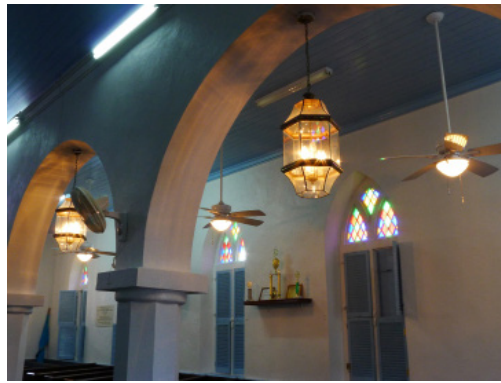
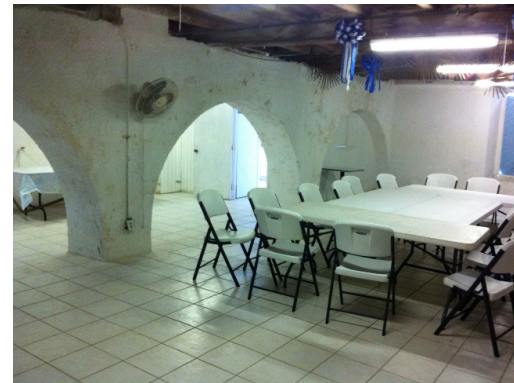
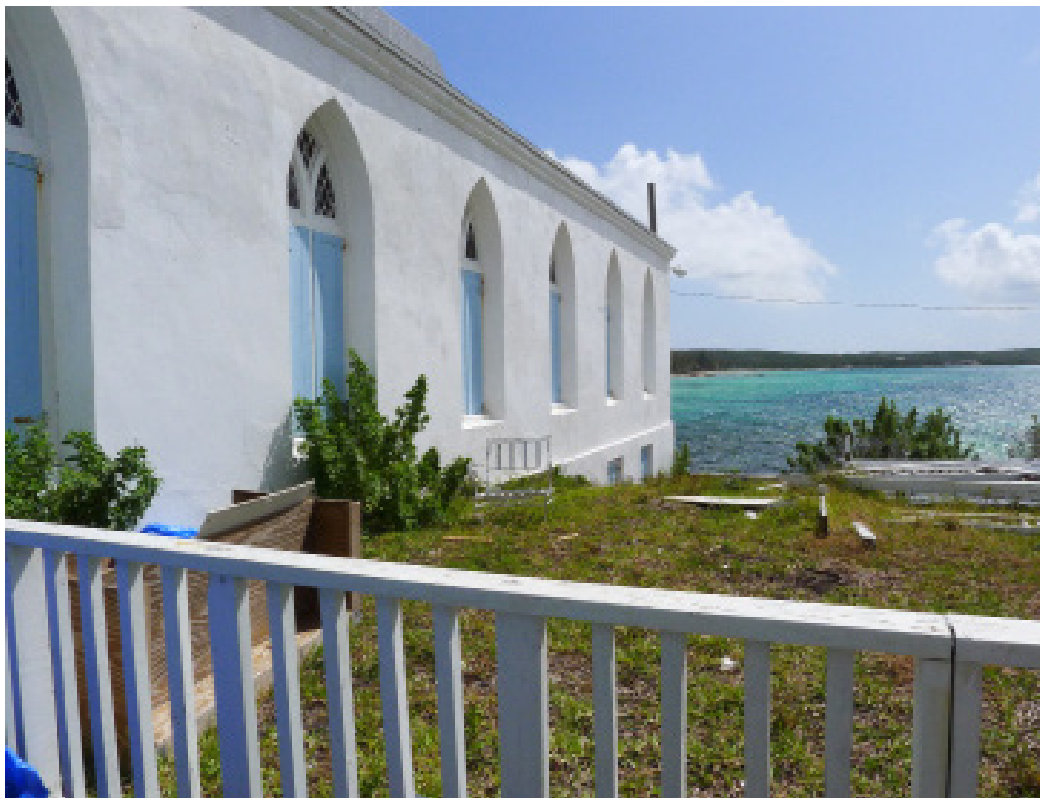
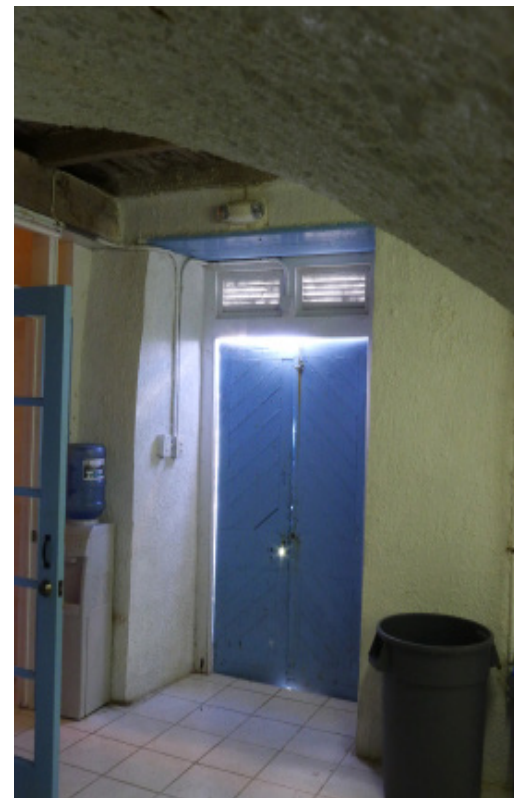
Figures 83 to 87 (from top left clockwise): interior of the church showing the side aisle and the double wooden shutters characteristic of the windows; post and arch construction of the side aisles; ground floor showing ceiling beams and arched construction of the support walls; ground floor entrance door with stucco arch in the foreground; southern facade showing exterior detail of the windows and exterior wooden shutters.

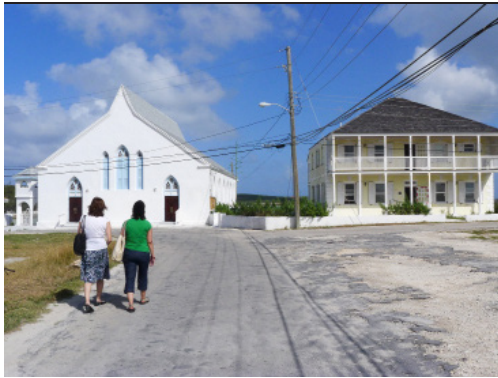
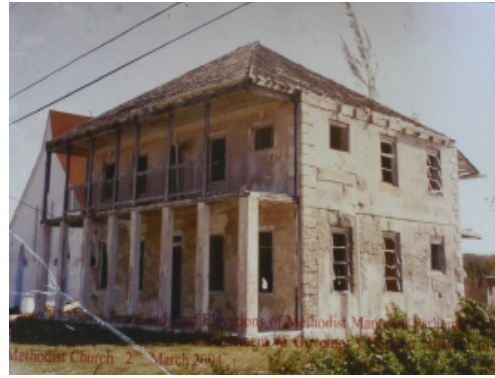
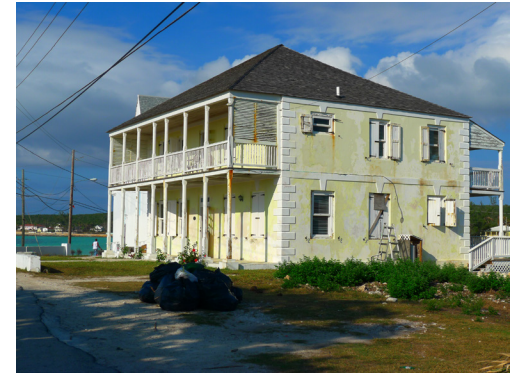
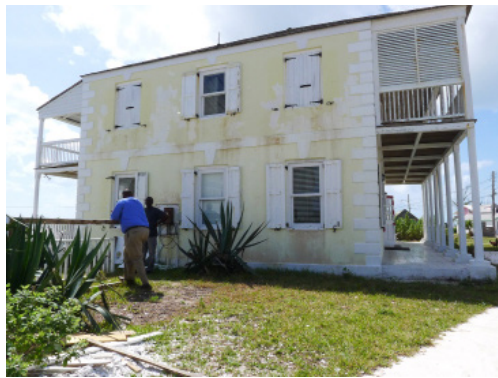
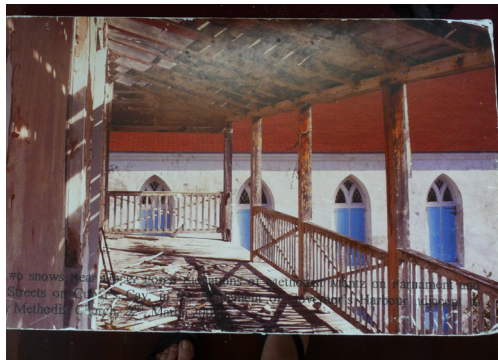
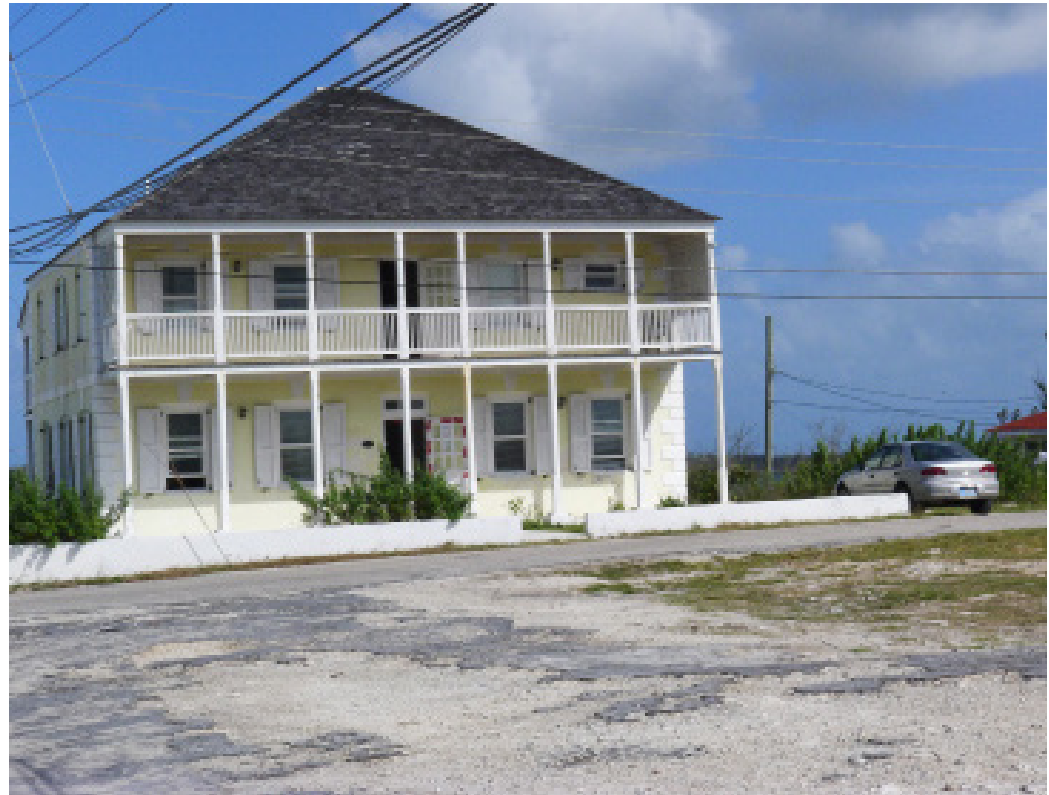
Methodist Church Manse

Built in 1845 by John Rhodes Davis, the Manse was restored in 2005. It currently serves as a children's center.

Figures 88 to 93 (from top left clockwise): view from the west of the Methodist Church (left) and the Manse (right); the condition of the Manse before restoration in 2004; the south facade; the main west facade; photo of the rear balcony before restoration.

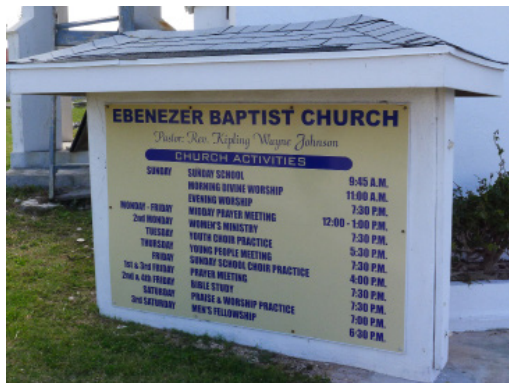
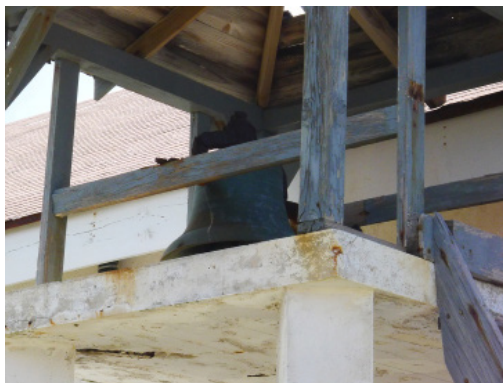
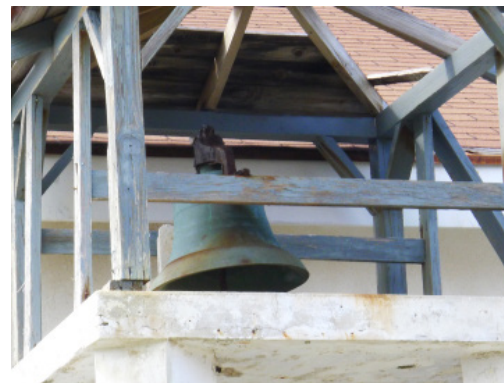
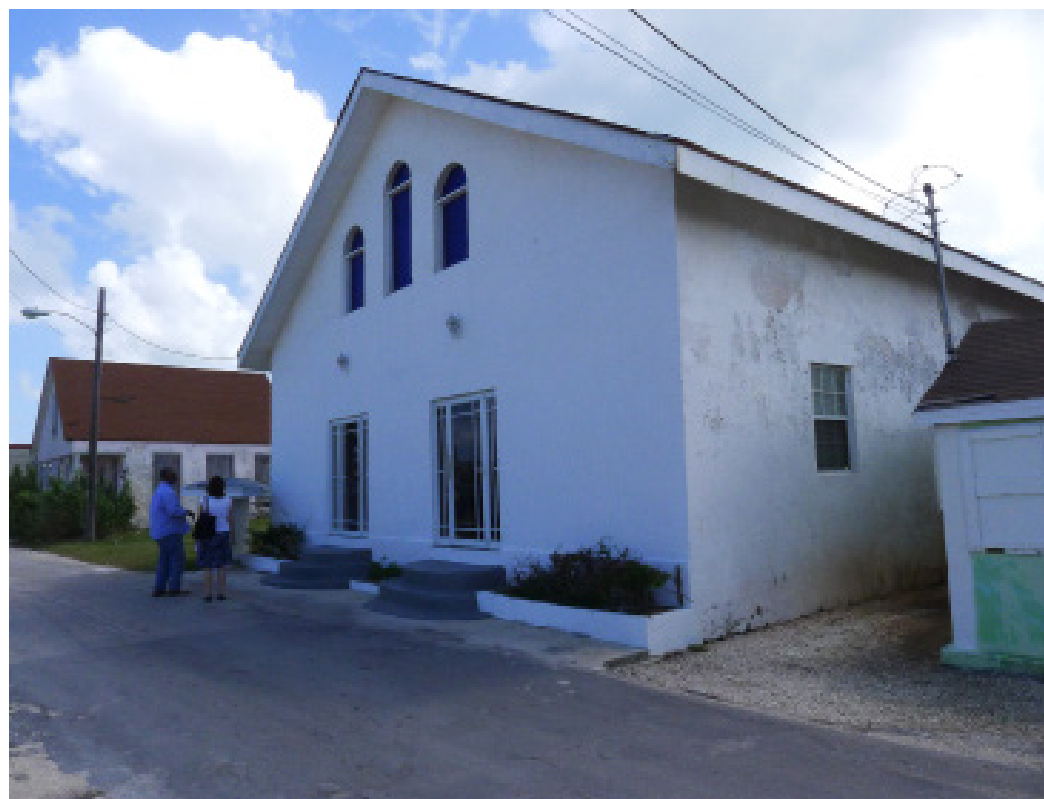
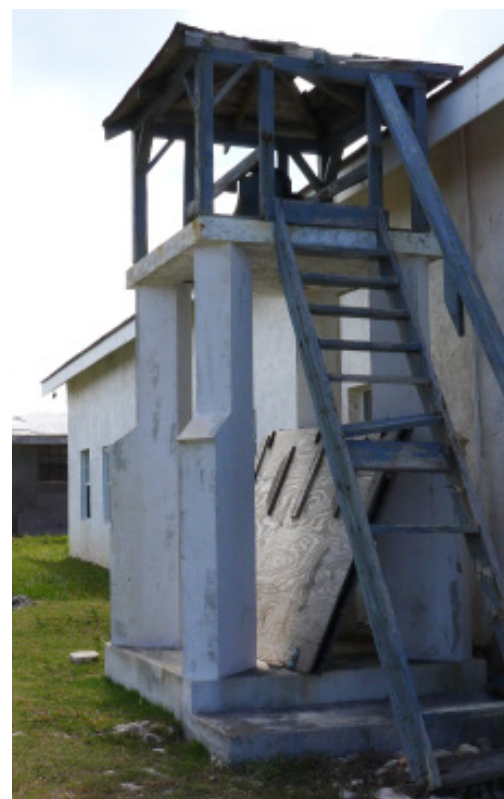
Baptist Church

Figures 94 to 98 (from top left clockwise): church signboard; detail of the wooden roof and belltower structure; copper bell; bell tower with concrete and stucco base and wooden stairs and bell-support structure; north facade of church building, bell tower is located to the left of the building.

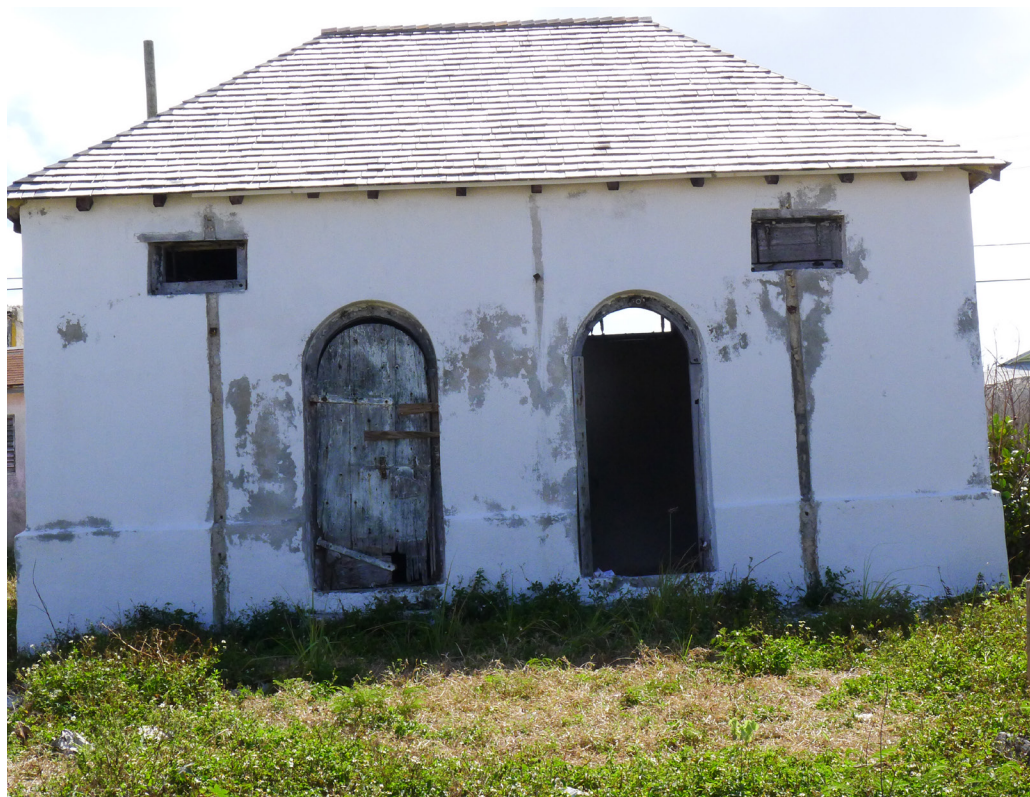
Jail:

Figures 99 to 103 (from top left clockwise): curved wooden door frame of the entrance to the right-hand cell; interior view of front cell window; interior roof joists and beams; north facade of the jail building with two cell entrances; wooden door to the left cell.

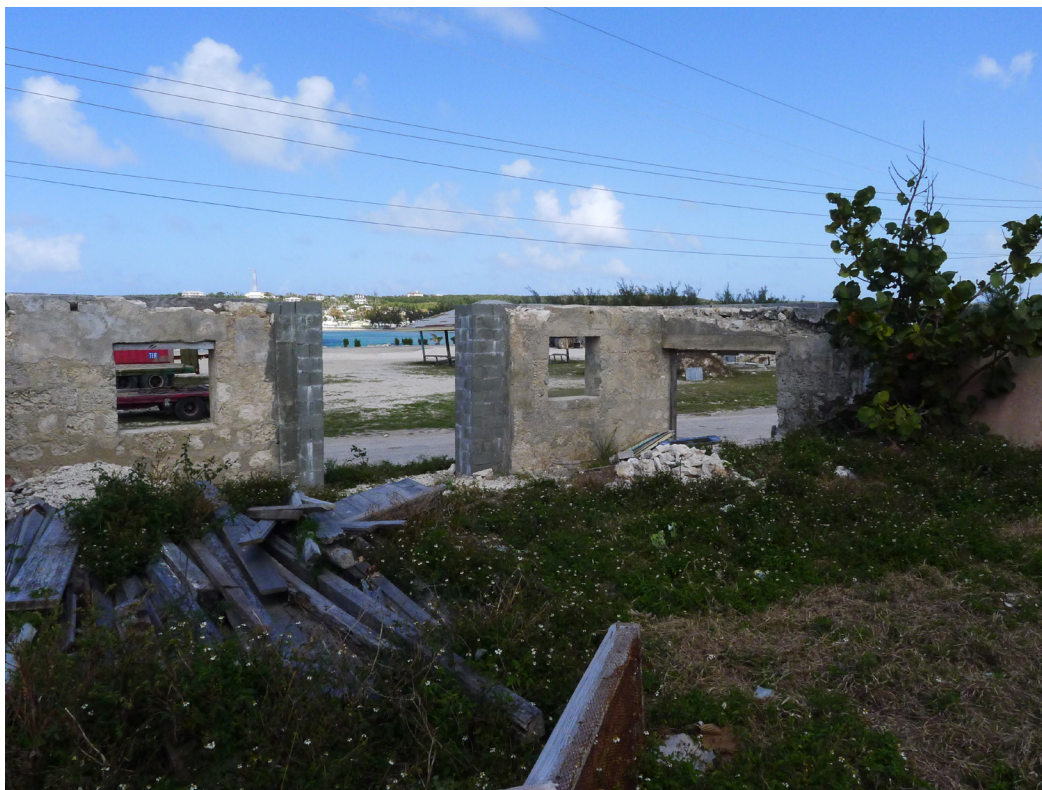
Figures 104 to 108 (from top left clockwise): concrete cistern on the south facade of the jail building; upper and lower terraces of the jail complex; arrow-headed strap hinge on discarded right hand cell door; interior view of left hand cell; view of the northern portion of the jail yard showing the surrounding stucco and concrete and rubble walls surrounding the yard.

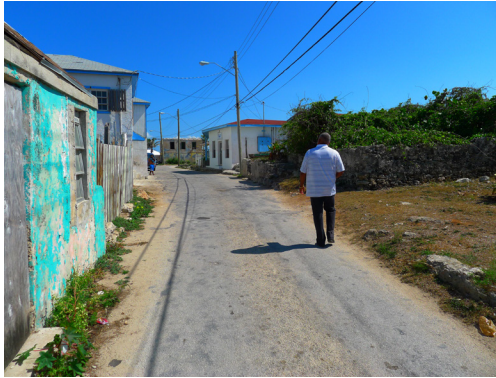
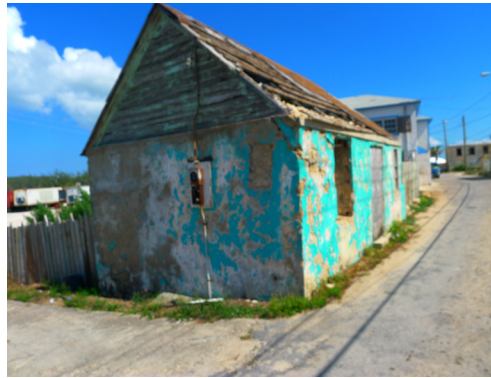
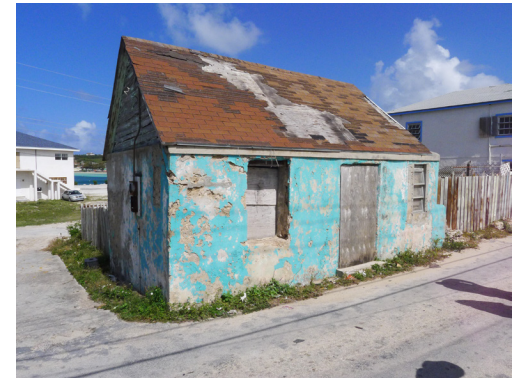
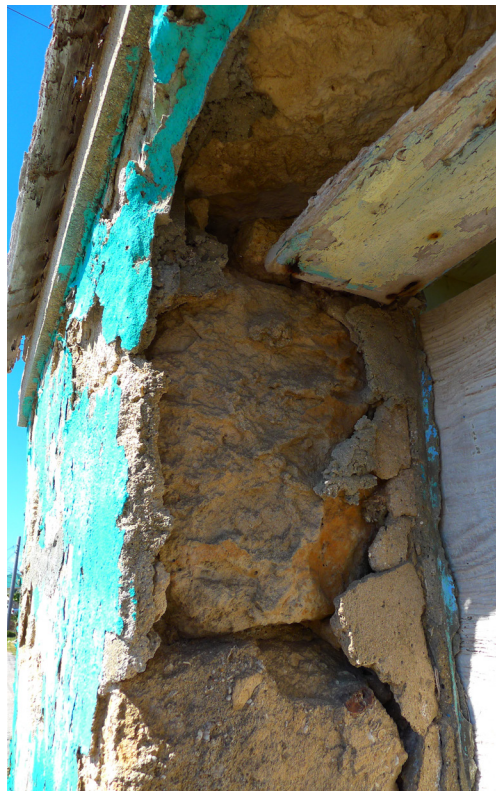
First Parliament

Site of the first Parliament of the Bahamas. Figures 109 to 113 (from top left clockwise): street view; west facade; south facade; south facade showing adjacent fence; detail of window frame on the south facade showing mortared cut stone construction.

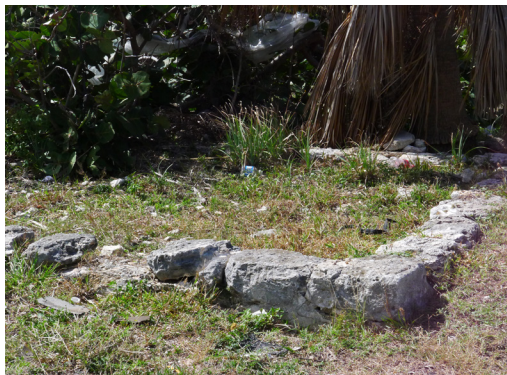
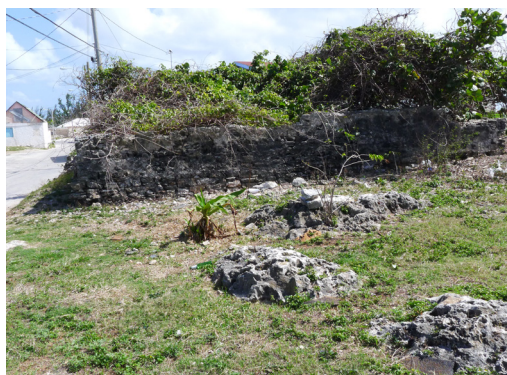
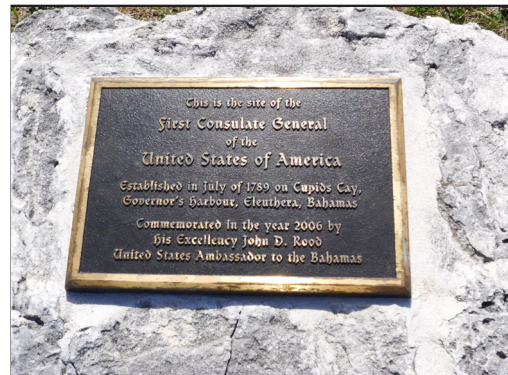
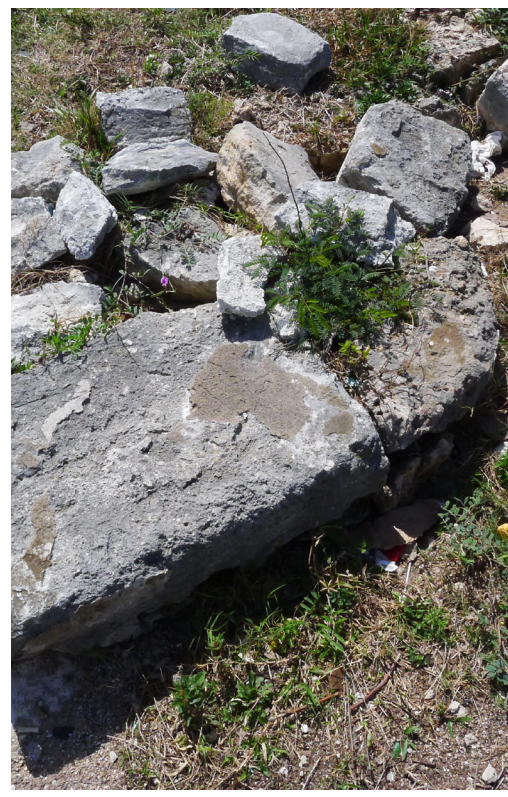
First American Embassy Site

Site of the first Consulate General of the United States, established in July, 1789. Figures 114 to 118 (from top left clockwise): foundation remnants on the site; terracing remaining for the site of the Governor's house; commemorative plaque for the site of the first US Consulate; street view of the area; remnants of cut stone stairs.

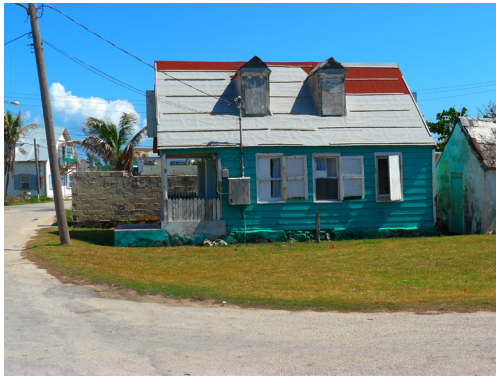
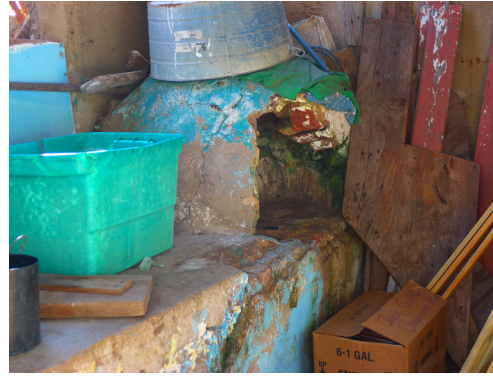
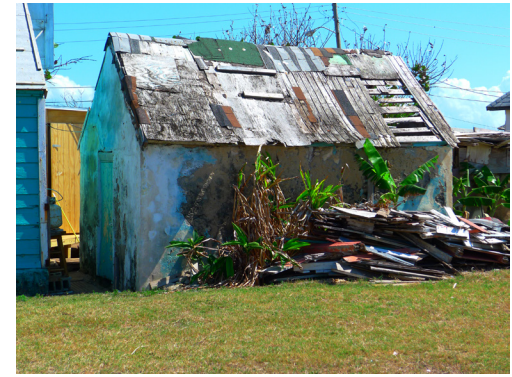
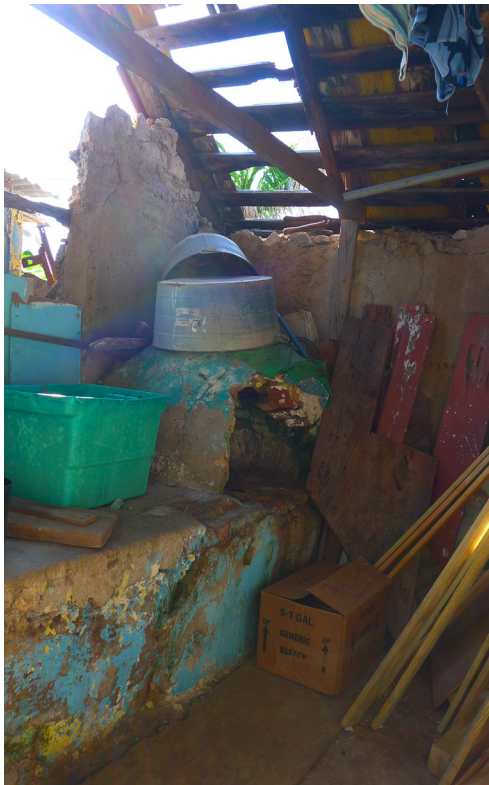
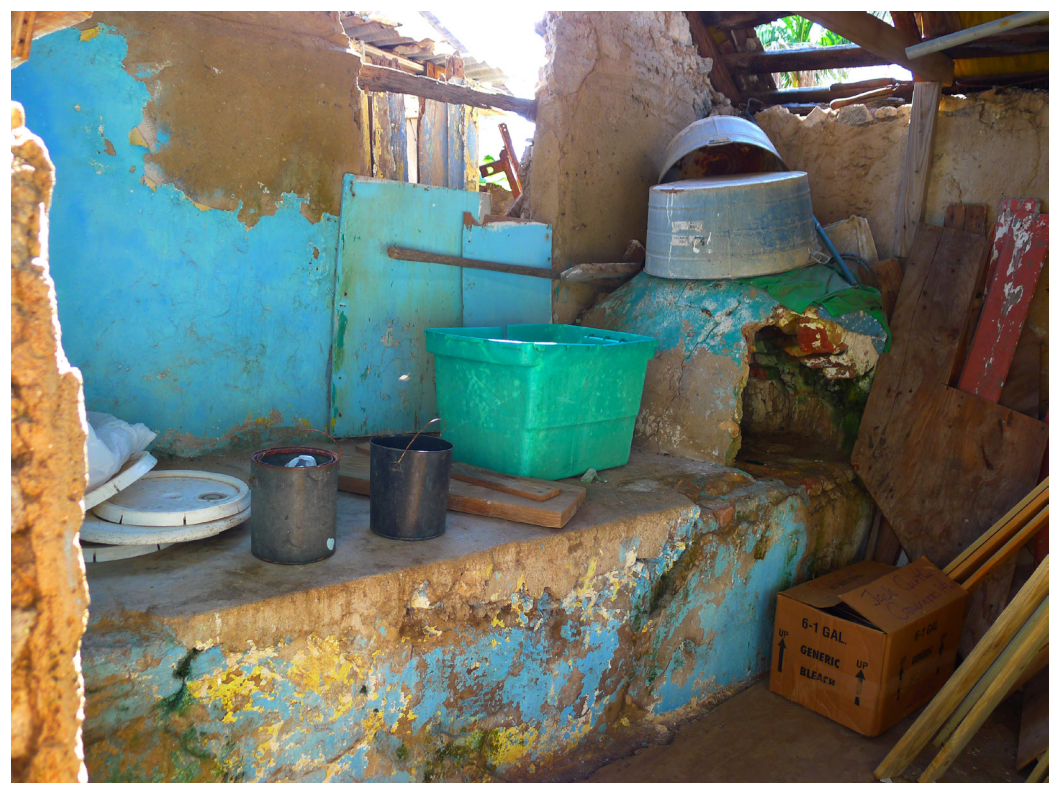
Old Brick Oven and Kitchen

Site of an old brick oven and kitchen in an accessory building. Figures 119 to 123 (top left clockwise): private home associated with the kitchen; close-up of brick oven; accessory kitchen building; view of brick oven and work area; condition of roof and walls of the kitchen.

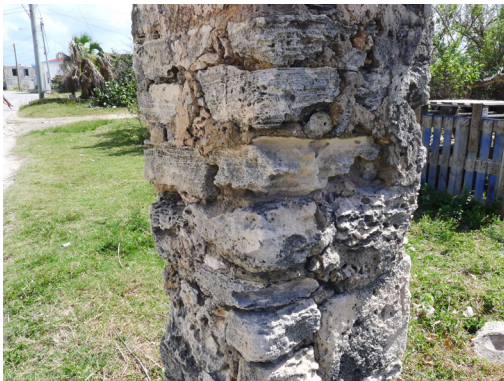
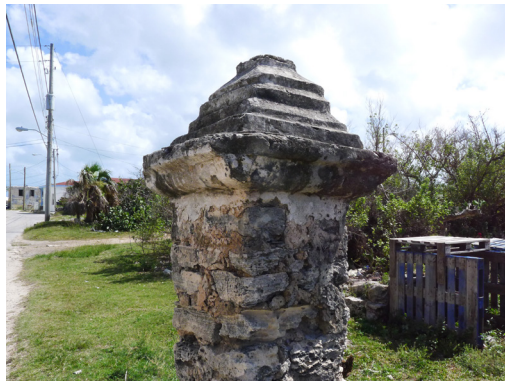
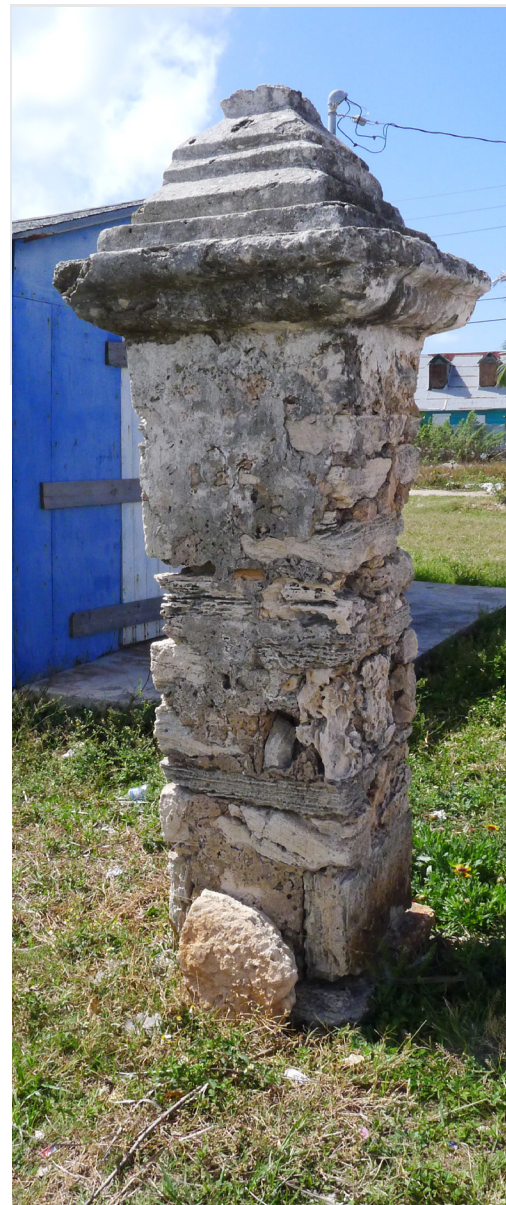
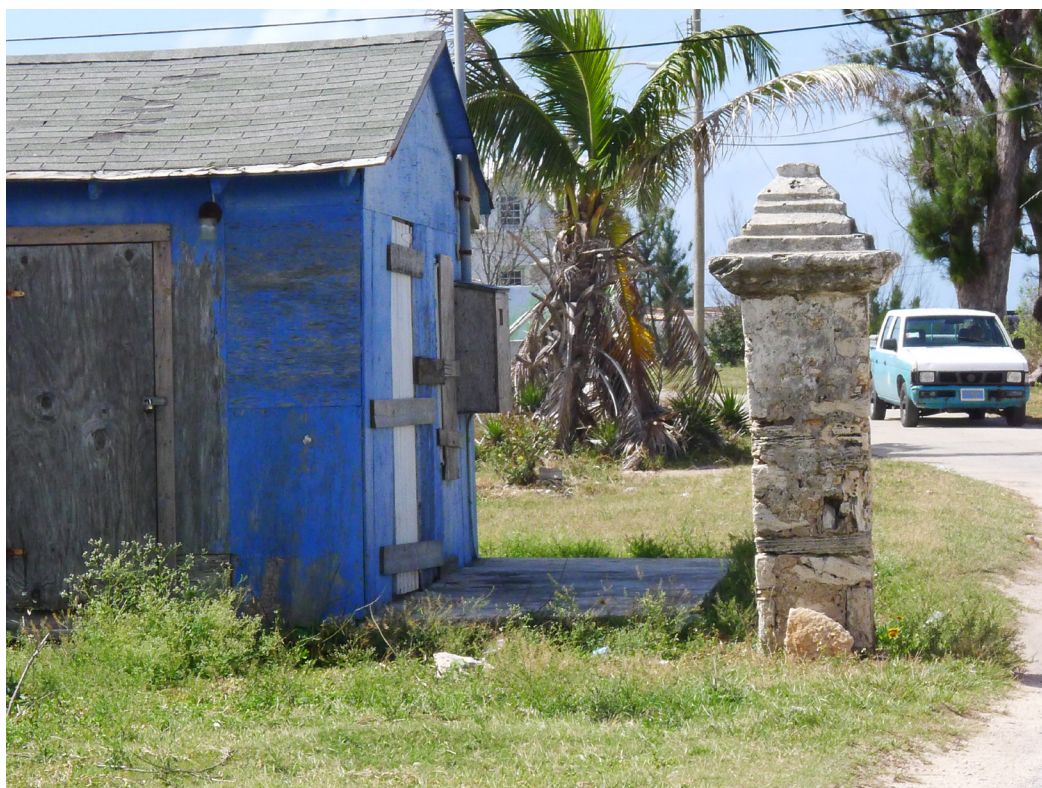
Pillar

Figures 124 to 127 (from top left clockwise): views of the extant decorative pillar at the western edge of the Consulate/First Parliament sites, closeup; decorative pediment detail; full view of the pillar constructed of cut stone and concrete; location view of the pillar next to the Old Bakery.
