Standing Structures Report

Cupid's Cay

Governor's Harbor
Eleuthera, Bahamas

UMASS AMHERST CENTER FOR
HERITAGE & SOCIETY

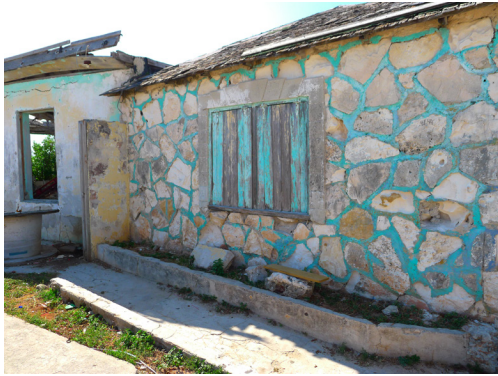
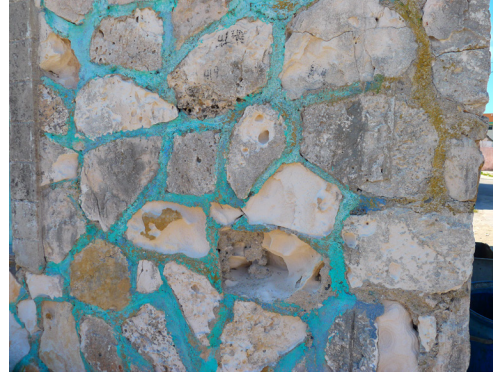
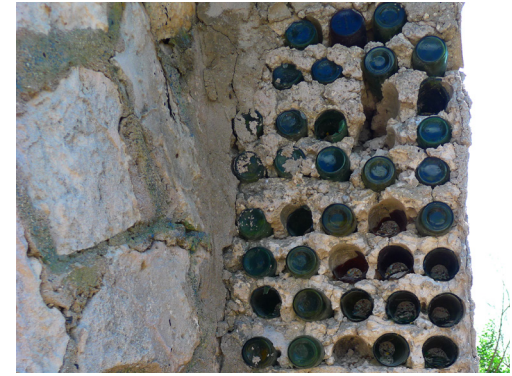
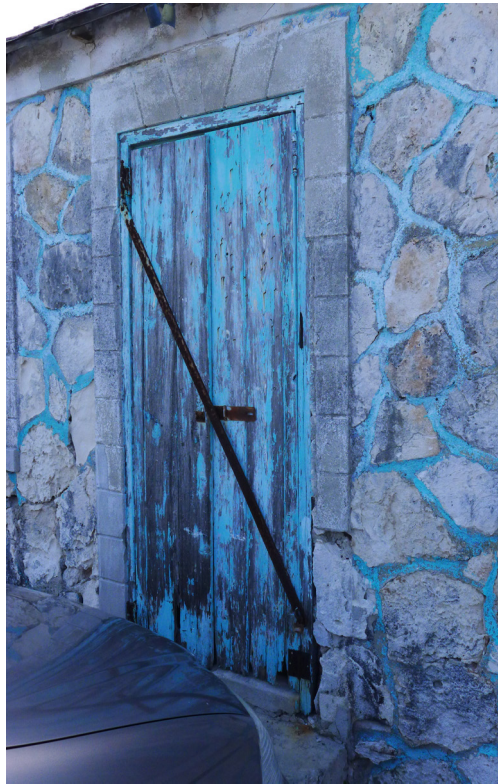
Dance Hall

Figures 128 to 132 (from top left clockwise): side facade of the dance hall; close-up of mortared stone construction; construction using bottles in mortar; front and west facade; front door with wrought iron strap.

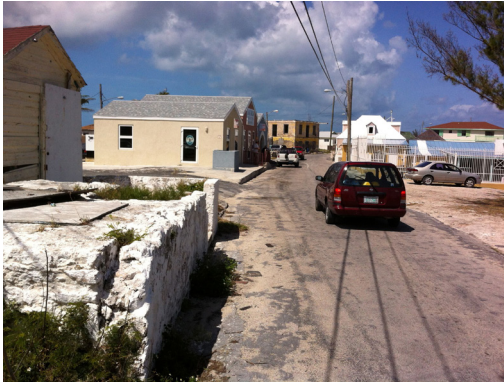
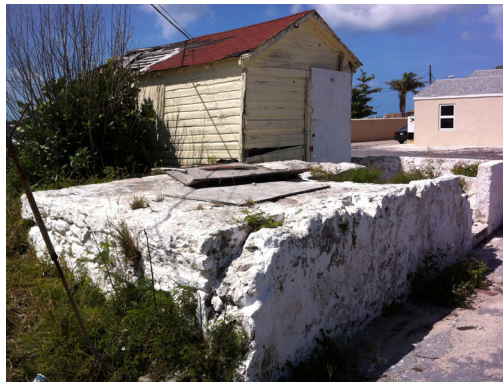
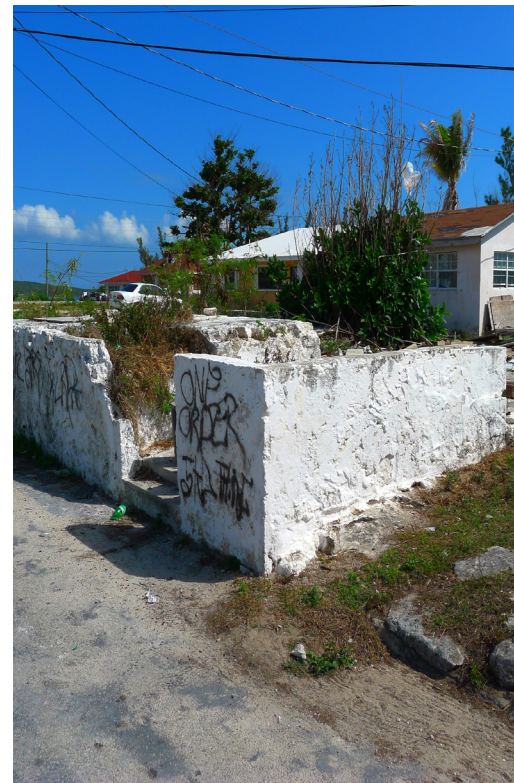
Old Bakery Site

Figure 133 to 137 (from bottom left clockwise): Site of the old bakery in March 2012 showing partially dismantled structure; location and street view; foundation of the old bakery; the site in March 2013, with loss of the remaining building on the site.

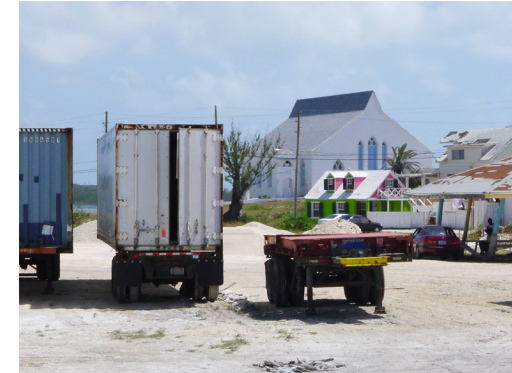
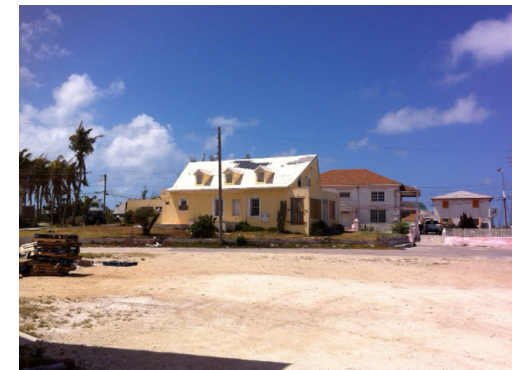
Figure 139 and 140: Views of the industrial character of the harborfront.

The area of the Cay that fronts on the inner harbor is the most in need of attention in order to make it more visually inviting. Used as a parking lot for large trucks, and as a staging area for shipping, the area has an industrial character. Although the use is compatible with the shipping function of the harbor, greater attention could be paid to the visual impacts the shipping functions have on this area, and attempts made to minimize

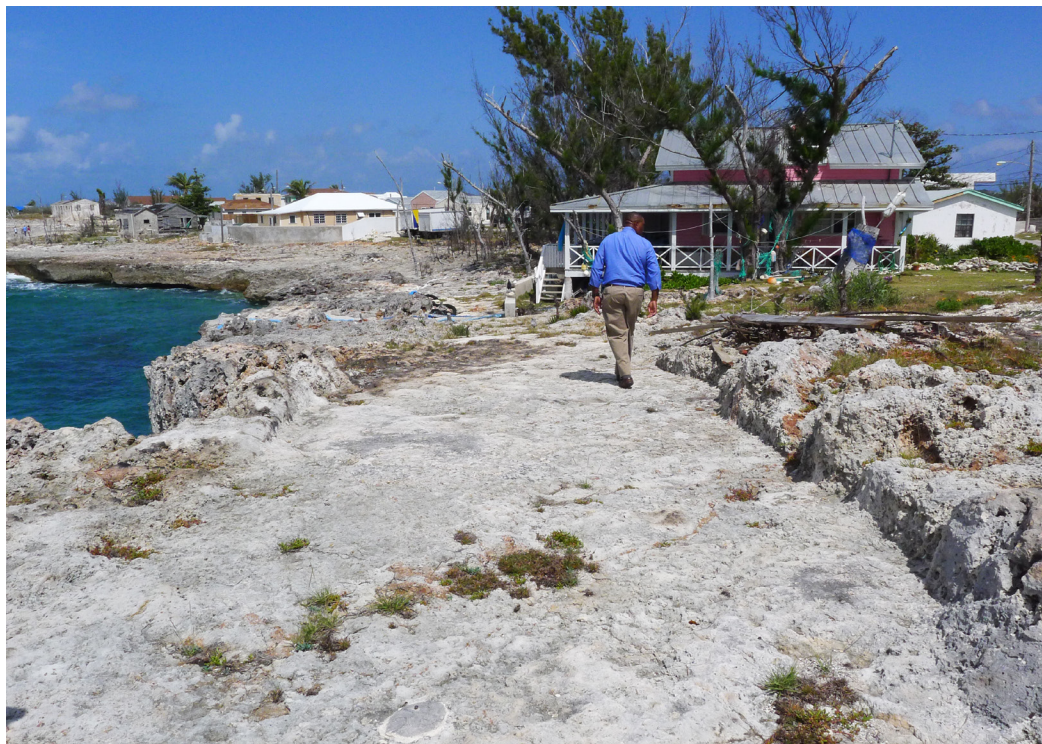
Figure 142: A view of the character of the southern shoreline.

Finally, the area along the southern shoreline is different from the other two zones of visual character of the Cay. Characteristically wind swept, the area is composed of exposed bedrock, with little soil covering. The historic colonial road provides an interesting visual quality to this area, with a reminder of the conflict between human and natural forces.

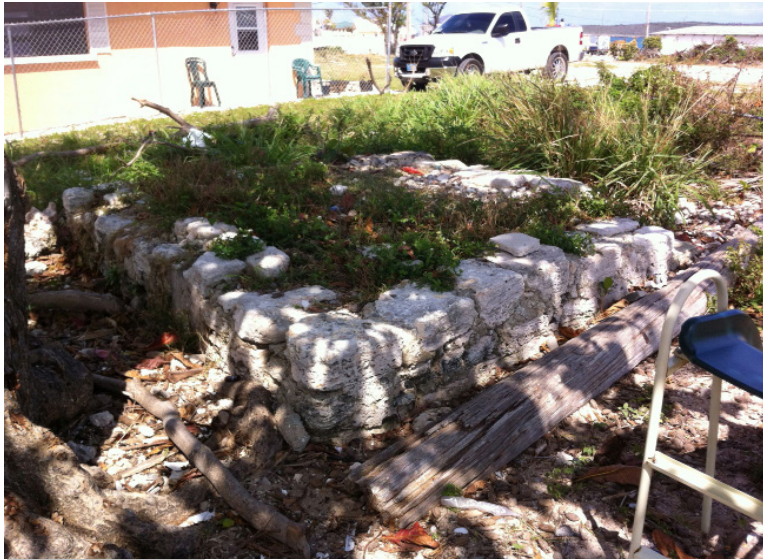
69

Although the aerial shows a structure in 2003, there are no remnants in 2013.

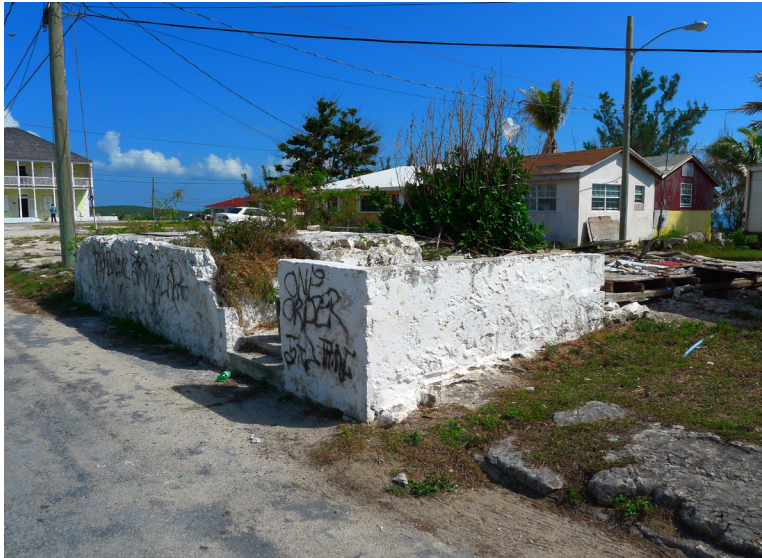
73

Old Bakery - March 2012

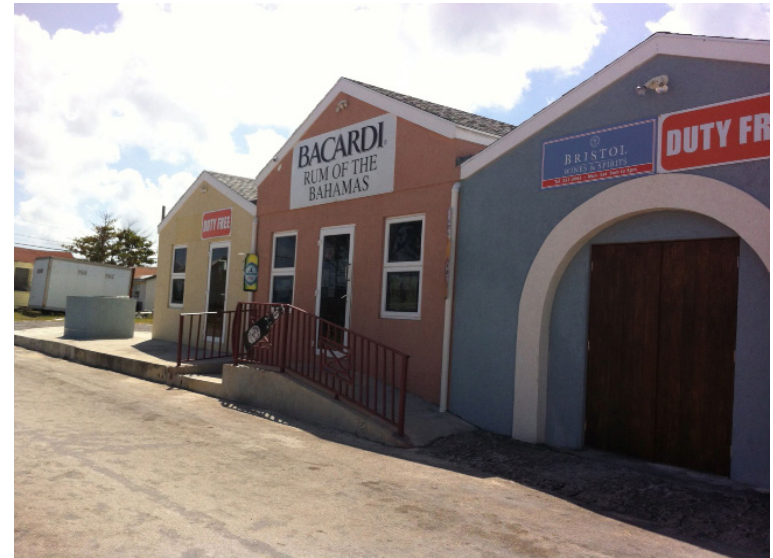
Old Bakery - March 2013
