Mémoire du
Diplôme de Spécialisation et d'Approfondissement — Architecture de Terre et Patrimoine,
DSA-Terre 2016 - 2018

**Comparaison de l'architecture vernaculaire en terre
de Goa (ancienne colonie portugaise en Inde) et de l'Alentejo (Portugal):
Cultures constructives locales et approches de conservation**

**Comparison of the vernacular earthen architecture in
Goa (past Portuguese colony in India) and Alentejo (Portugal):
Local building cultures and conservation approaches**

RODRIGUES Chenelle Fatima

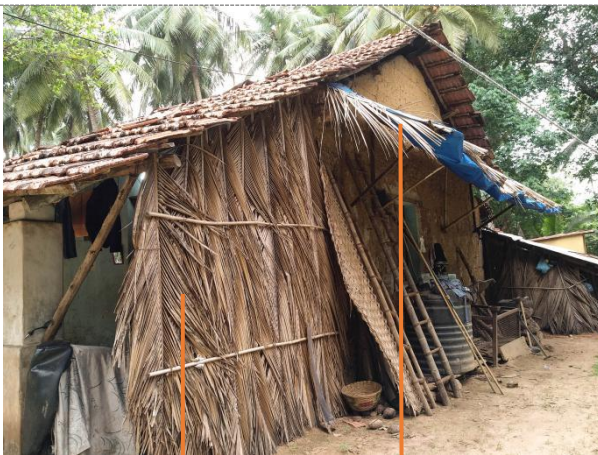
Palm-leaf barrier along walls ('dollois').

Palm-leaf overhang ('pakadi').

Maintenance and repairs: Woven coconut-palms ('molla'), palm-leaf barriers ('dollois'), and overhangs ('pakadi') are used to protect walls from rainwater.

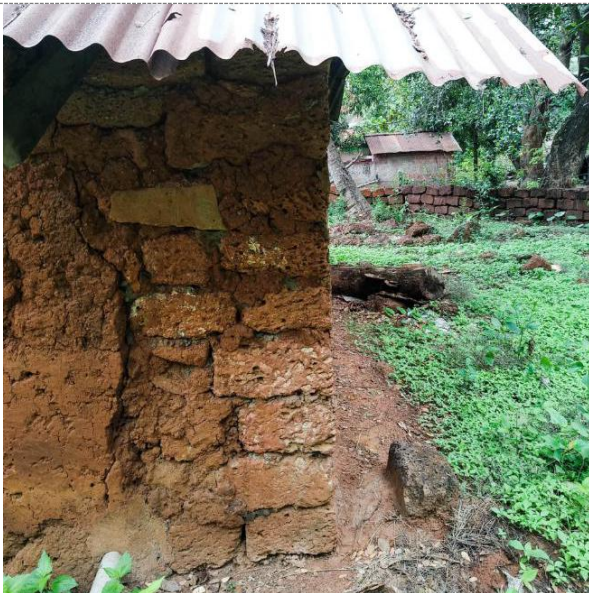
Observations: The laterite masonry in the corners has earthen or cement mortars. It is hard to say whether these corners are part of the original construction or a later addition.

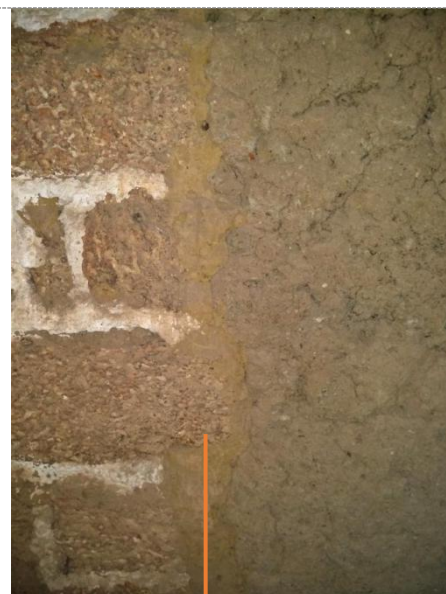
'menki matti' (a type of earth).

Maintenance and repairs: Crack filled-up with 'menki matti'.

Repairs: Some years ago, cracks on the west wall were filled-up with 'menki matti' (a type of earth). Just before 2004, some other cracks were covered with cement.

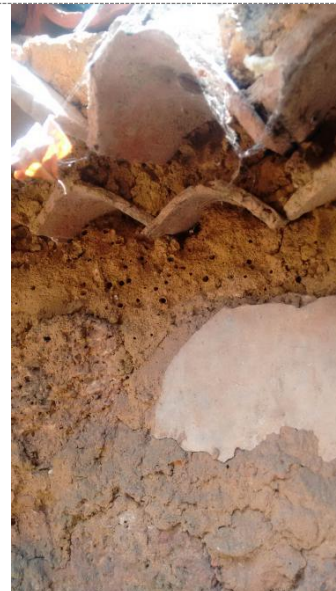
Damages incurred / problems faced: Mason-bee holes on the repaired part.

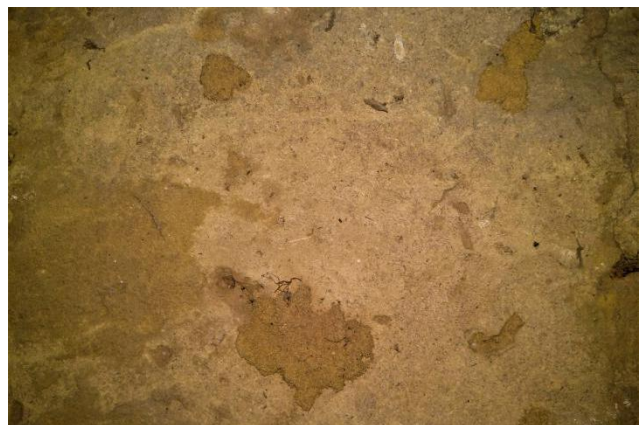
Damages incurred / problems faced: Insects have built earthen-nests on interior walls.

Periodic interventions: The roof is repaired every two years, earthen-nests built by insects are broken manually, fresh layer of cow-dung is applied every 2-3 months.

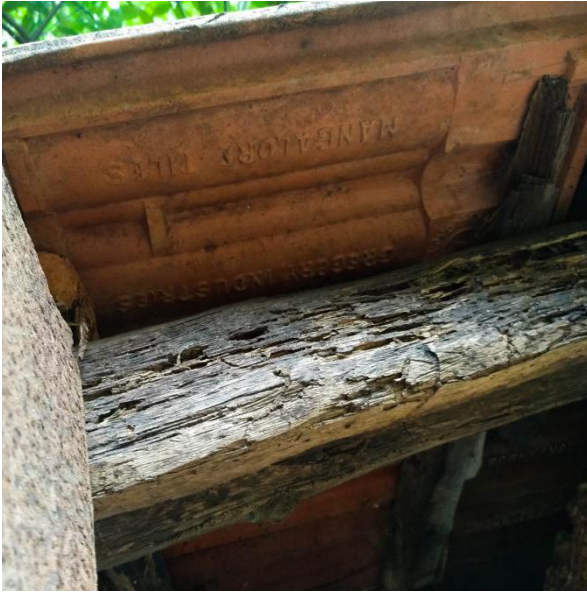
Damages incurred / problems faced: Roof-frame is rotting.

Observations: Roof-frame is rotting and failing. Structural and non-structural cracks on walls, north wall seems to be tilting towards the inside, wall-bases eroded, mason-bee holes, insects have built earthen-nests on wall.

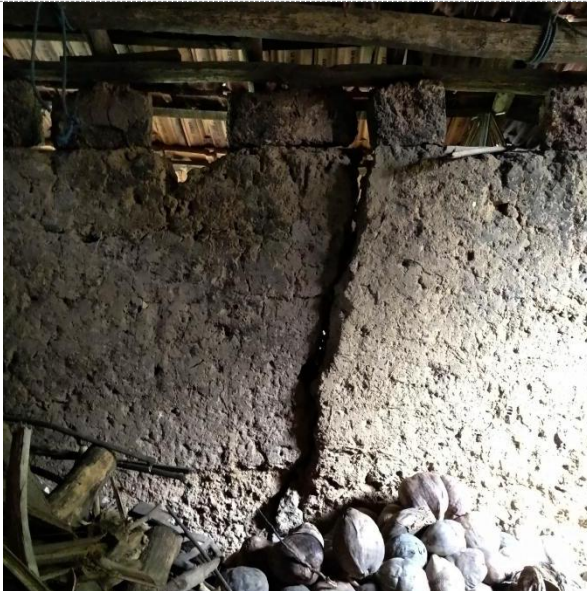
Damages incurred / problems faced: Structural cracks.

Observations: Looks like attempts had been made to repair wall cracks with earth. Temporary measures to salvage the structure include palm-leaf barriers built to protect walls, tree branches used to support the roof, metal-sheets cover damaged parts of roof.

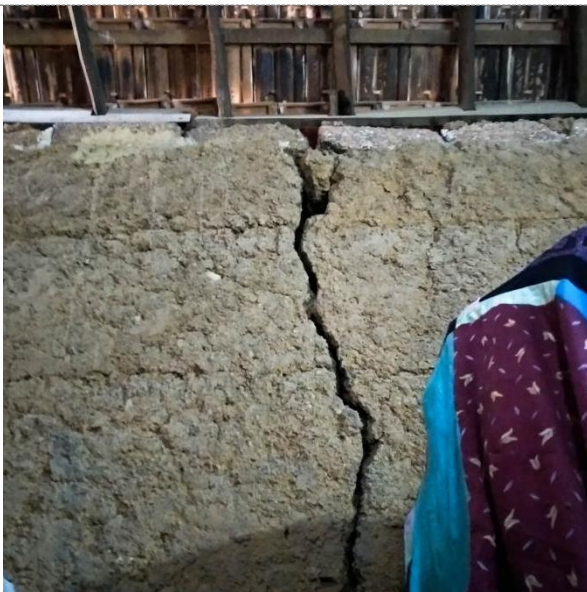
(North wall.)

Damages incurred / problems faced: Cracks.

Repairs: Cement used to repair cracks.

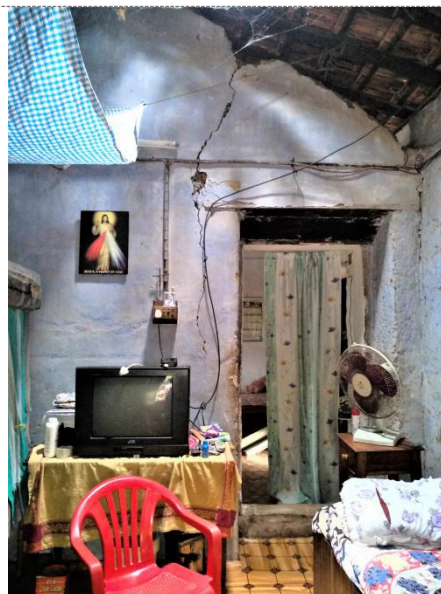
(Bedroom.)

Damages incurred / problems faced: Cement was used on one side of the wall, and the crack on the other side started getting longer (common wall that separates hall and bedroom).

4. About 3-4 years back, cement was used on a wall, and the crack on the other side of the same wall started getting longer (wall that separates hall and bedroom).

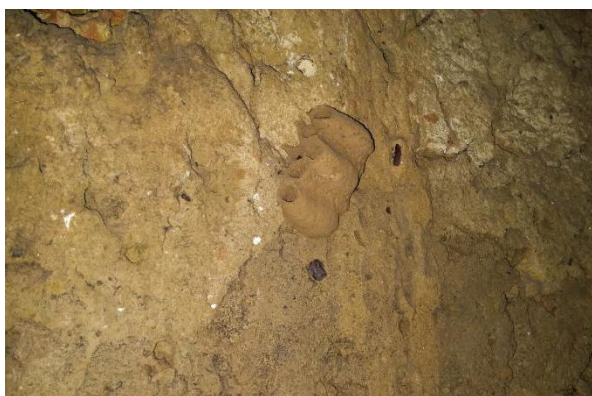
Damages incurred / problems faced: Honey-bees build earthen-nests on the wall surfaces, and store worms in them, especially during the monsoons.

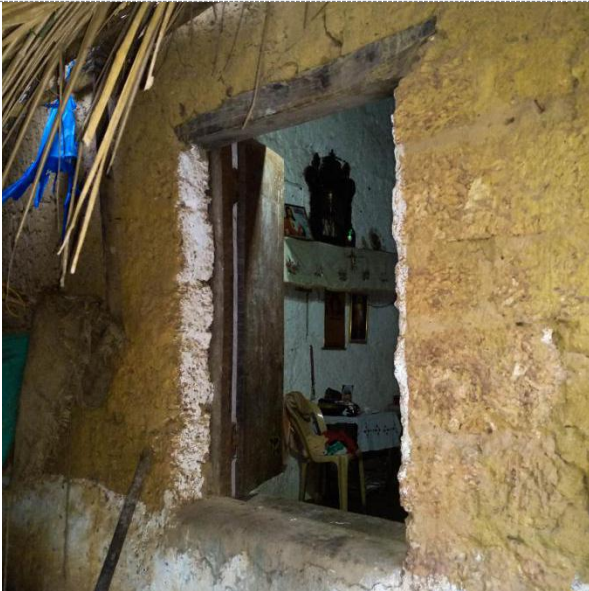
Plasters: Thin coat of lime on earthen walls (interior), including window jambs.

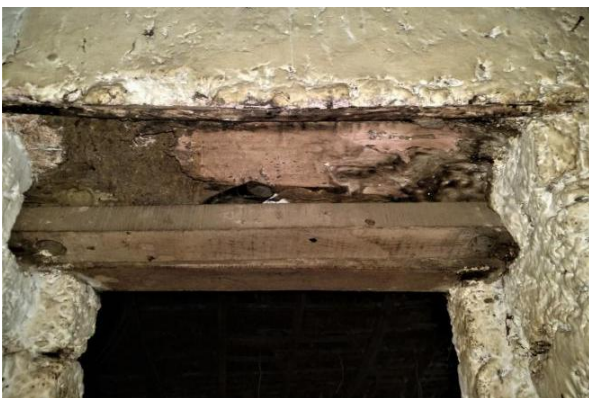
Damages incurred / problems faced: Rotting of lintels.

Observations: Signs of water run-off on walls, visible on south-east exterior corner. Cracks, especially in corners. Rotting of wooden lintels. Holes in cow-dung floors, and chipping of cow-dung and cement floors.

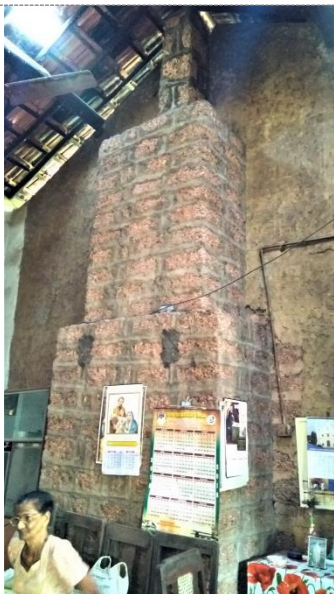
Maintenance and repairs: A laterite block was built to cover the major crack and window opening, and thereby stabilise the wall. The block turned out to be more voluminous than needed.

About 20 years ago, a storm led to many cracks on walls. One major crack around the window of the west wall destabilised the wall. Parrots make holes in the walls.

Repairs: The smaller cracks that appeared with the storm were repaired with 'menki mati' (type of mud), and the big ones were covered with cement. A laterite block was built to cover the major crack as well as the window opening on the west wall, and thereby stabilise it. The block turned out to be more voluminous than needed; it was a mason who went ahead with it and charged INR 15,000/-.

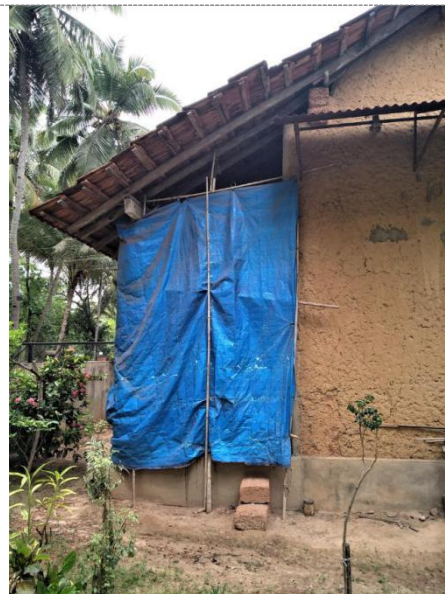
Observations: Metal overhangs and tarpaulins protect walls from rainwater.

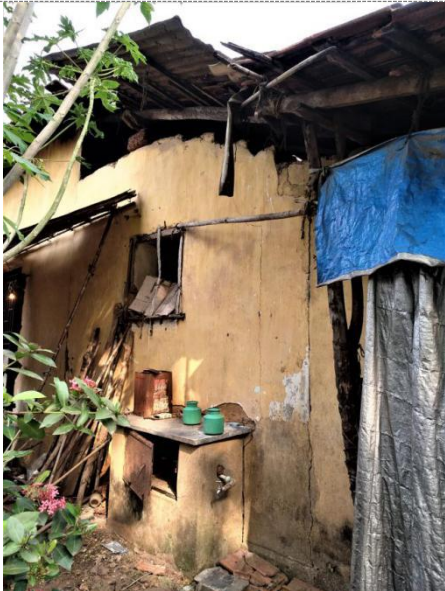
North facade, adobe-brick extension. Observations: Stepped decline on the wall top. Damages: Cracks demarcating the original, earthen-walls and the new, laterite-walls.

Observations: Cracks demarcating the original, earthen-walls and the new, laterite-stone walls. Flaking and falling plasters. Walls have blackened due to the smoke from the oven.

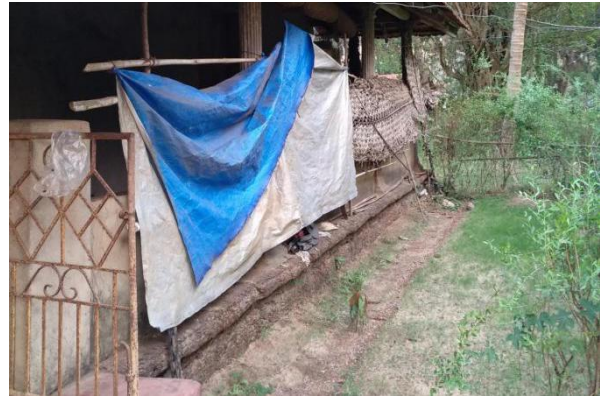
Distinct architectural details: Decorative laterite masonry base-course on front facade.
Maintenance and repairs: Tarpaulins, coconut palms and woven coconut-palms protect the veranda from rainwater.

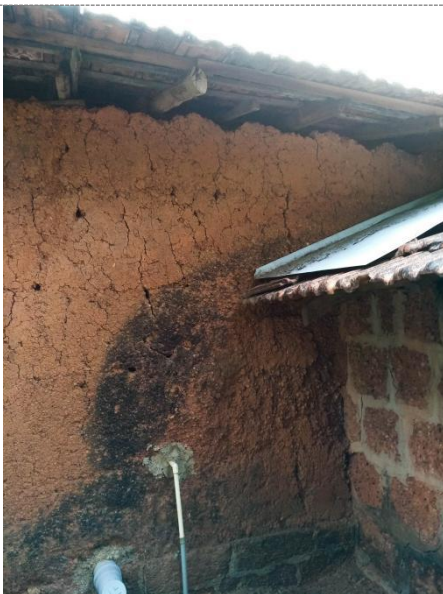
Damages incurred / problems faced: Black dampness blotch on rear wall.

Observations: Some roof-tiles missing along overhangs, evidence of termite attack on rafters, small holes in walls, black dampness blotch on rear wall.

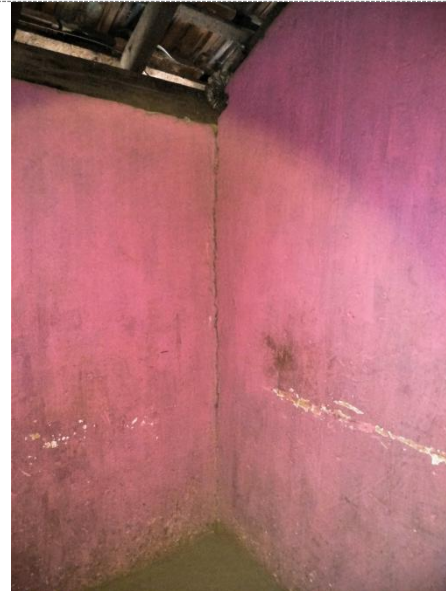
Damages incurred / problems faced: A crack appeared just after the construction was complete.

A crack appeared just after the construction was complete.

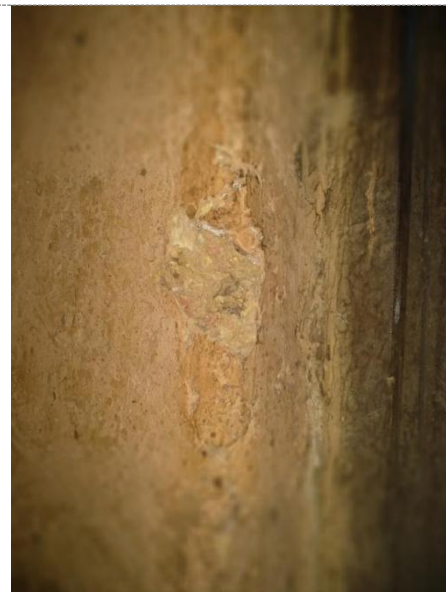
Damages incurred / problems faced: Chipping of wall edges.

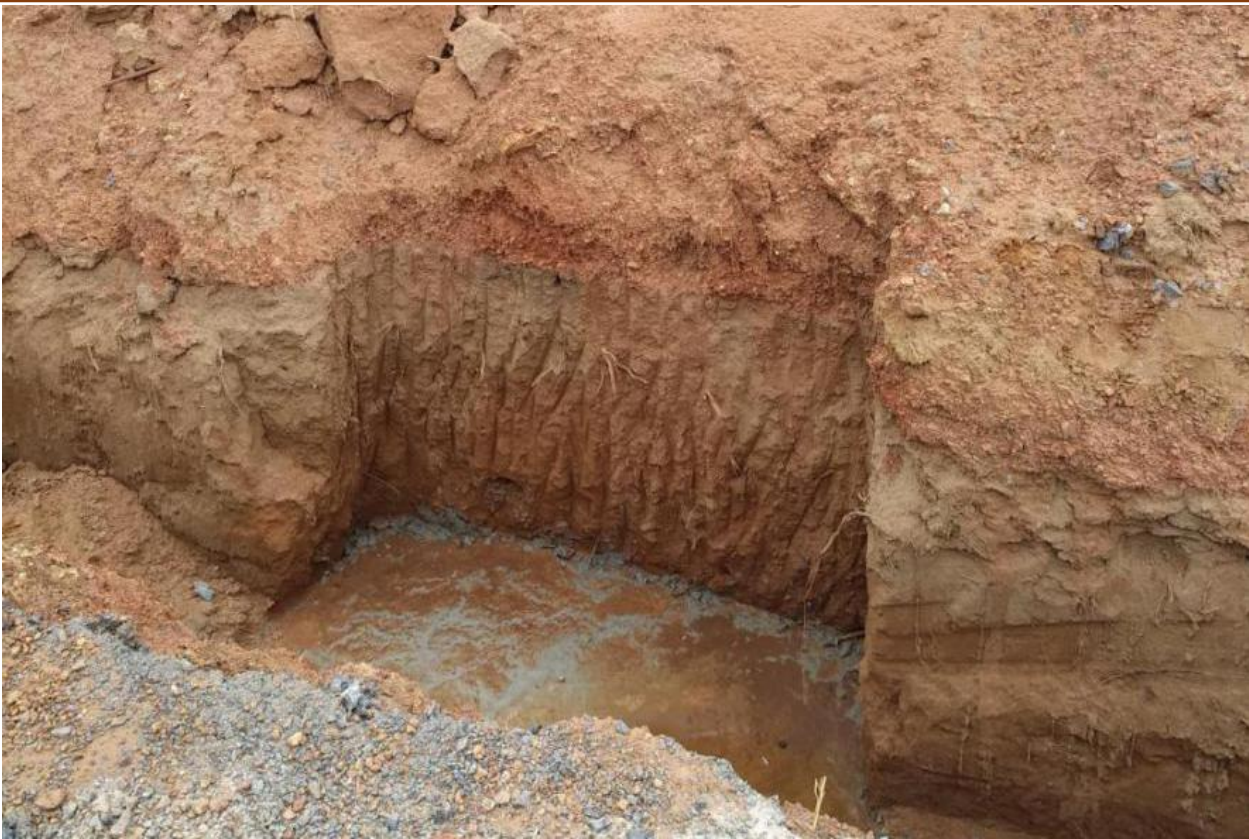
Image 69: Generally, top soil tends to be more sandy with more rubble.

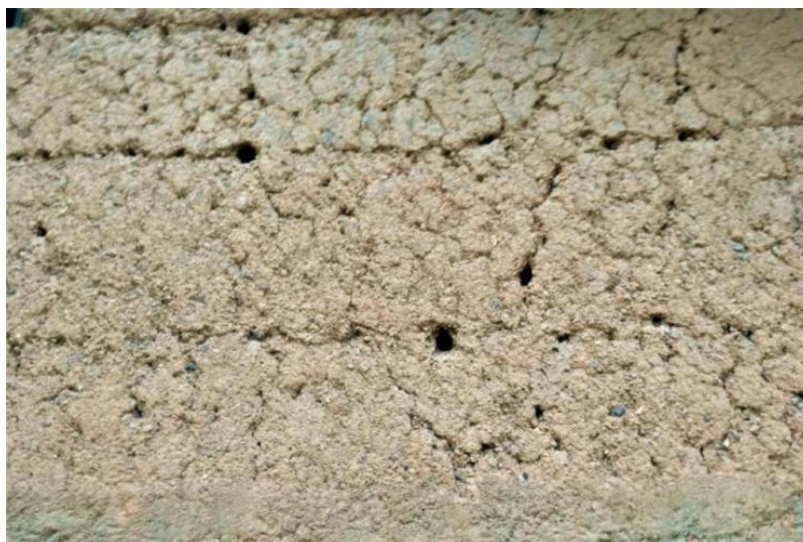
In Survey no. 11, there were holes along the horizontal 'lift' joints, which perhaps indicates the use of form-work in cob construction.

Image 70: Holes along the horizontal 'lift' joints, which perhaps indicates the use of form-work in cob construction (Survey no. 11).

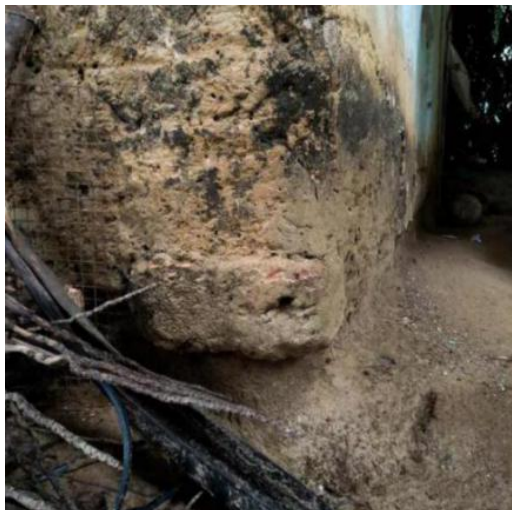
Image 71: Corners; a laterite-stone sits above the earthen base-course (Survey no. 1).

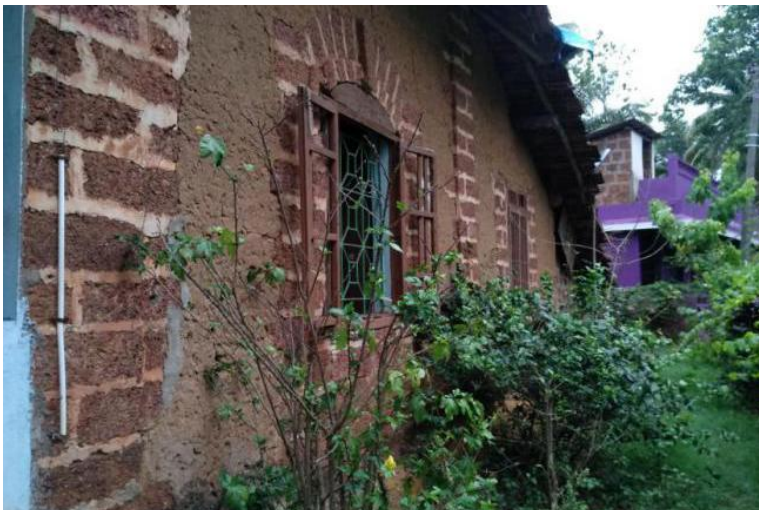
Image 72: Corners; laterite-and-earth masonry (Survey no. 3a).

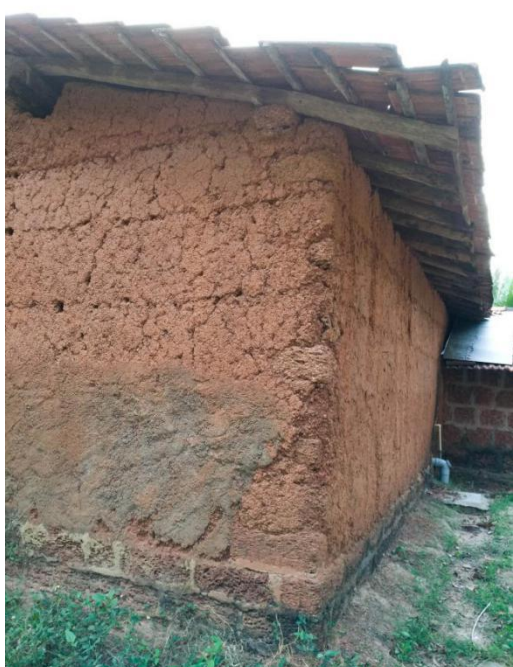
Image 73: Corners; earth with laterite-stones at intervals (Survey no. 11).

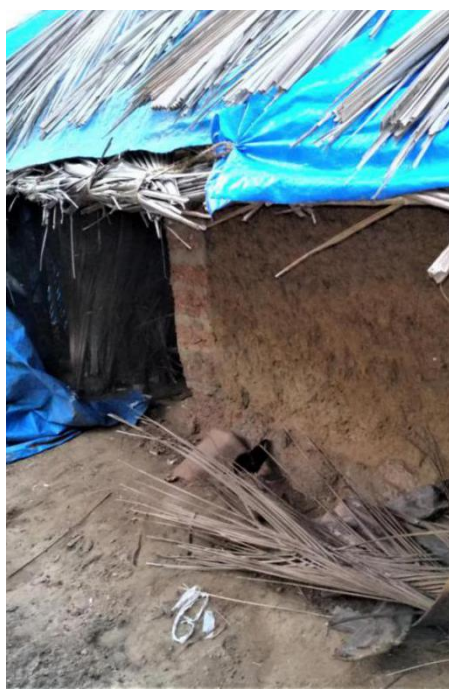
Image 74: Corners; laterite-and-cement pillars; not original to the structure (Survey no. 4).

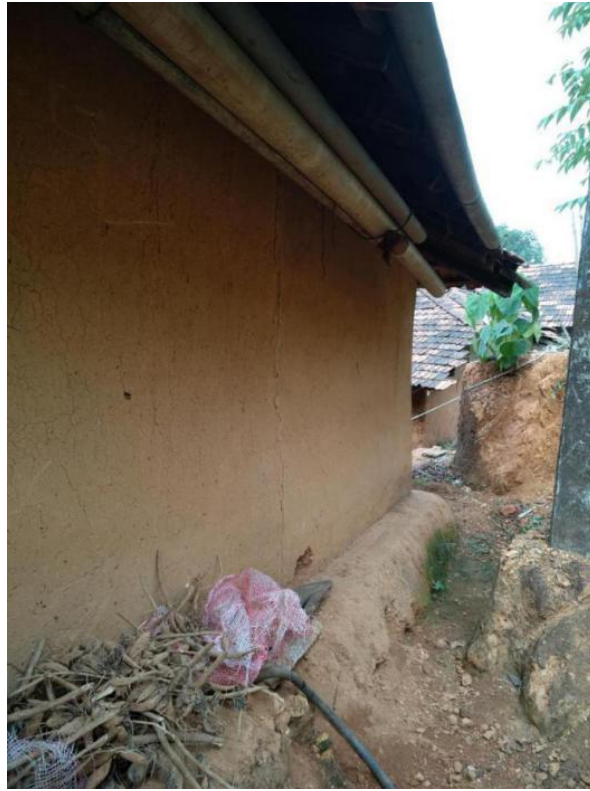
Image 75: Rammed-earth 'lifts' could not be determined as the walls displayed an uniform texture. The walls were beaten with a wooden baton during construction to compact them and realise a neat finish (Survey no. 13).

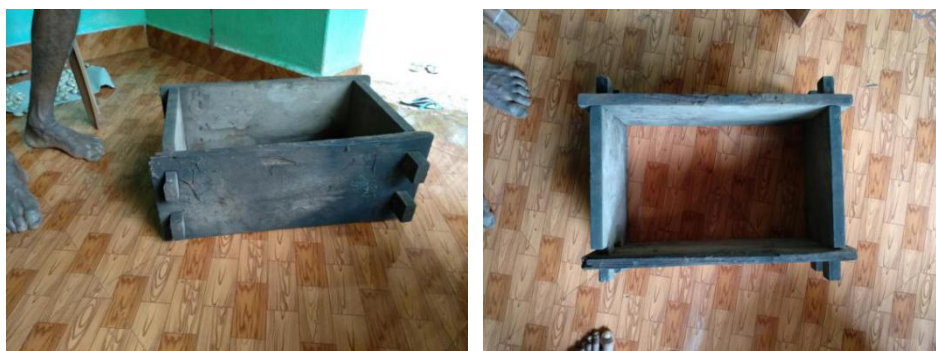
Image 77 and Image 78: Mason Babuso's adobe-brick mould.

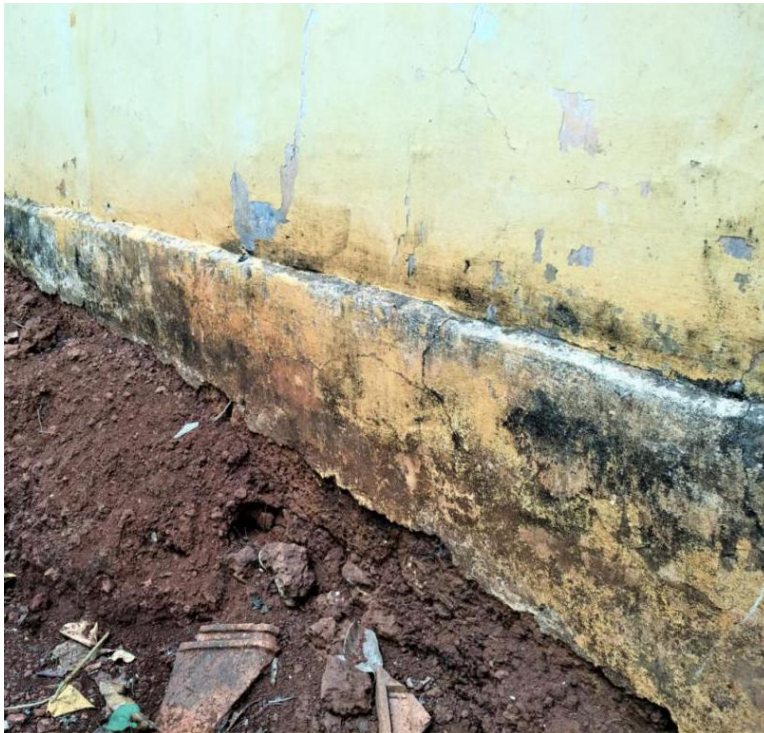
Image 79: Evidence of laterite masonry base-course (Survey no. 14).

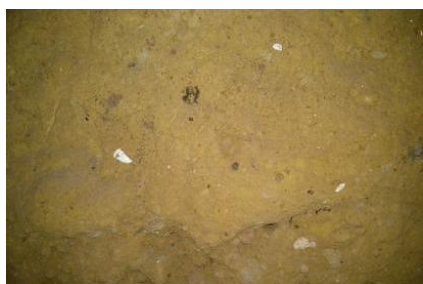
Image 80: Yellowish soil; includes clay, sand, and rubble (Survey no. 4).

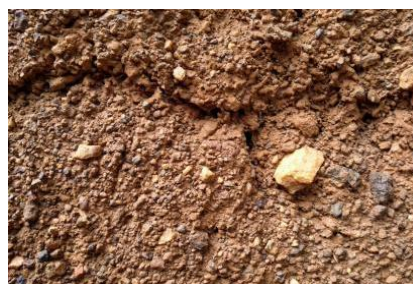
Image 81: Red, lateritic soil with lots of rubble (Survey no. 6).

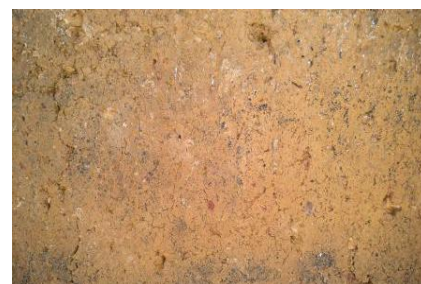
Image 82: Yellow-brown-red soil, more clayey than sandy (Survey no. 13).

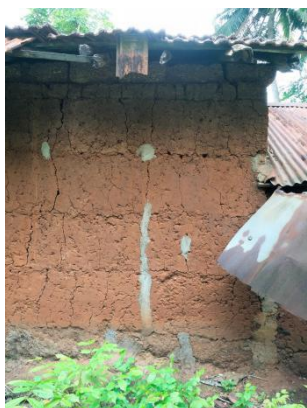
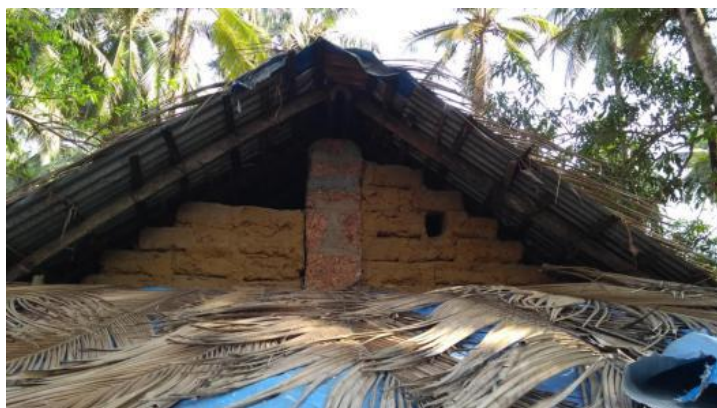
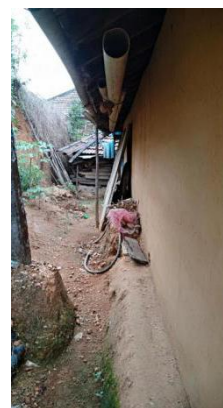
Image 83: Cob (Survey no. 2). Image 84: Adobe-bricks (Survey no. 4). Image 85: Rammed-earth (Survey no. 13).

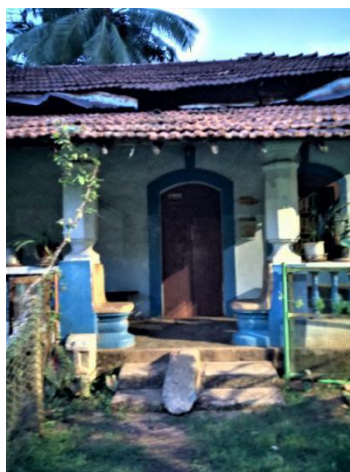
Image 86: Almost all the structures visited for this study had verandas, porches and/or 'sopos'. Some verandas had inbuilt masonry seats. (Survey no. 3a).

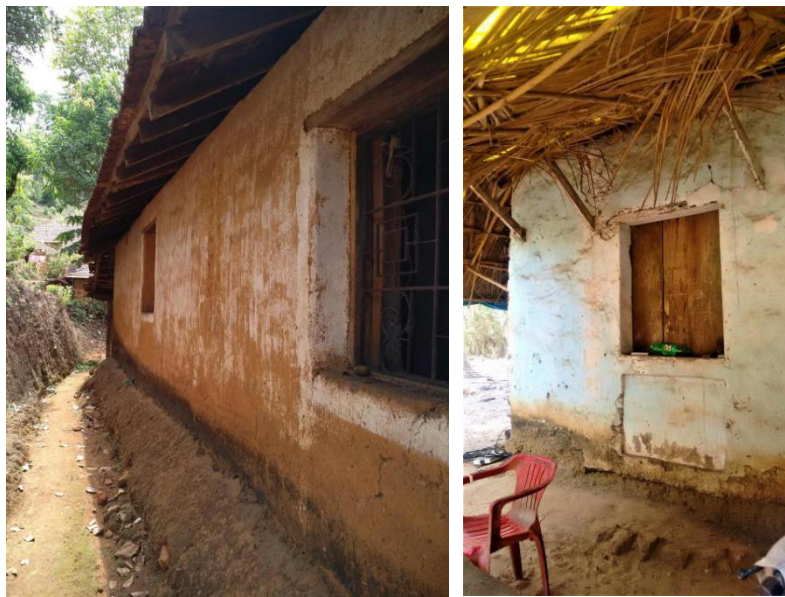
Image 87: A small, earthen gradient covered the foot of external walls (Survey no. 12).

Image 88: Sometimes, laterite-stones fringe the gradient (Survey no. 1).

The earthen gradient acts as a barrier, and aids keeping rainwater from seeping into the wall. As spelled-out by Romeo (Survey no. 2), if rainwater accumulated around the house and rose by a few centimeters, the slope would prevent the water from entering the wall. However, if there is a flood, the slope would not help.

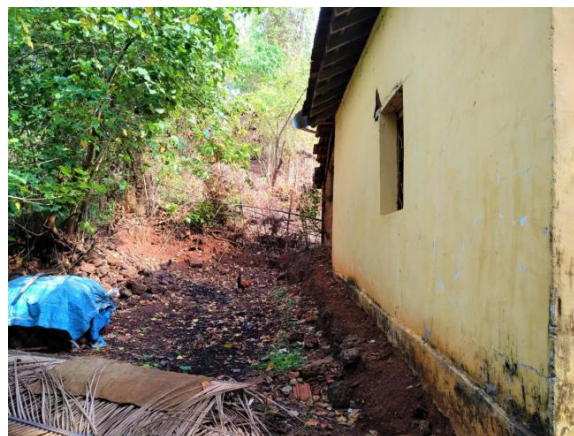
Image 89: Setback along the base-course (Survey no. 14).

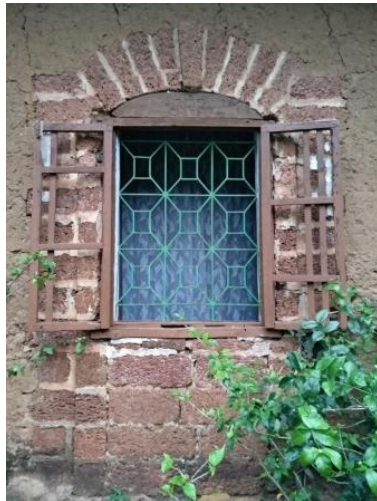
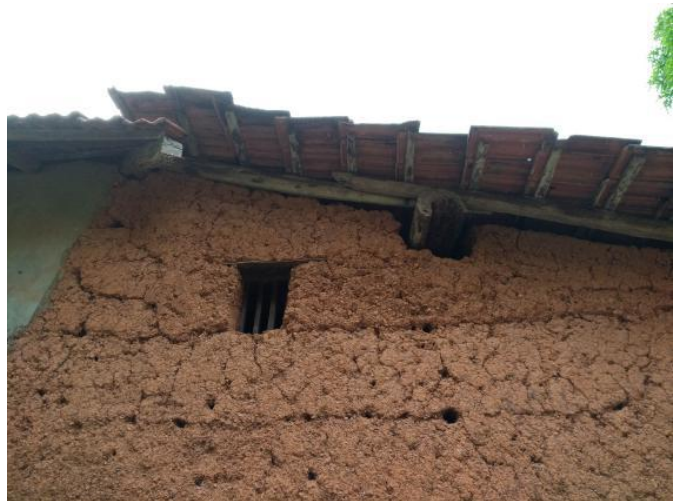
Image 90: Front facade window of the hall (Survey no. 3a). Image 91: Rear, service area window (Survey no. 11).

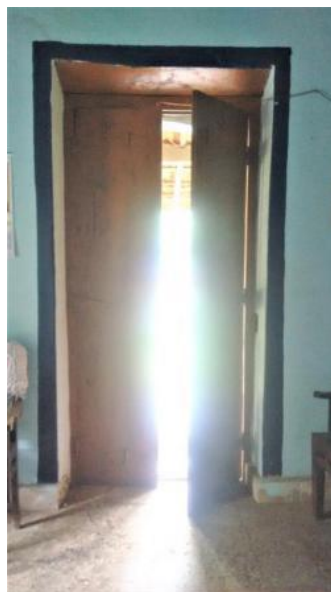
Image 92: Lintels of doors and windows were mostly slanted, and opened up to the interior of the house (Survey no. 3a).

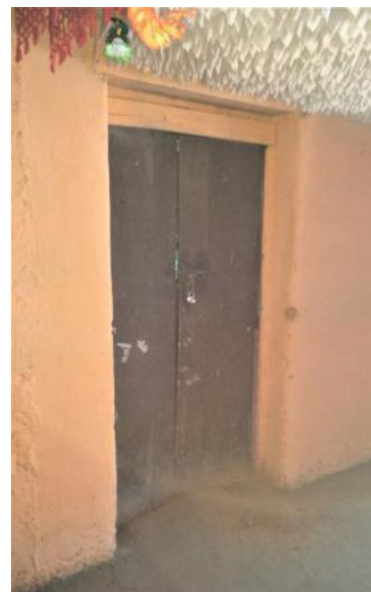
Image 93: In a few cases, the lintels were simply placed horizontally (Survey no. 12).

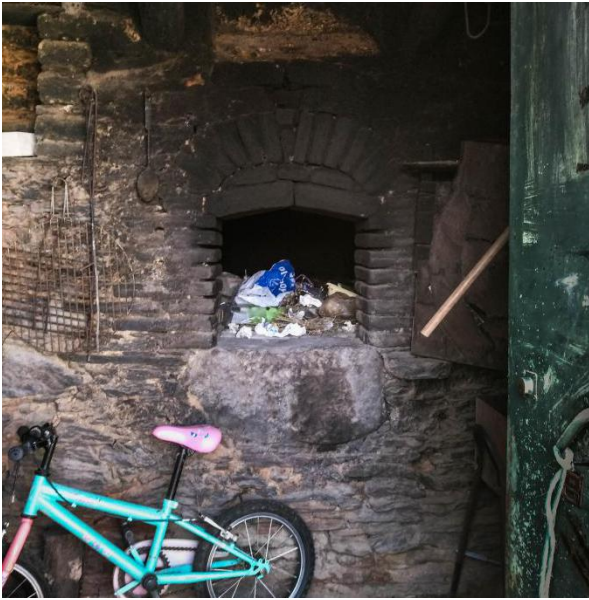
Oven inside the house.

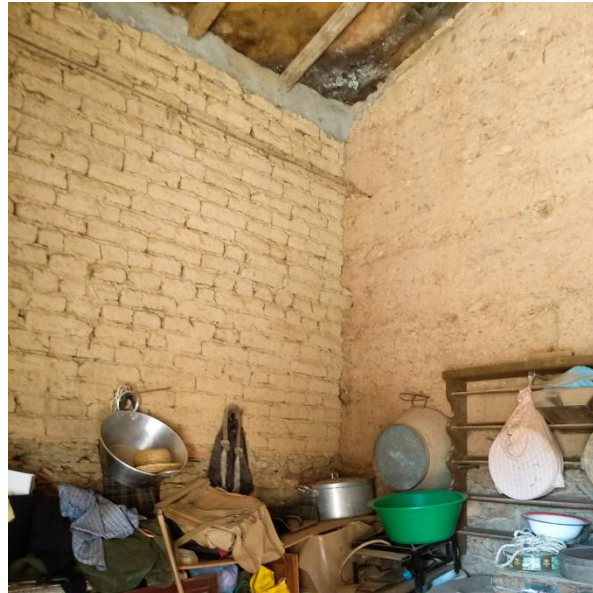
Distinct characteristics: Interior walls are in adobe-bricks.

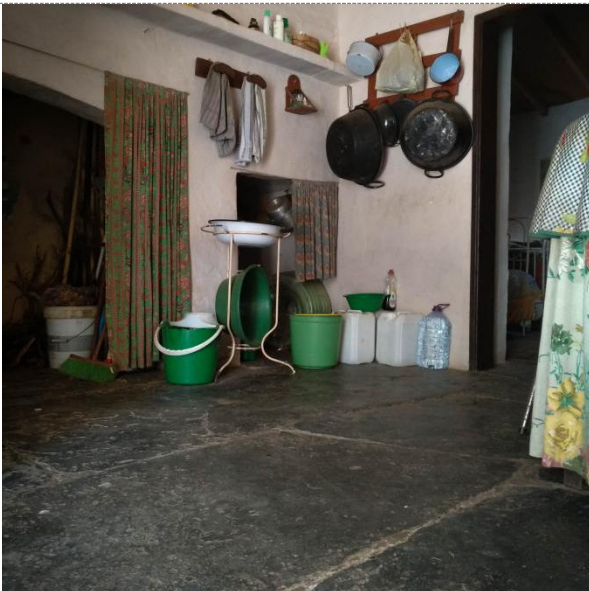
Flooring: Stones were commonly used as floor tiles in the kitchen because they are easy to clean.

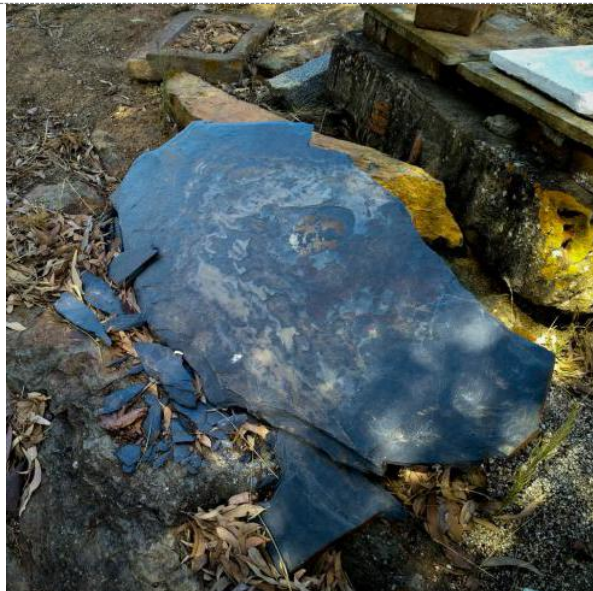
Flooring: Stones used for flooring is naturally found in the region.

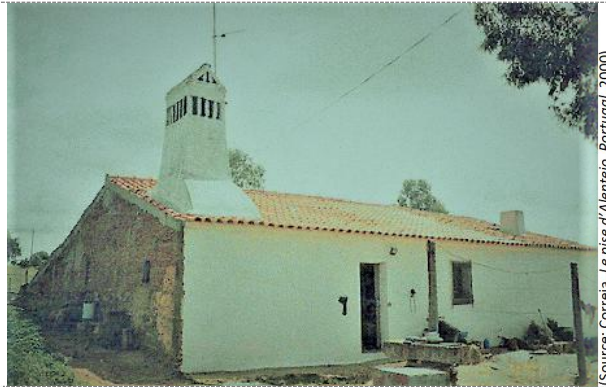
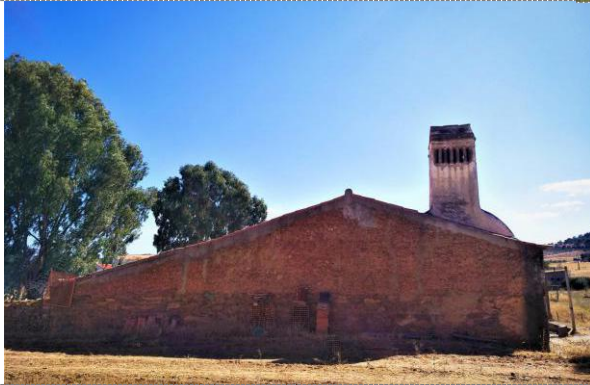
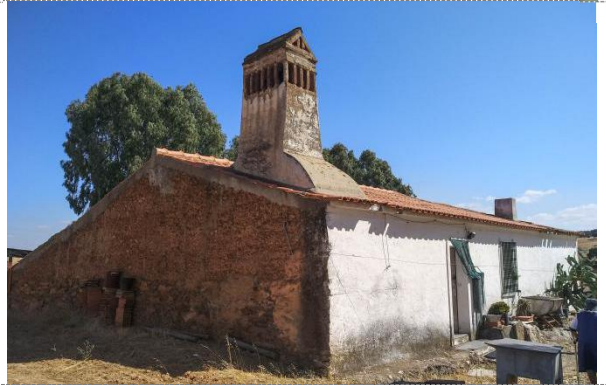
In 2000

The roof of the lean-to has fallen. The wooden part of the east wall is now covered with panels and shutters.

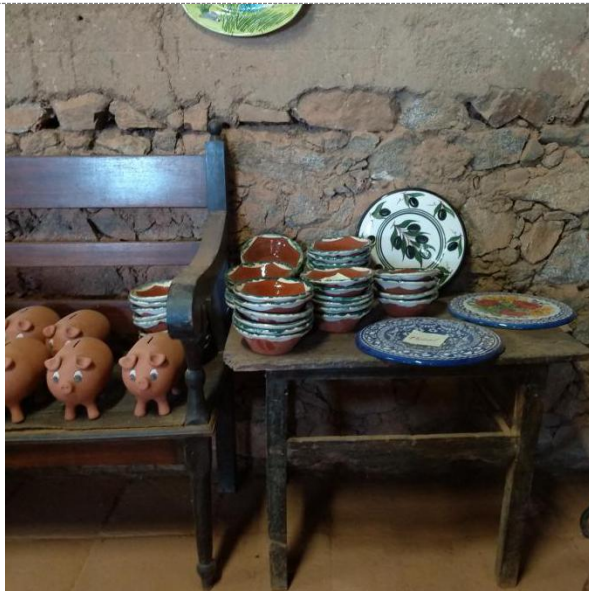
Base-course: Stone masonry.

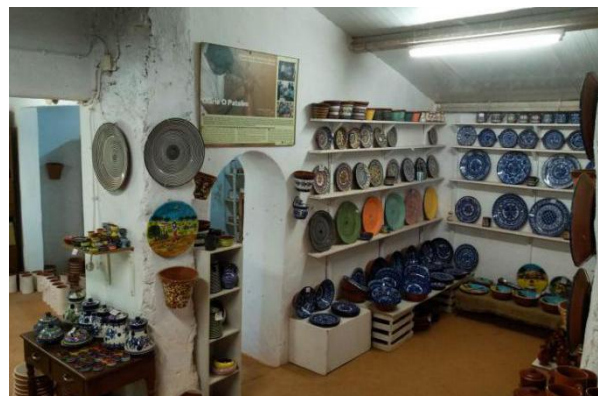
Restorations and/or interventions: The old workers' quarters is converted into an atelier.

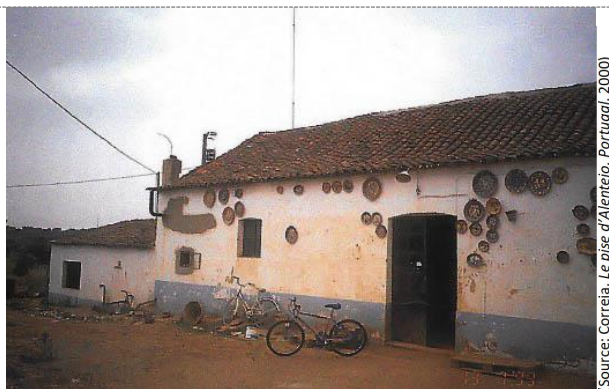
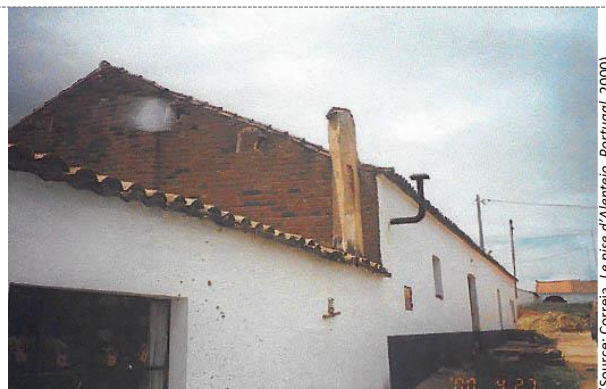
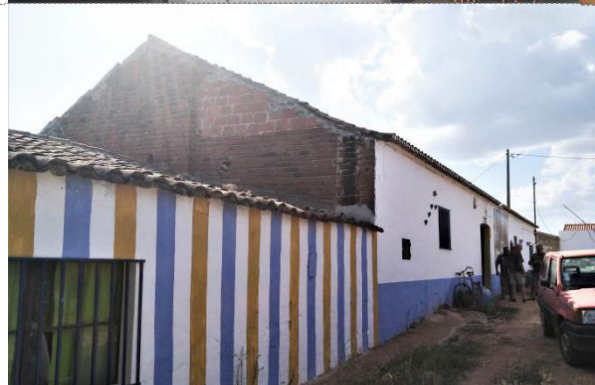
In 2000

Roof replaced, workers' quarters converted into an atelier, chimney torn-down and east gable wall partly reconstructed, facade walls repainted in white, blue and yellow.

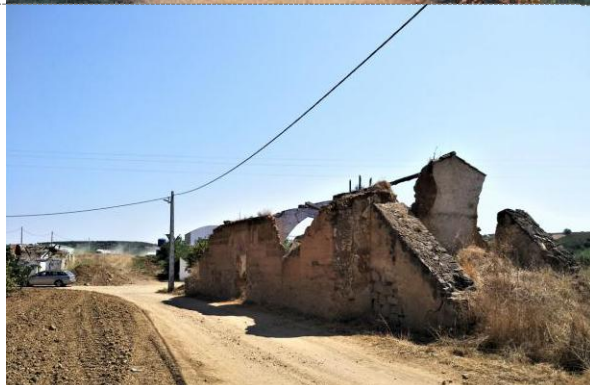
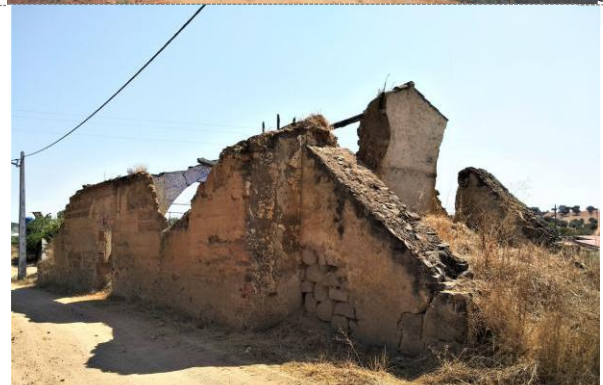
In 2018

Roof has collapsed; walls in ruins; blue daubs or design on interior plaster, especially on arches.

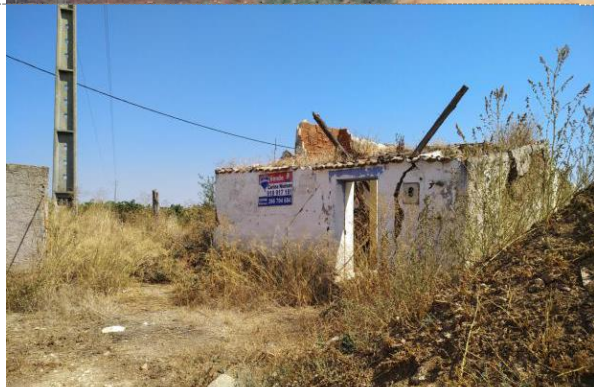
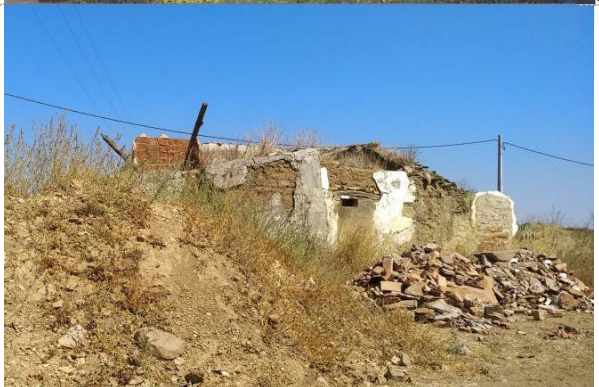
In 2018

The house is in ruins. The chimney and roof have fallen, walls are cracked and broken, there are debris and abandoned cars around the house. Wall extended in brick along east facade. Wall-bases repainted in blue (records from 2000 show yellow), door border also painted.

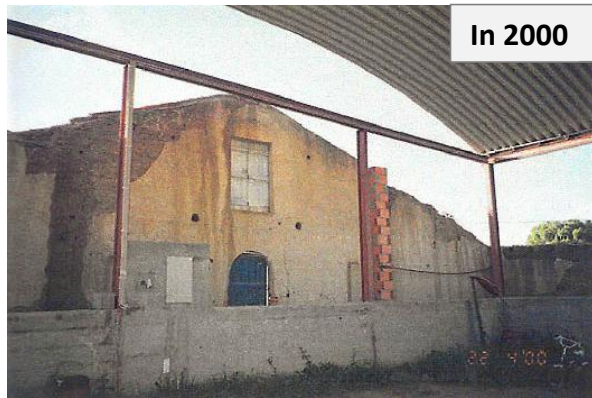
Interior view before the fire.

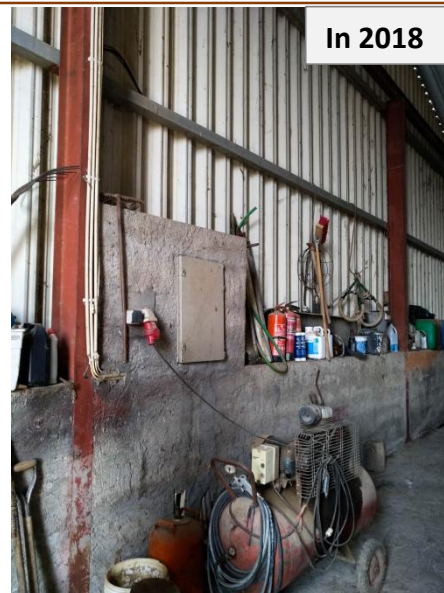
Interior view after the structure was rebuilt.

The building caught fire. No rammed-earth walls remain. It was **rebuilt**, and is covered on all four sides by cement blocks and metal sheets.

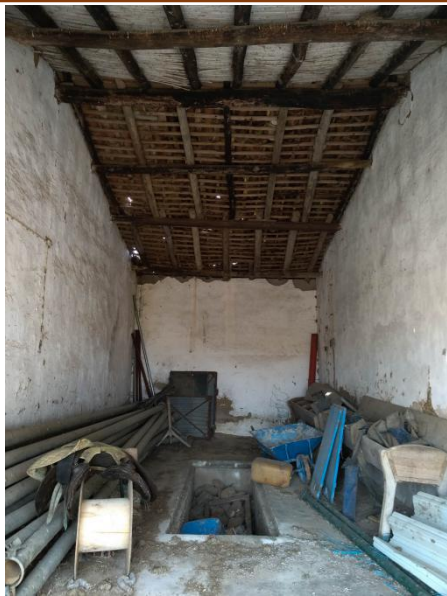
Interior view.

Observations: Warping, cracking and fallen plaster. Some floor-tiles chipped-off.

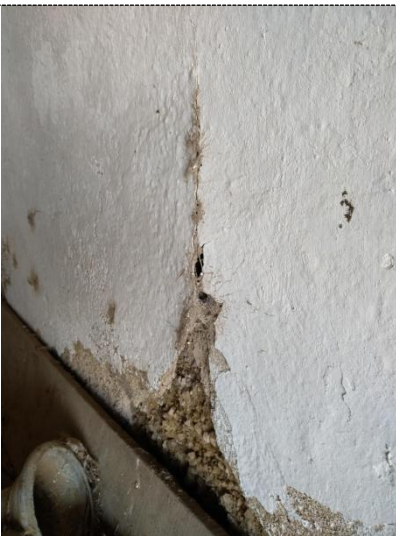
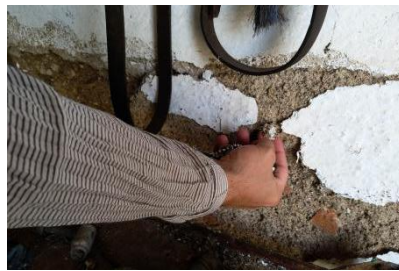
Damages incurred / problems faced: Warping, cracking and fallen plaster.

Repairs: The roof has been repaired many times.

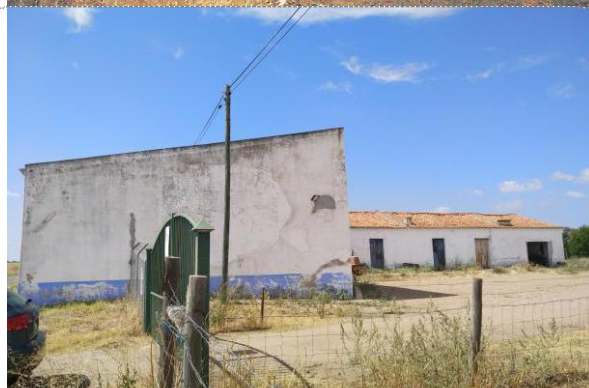
In 2018

Chimney no longer there, roof repaired, blue paint along wall-bases on front facades.

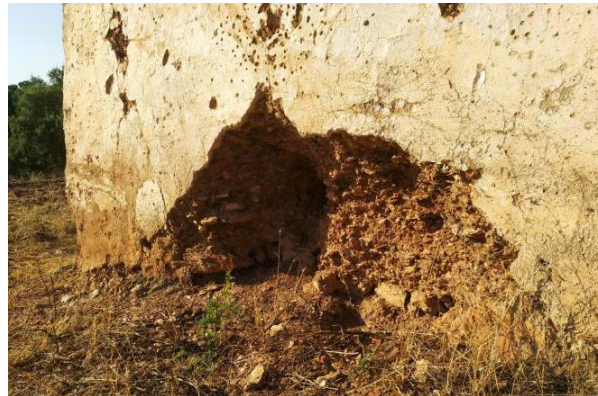
Damages incurred / problems faced: Holes in walls especially where there is lime-based plaster.

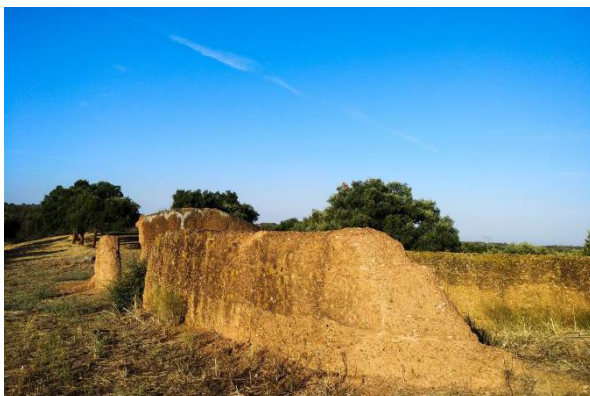
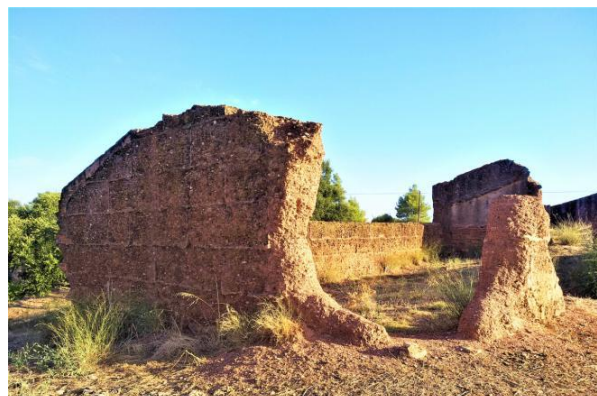
Damages incurred / problems faced: Wall damages got worse with time as the building has not had a roof for many years, some parts of the walls have fallen, vegetation in and around the structure.

Observations: Some parts of the walls have fallen, there are cracks, degraded bricks and mortars, graffiti on north wall, holes in walls especially where there is lime-based plaster, vegetation on and round the walls.

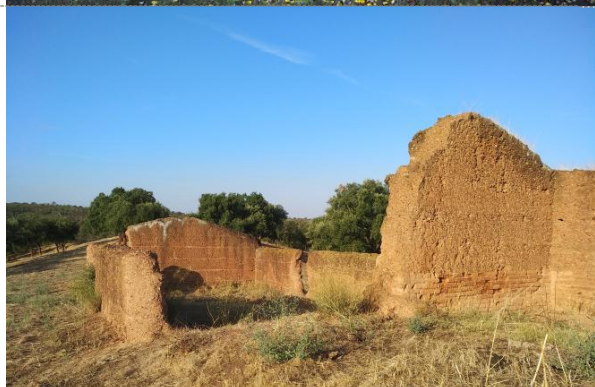
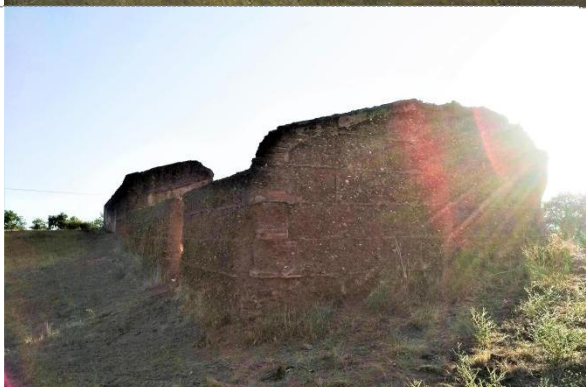
In 2018

Parts of rammed-earth walls have fallen.

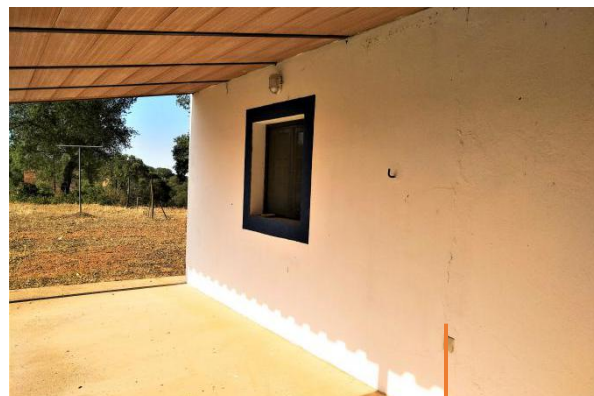
Damages incurred / problems faced: There is a vertical crack along the front facade; it demarcates the new extension.

Observations: There is a vertical crack along the front facade; it demarcates the new extension.
